# California Regional Water Quality Control Board Central Valley Region

1 March 2010

## **ADMINISTRATIVE CIVIL LIABILITY ORDER R5-2010-0508, DEL RAPINI CONSTRUCTION INC., PINE GROVE BLUFFS, AMADOR COUNTY**

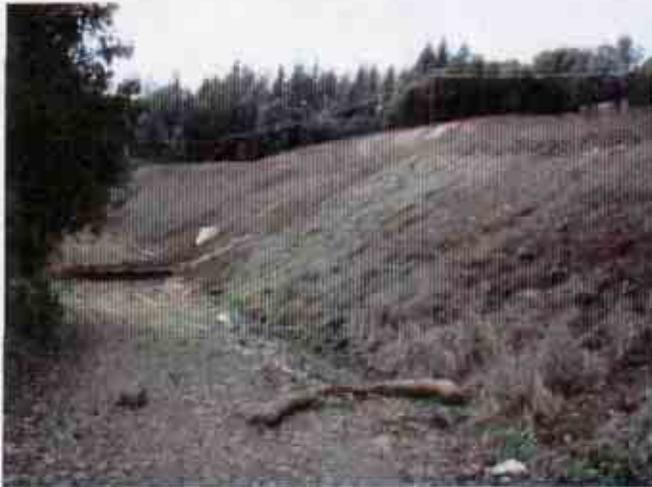
**Figure 1:** One of the discharge locations

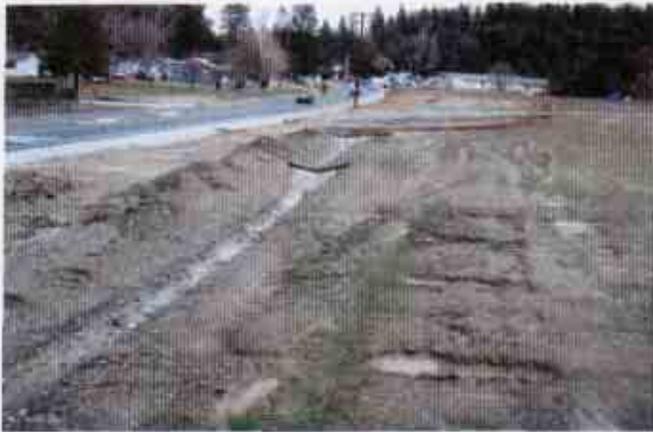
**Figure 7:** Poor erosion control BMPs

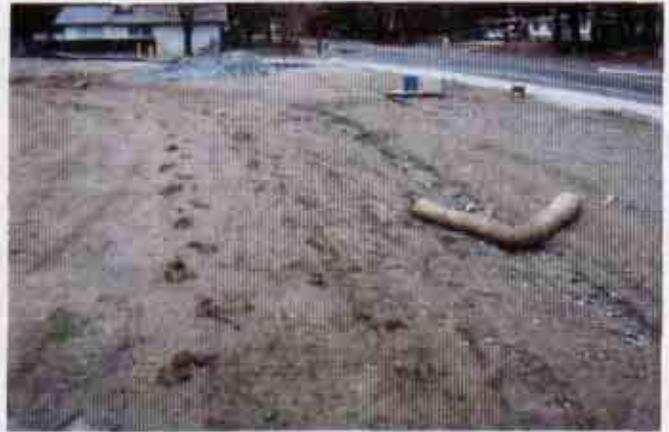
**Figure 8:** Another view of a portion of the project which requires additional BMPs

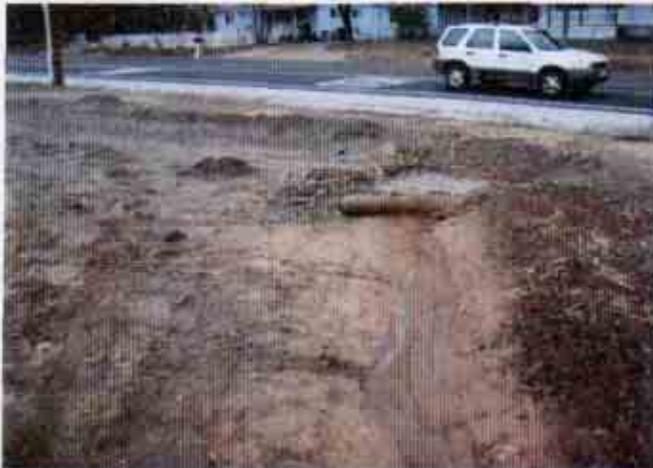
**Figure 9:** Poorly protected drain inlet

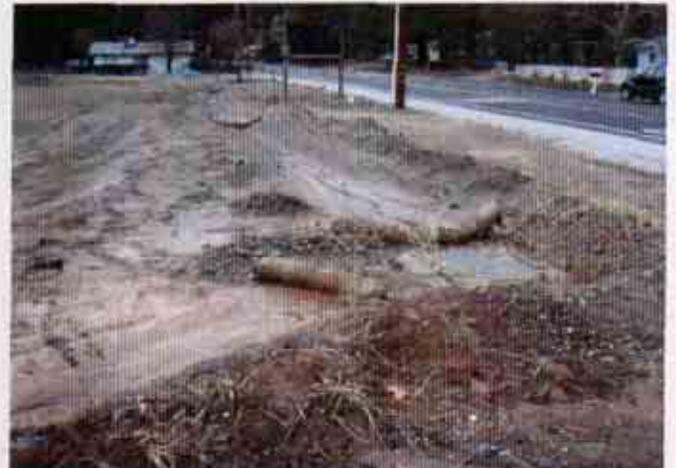
**Figure 10:** Another view of the protected drain inlet

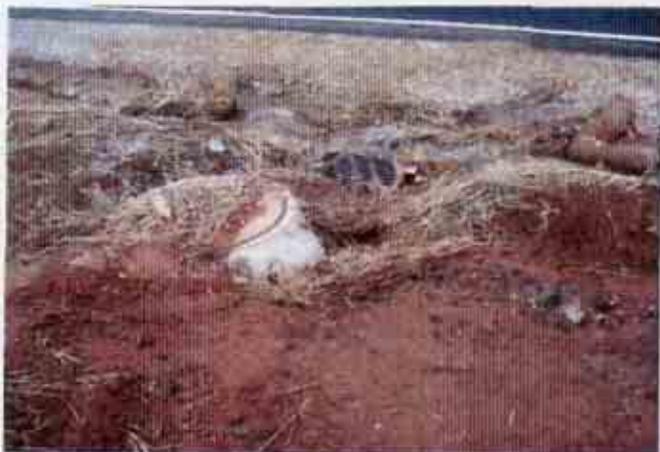
**Figure 11:** Another view of the protected drain inlet

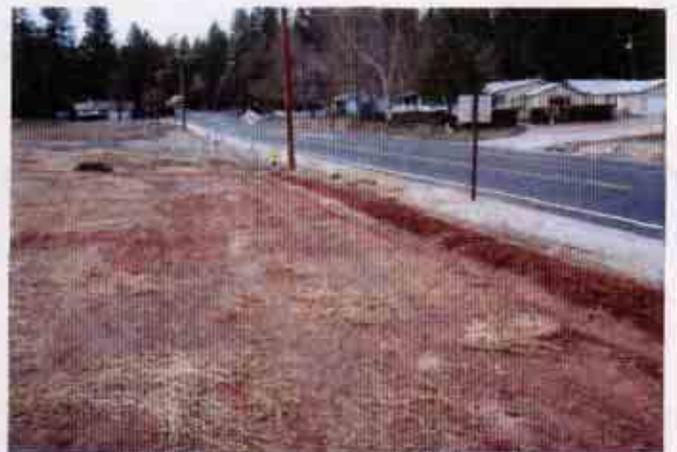
**Figure 12:** : Poor erosion control BMPs

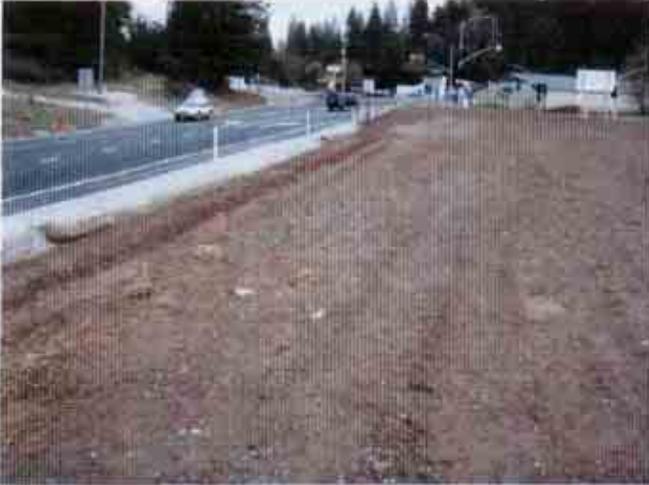
**Figure 13:** : Poor erosion control BMPs

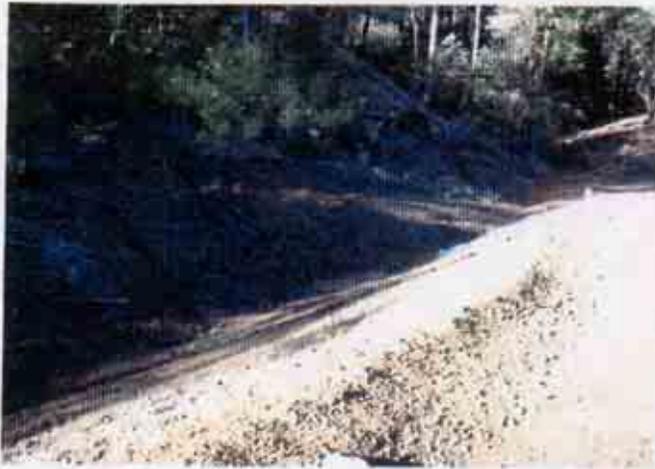
**Figure 1:** Area on the construction site that has not been effectively stabilized

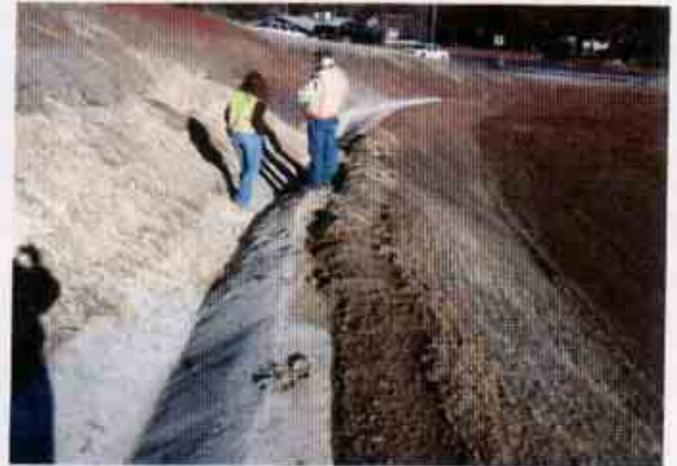
**Figure 2:** Erosion on the steep cut slope on the development

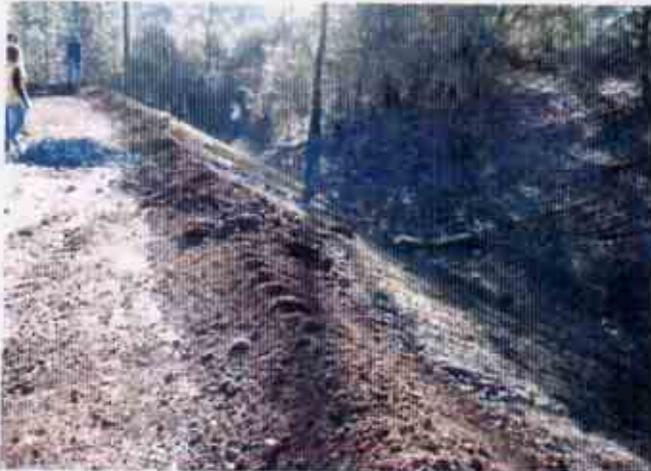
**Figure 3:** Another area that is poorly protected

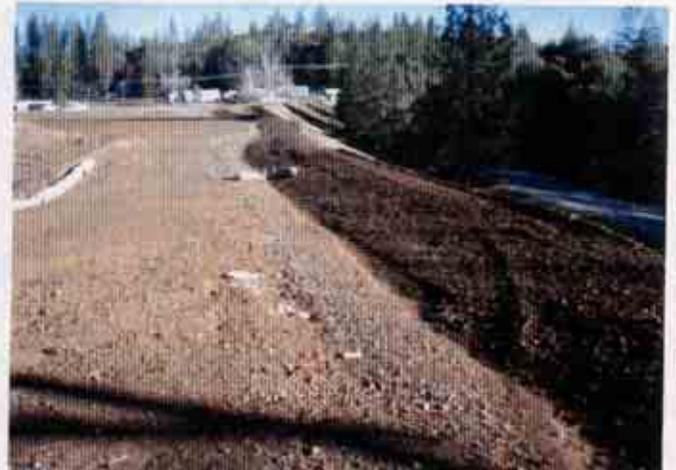
**Figure 4:** Lack of an effective combination of erosion and sediment control BMPs

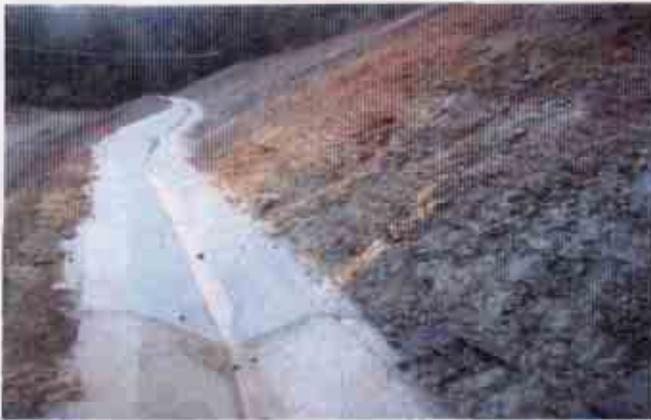
**Figure 1:** One of the many areas where soil is slumping on the steep slopes on the northern side of the project

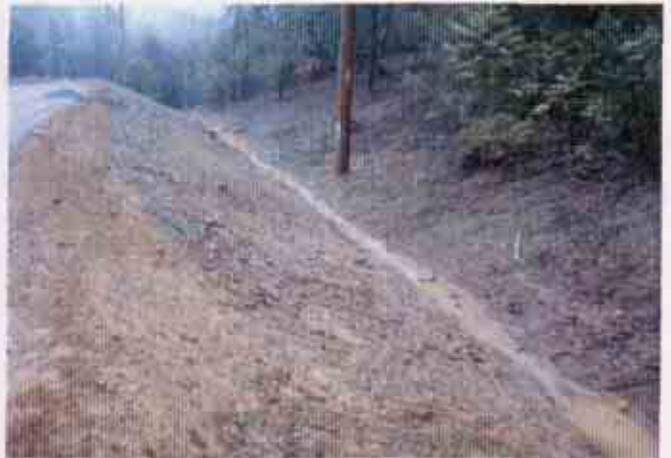
**Figure 4:** Lack of an effective combination of erosion and sediment control BMPs

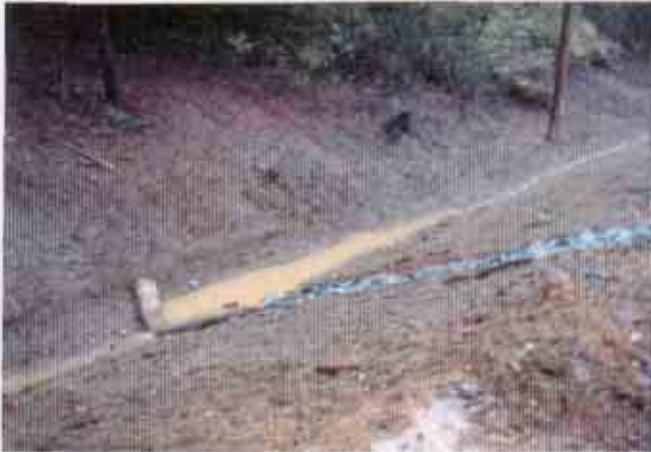
**Figure 7:** Lack of an effective combination of erosion and sediment control BMPs

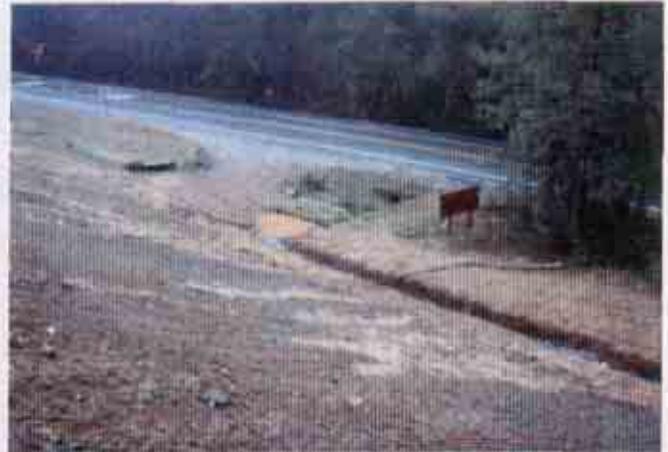
**Figure 8:** Partially protected slope Note: the turbid discharge leaving the site which flows directly under the roadway and into the creek

The discharge of sediment-laden water from your site is a violation of Discharge Prohibition A.3 of the General Permit, which states, *"Storm water discharges shall not cause or threaten to cause pollution, contamination, or nuisance."* Sediment-laden storm water from your construction site threatened to cause a condition of pollution and/or nuisance in Jackson Creek, therefore, is a violation of Prohibition A. 3. (See photographs 8, 15, 23-25).

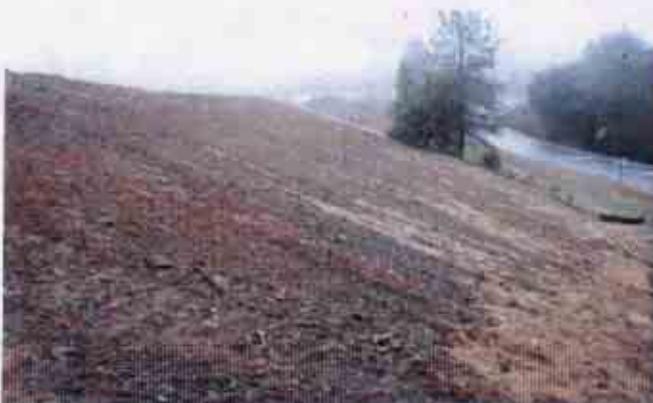
**Figure 9:** Poorly protected slopes

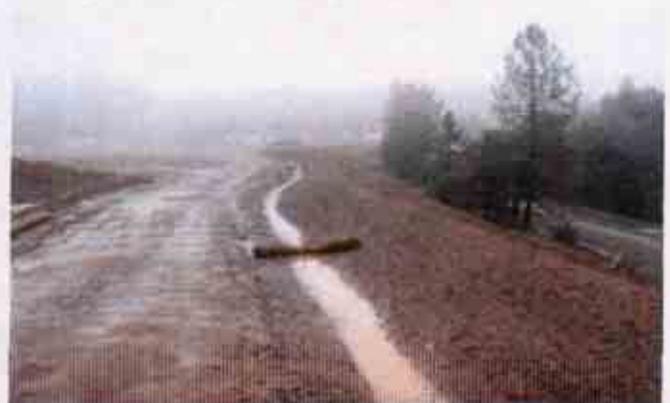
**Figure 10:** Lack of an effective combination of erosion and sediment control BMPs on a portion of the project

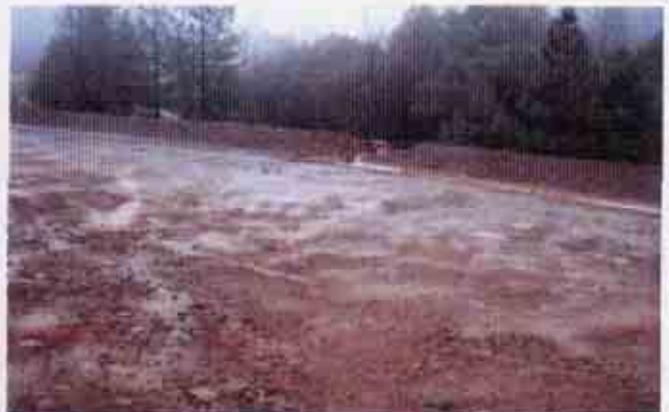
**Figure 12:** Lack of an effective combination of erosion and sediment control BMPs on still another portion of the project

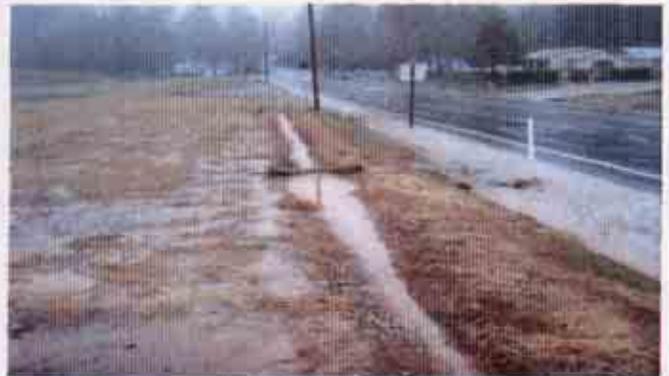
**Figure 16:** Storm water flowing on the site along Ridge Road

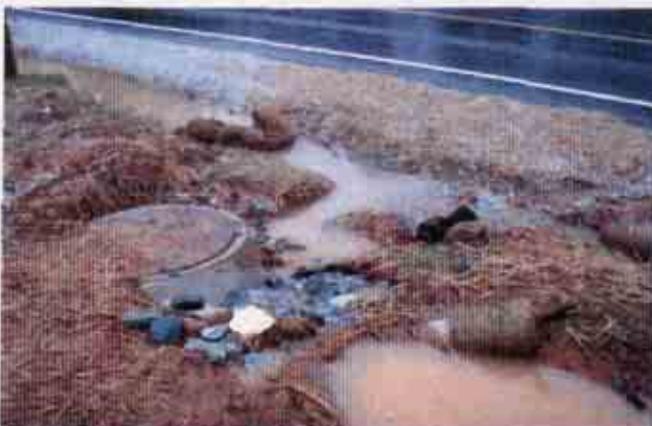
**Figure 17:** Poorly protected drain inlet along Ridge Road

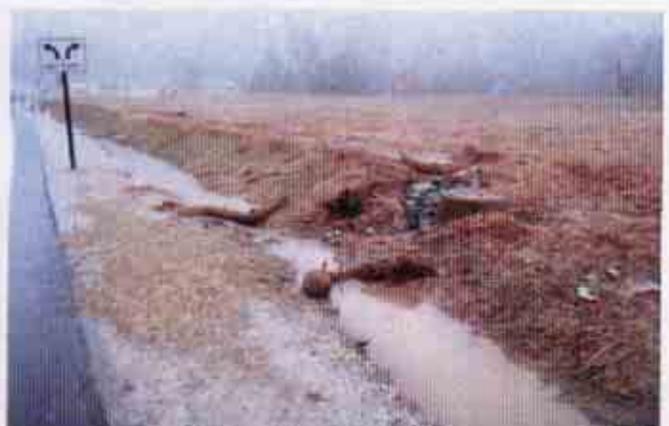
**Figure 18:** Another view of the poorly protected drain inlet

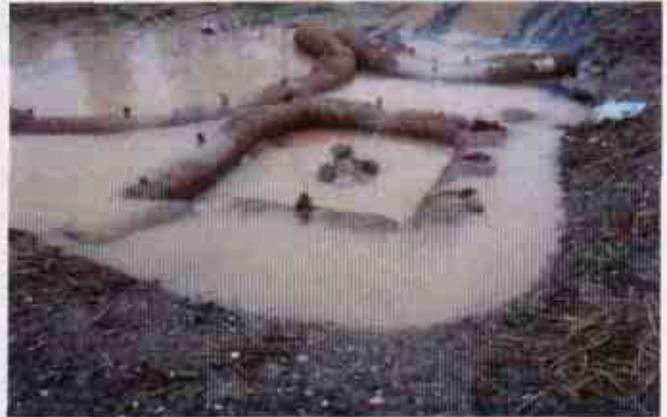
**Figure 20:** Pondered storm water around another drain inlet

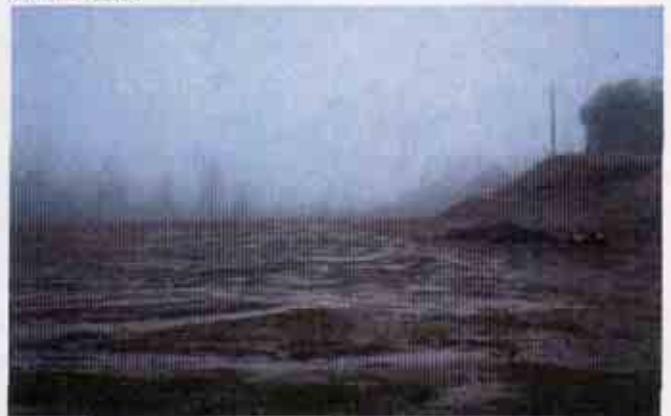
**Figure 22:** Lack of an effective combination of erosion and sediment control BMPs on another portion of the project

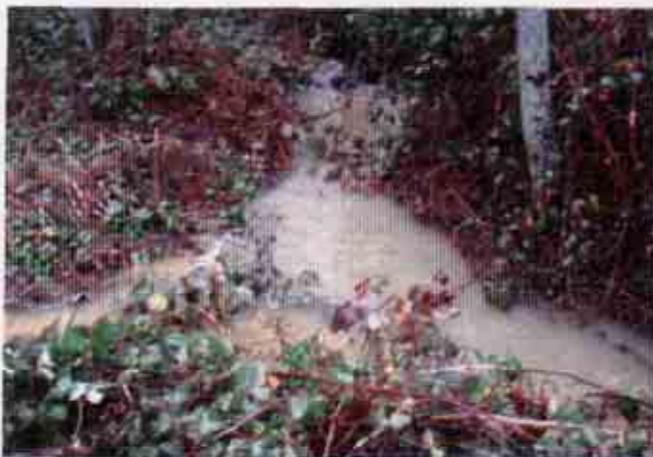
**Figure 23:** Storm water from the site mixing in the creek at one of the discharge locations Note: the storm water from the site is on the left hand side of the photograph

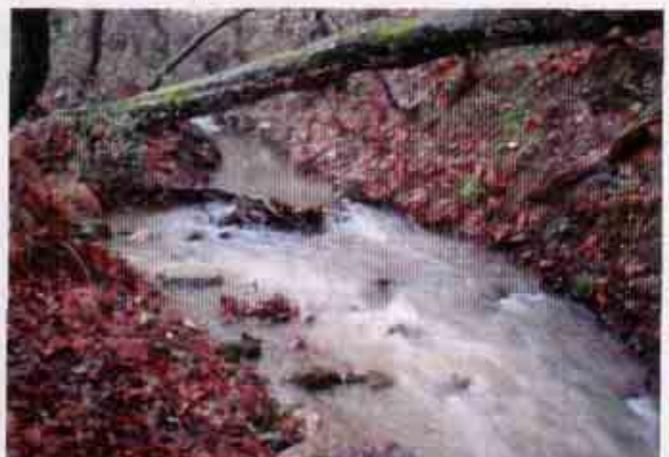
**Figure 24:** Storm water from the site mixing in the creek at another discharge location Note: the storm water from the site is on the left hand side of the photograph

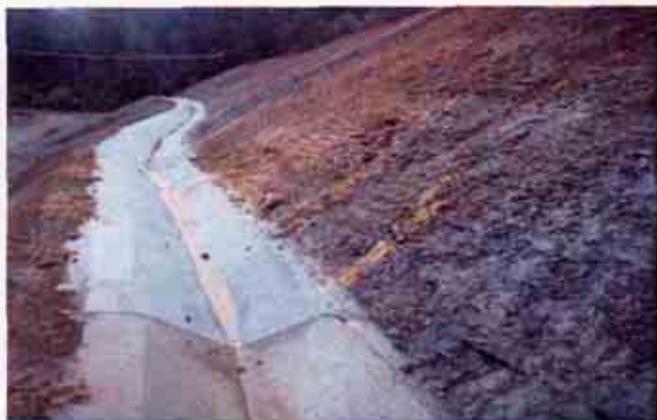
**Figure 1:** One of the many areas where soil is slumping on the steep slopes on the northern side of the project

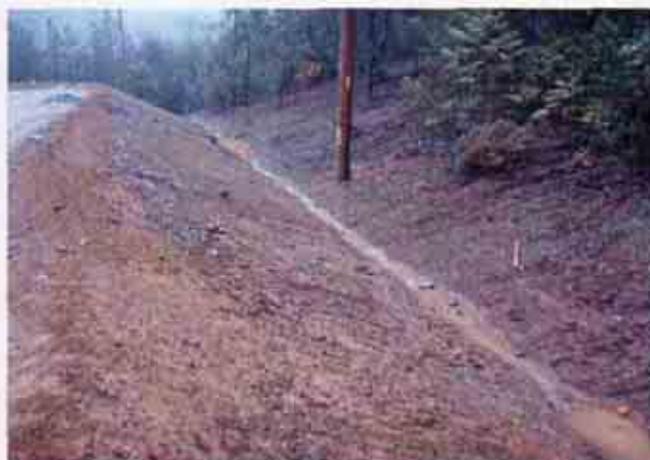
**Figure 4:** Lack of an effective combination of erosion and sediment control BMPs

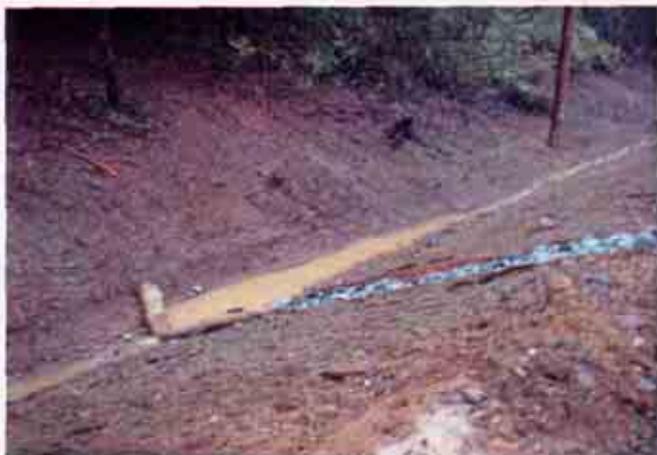
**Figure 7:** Lack of an effective combination of erosion and sediment control BMPs

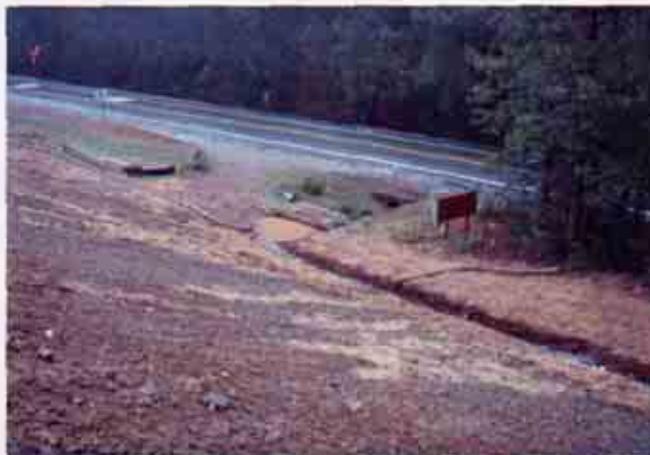
**Figure 8:** Partially protected slope Note: the turbid discharge leaving the site which flows directly under the roadway and into the creek

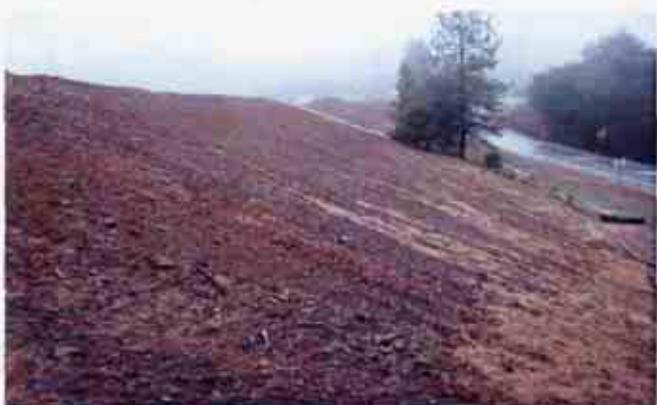
**Figure 9:** Poorly protected slopes

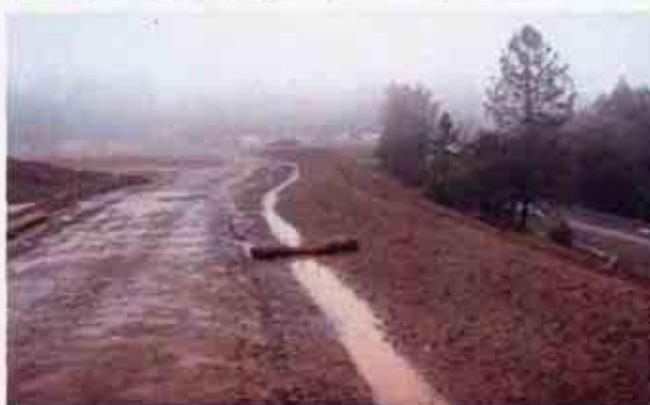
**Figure 10:** Lack of an effective combination of erosion and sediment control BMPs on a portion of the project

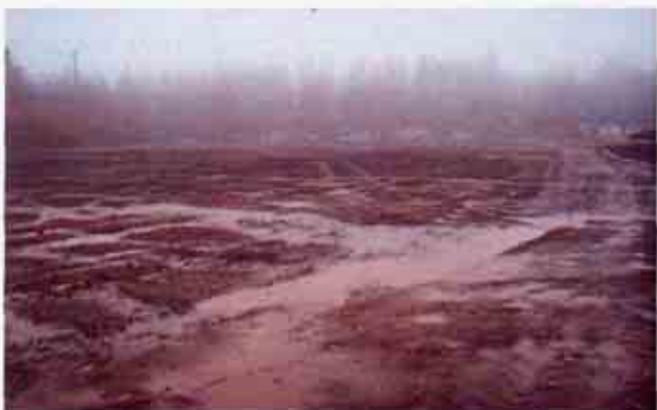
**Figure 11:** Lack of an effective combination of erosion and sediment control BMPs on another portion of the project

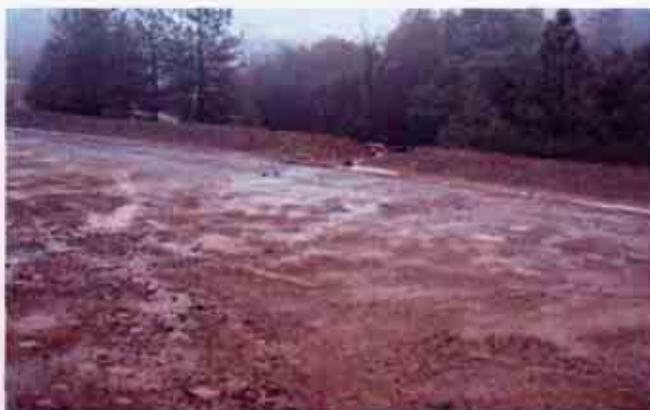
**Figure 12:** Lack of an effective combination of erosion and sediment control BMPs on still another portion of the project

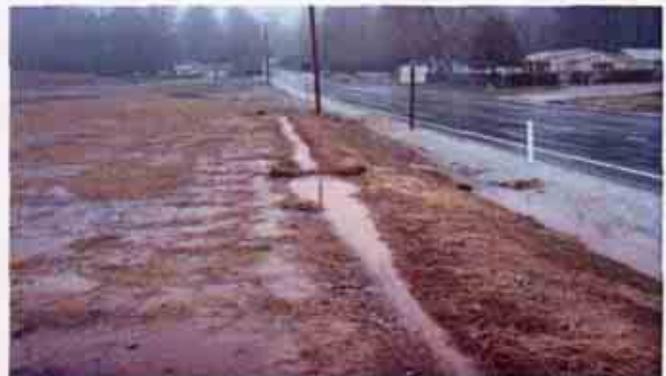
**Figure 16:** Storm water flowing on the site along Ridge Road

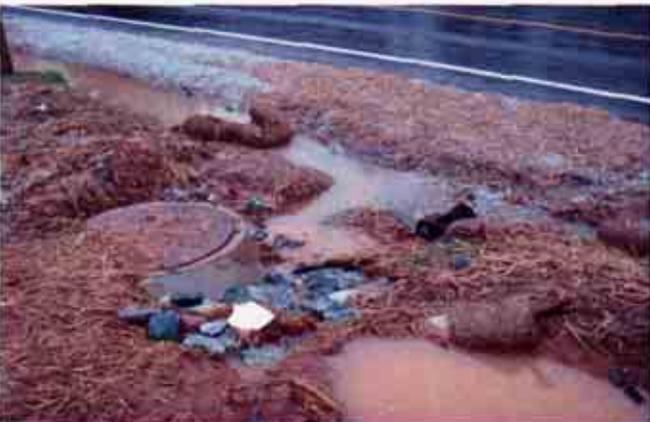
**Figure 17:** Poorly protected drain inlet along Ridge Road

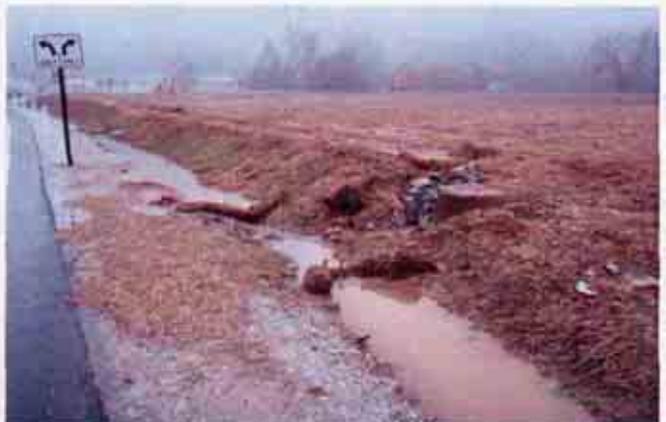
**Figure 18:** Another view of the poorly protected drain inlet

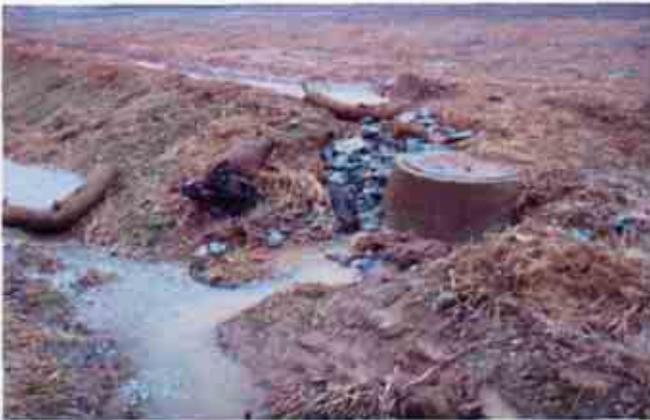
**Figure 19:** Another view of the same area

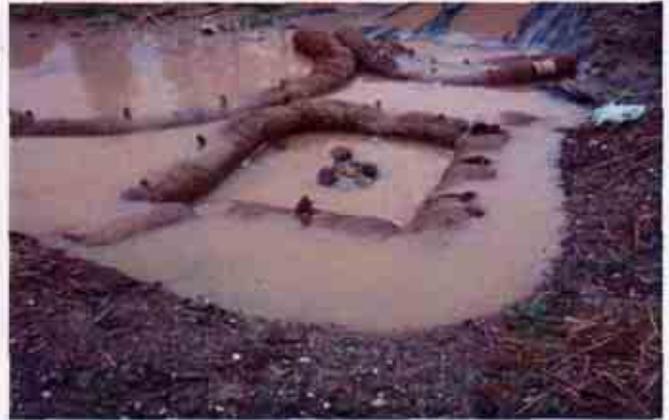
**Figure 20:** Pondered storm water around another drain inlet

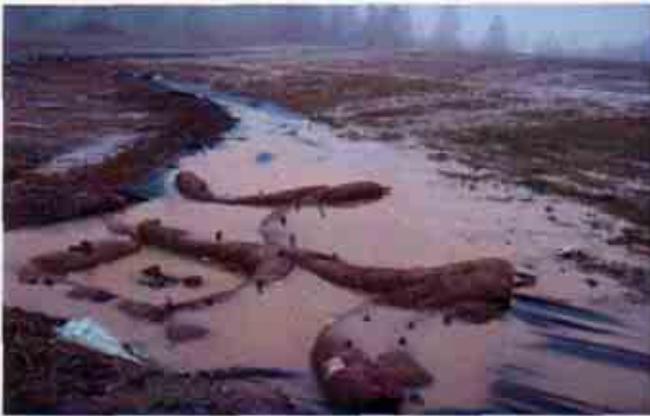
**Figure 21:** Still another view of the same area

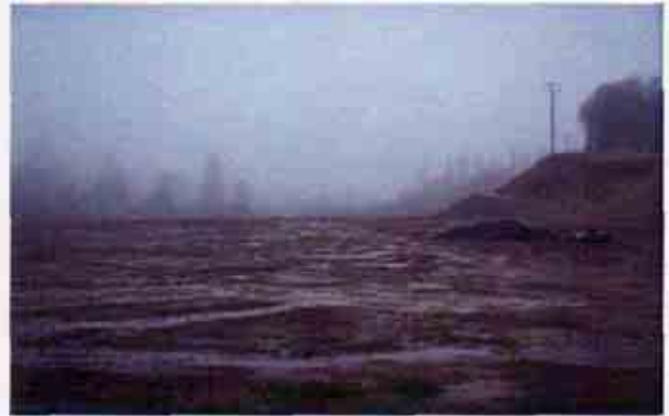
**Figure 22:** Lack of an effective combination of erosion and sediment control BMPs on another portion of the project

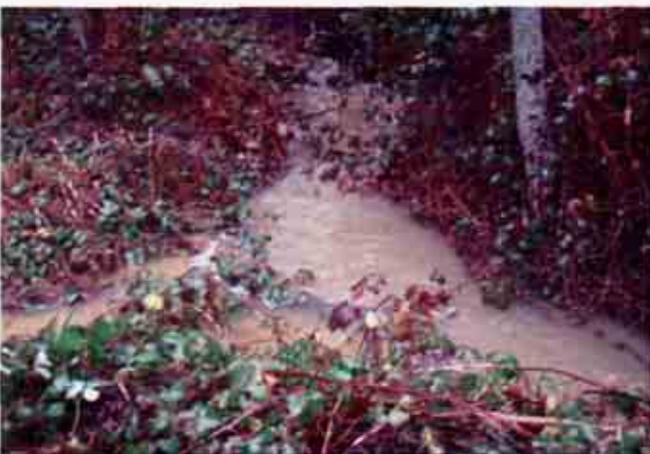
**Figure 23:** Storm water from the site mixing in the creek at one of the discharge locations. Note: the storm water from the site is on the left hand side of the photograph

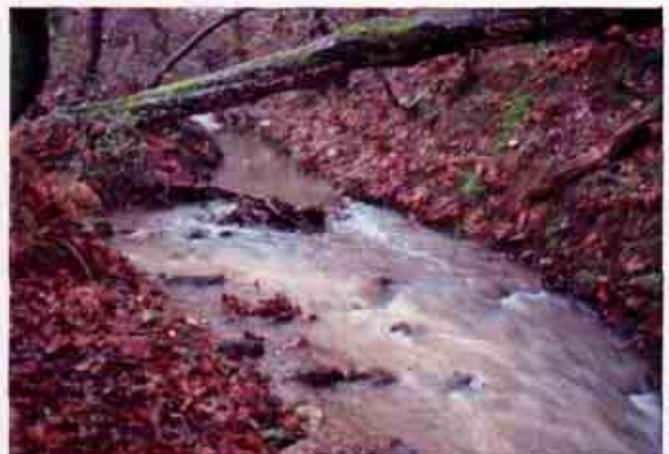
**Figure 24:** Storm water from the site mixing in the creek at another discharge location. Note: the storm water from the site is on the left hand side of the photograph

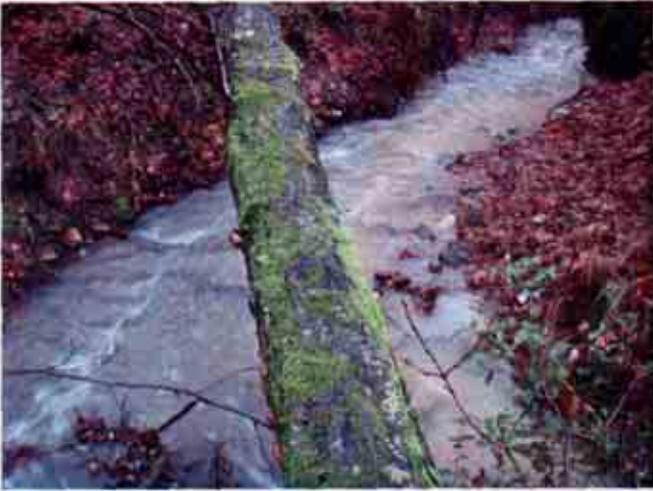
**Figure 25:** Another view of the same area

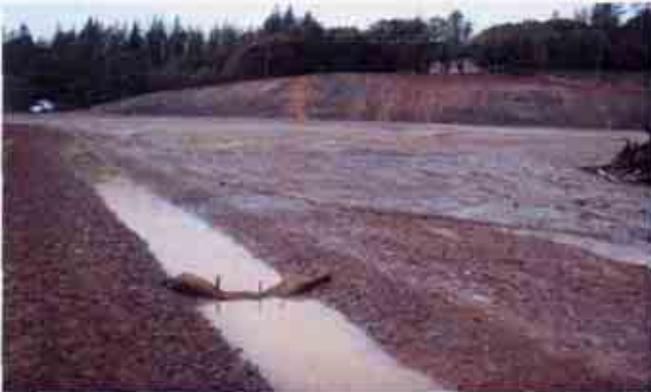
**Figure 3:** Another view of a portion of the project. Note the lack of BMPs.

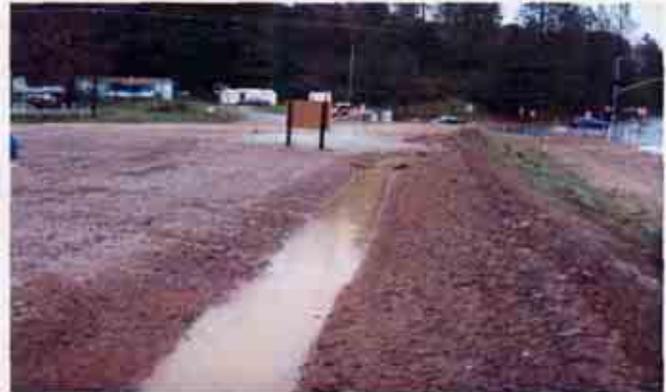
**Figure 4:** Another portion of the project.

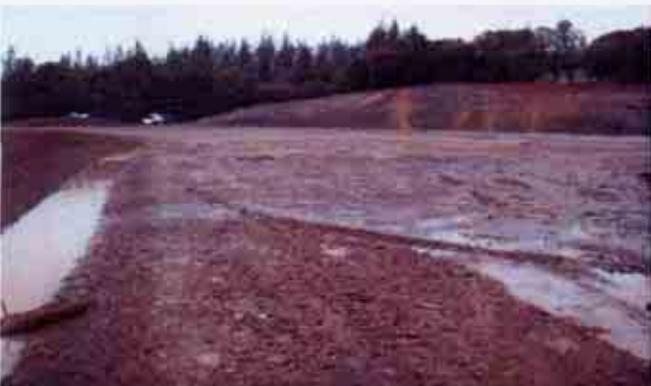
**Figure 5:** Another view of the graded area.

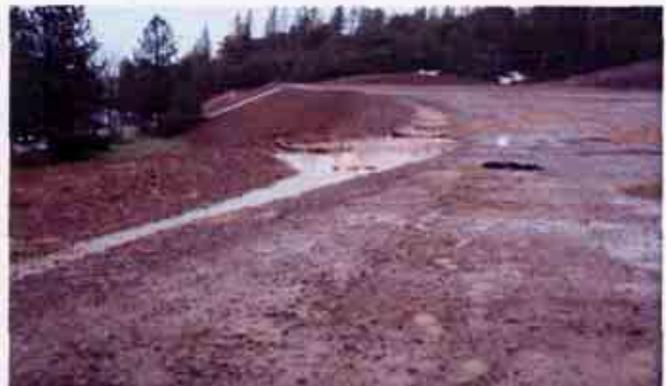
**Figure 6:** Turbid storm water discharging into the culvert.

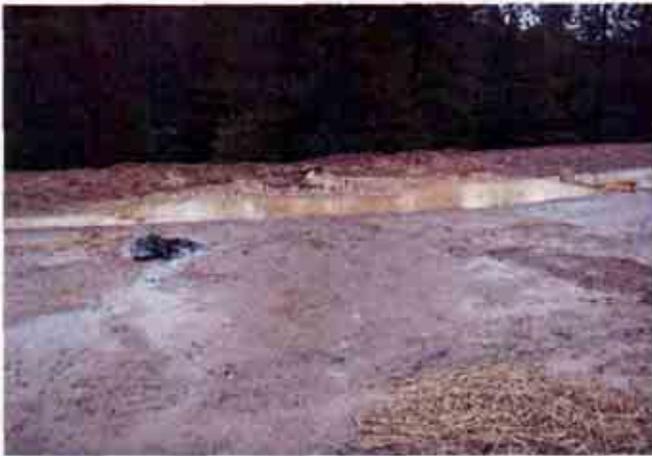
**Figure 7:** Turbid storm water sheet flowing to a culvert which conveys storm water down slope.

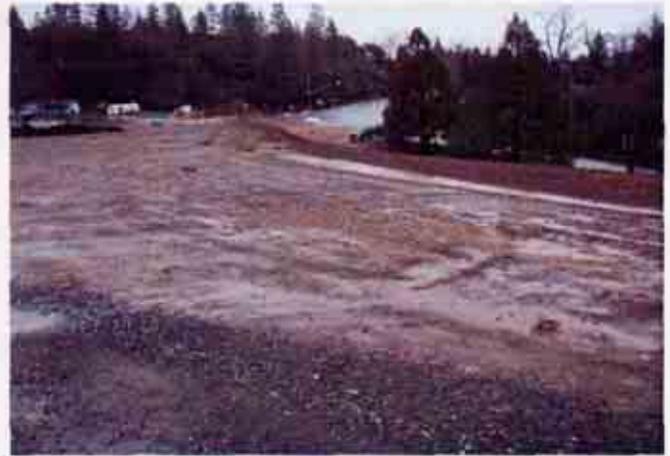
**Figure 8:** Another portion of the project without effective storm water management BMPs.

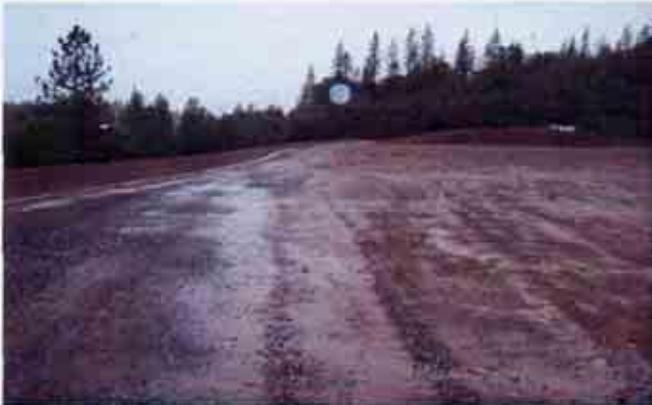
**Figure 9:** Another view of a portion of the flat pad without effective BMPs.

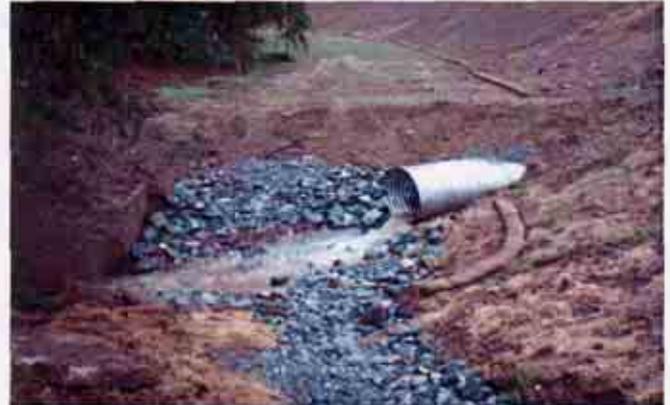
**Figure 10:** Turbid discharge from the project flowing from the eastern culvert.

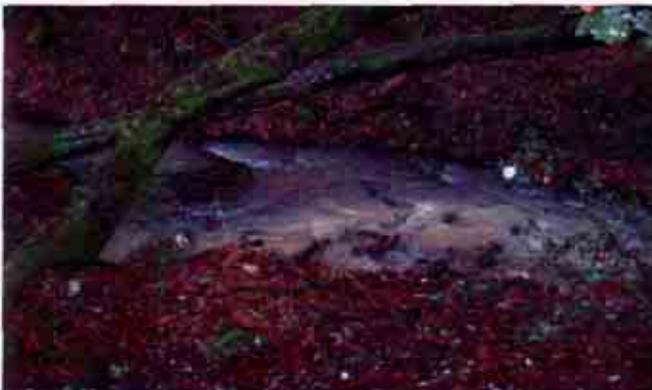
The discharge of sediment-laden water from your site is a violation of Discharge Prohibition A.3 of the General Permit, which states, "Storm water discharges shall not cause or threaten to cause pollution, contamination, or nuisance." Sediment-laden storm water discharges from your construction site threatened to cause a condition of pollution and/or nuisance in Jackson Creek; therefore, you are in violation of Prohibition A. 3 (see photographs 11, 17, 18).

**Figure 11:** Turbid discharge from the eastern culvert mixing with clear flow in Jackson Creek.

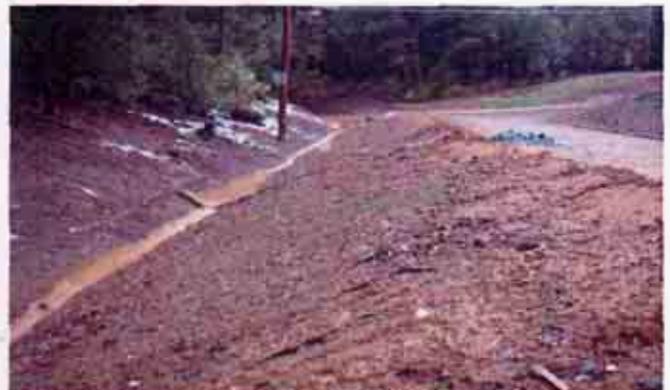
**Figure 12:** Partially stabilized slope on the western side of the project.

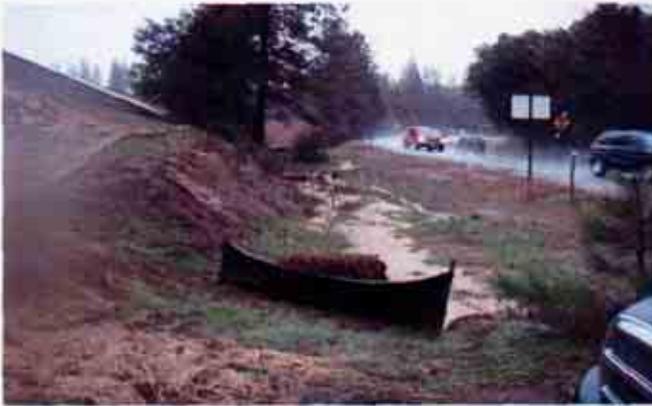
**Figure 13:** Discharge from the site flowing along the Highway 88 right of way.

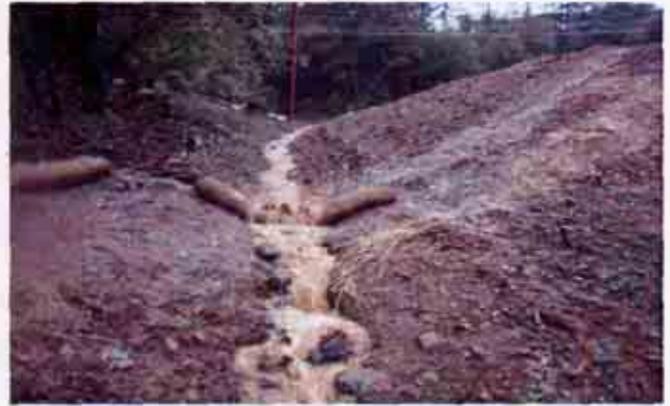
**Figure 14:** Discharge from the site cutting into the bank on the western side of the project.

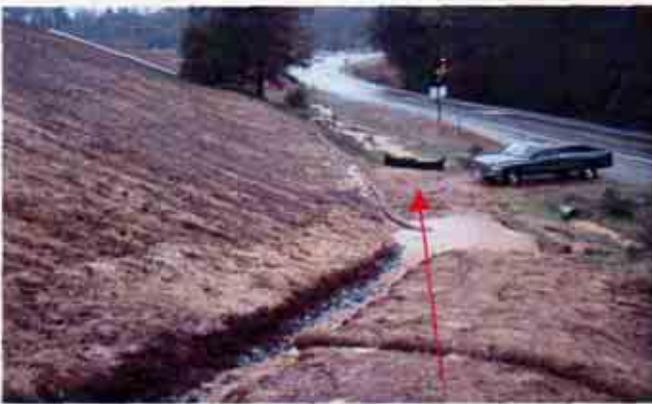
**Figure 15:** Turbid storm water from the project flowing down to the discharge location.

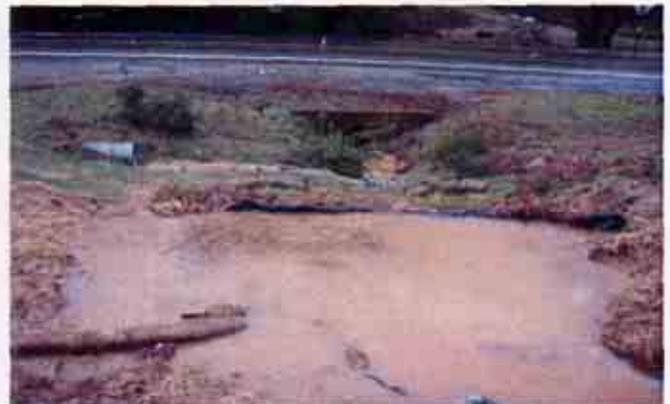
**Figure 16:** Very turbid storm water from the site discharging into the western culvert.

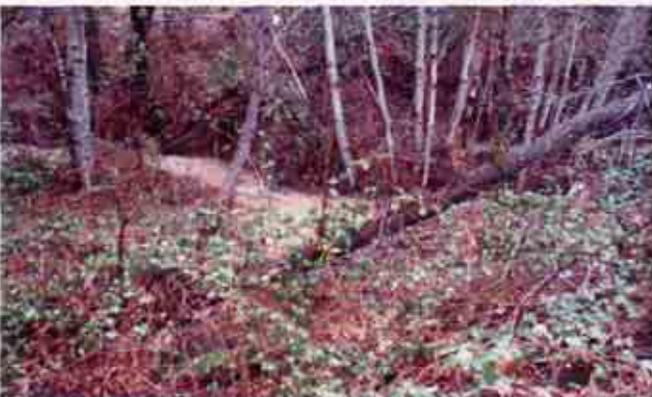
**Figure 17:** Storm water from the western culvert mixing in Jackson Creek. The water in Jackson Creek was already turbid from the upstream discharge from the eastern culvert of the project shown in Figure 10

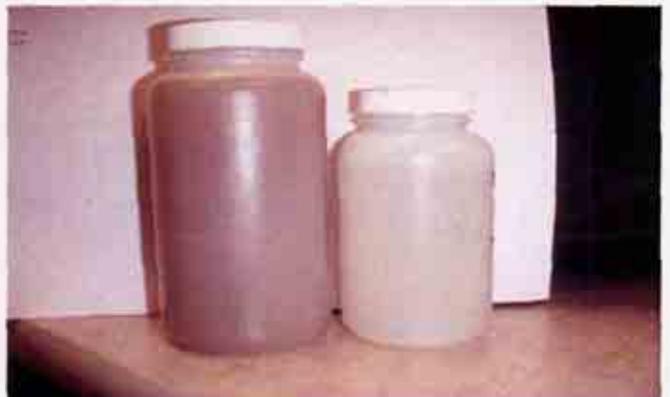
**Figure 18:** Bottles with water samples taken from Jackson Creek. The larger one was taken at the western culvert with a turbidity of over 900 NTUs. The smaller one was taken upstream of site, with a turbidity of 30 NTUs.

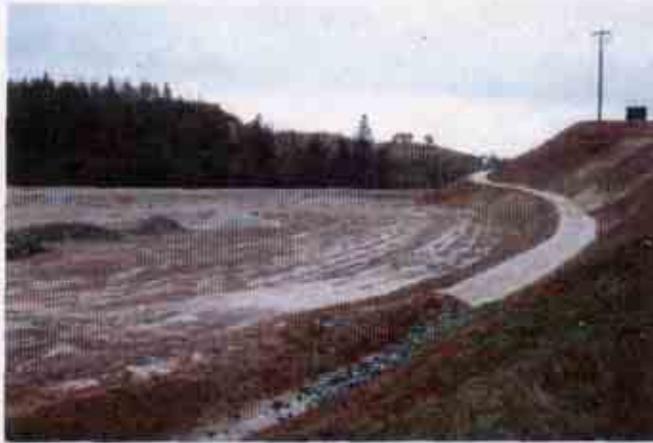
**Figure 1:** Lack of an effective combination of erosion and sediment control BMPs

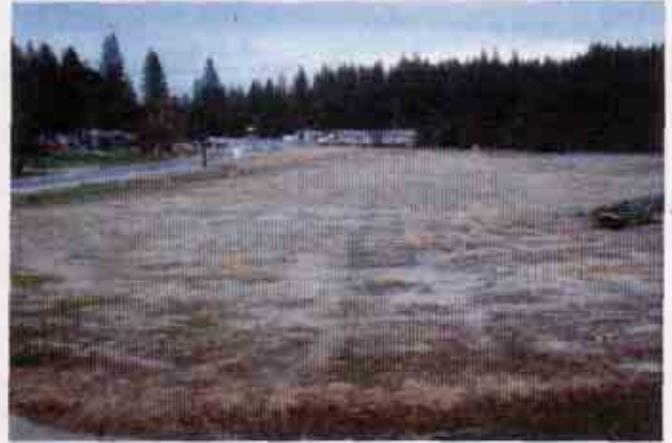
**Figure 2:** Lack of an effective combination of erosion and sediment control BMPs

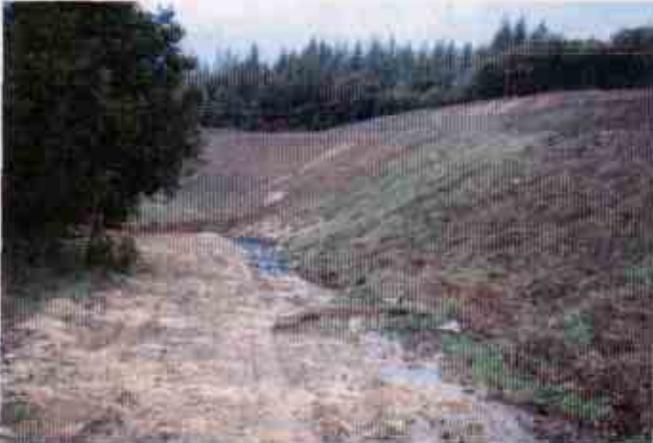
**Figure 3:** Storm water from the site flowing in a channel adjacent to highway 88 right-of-way

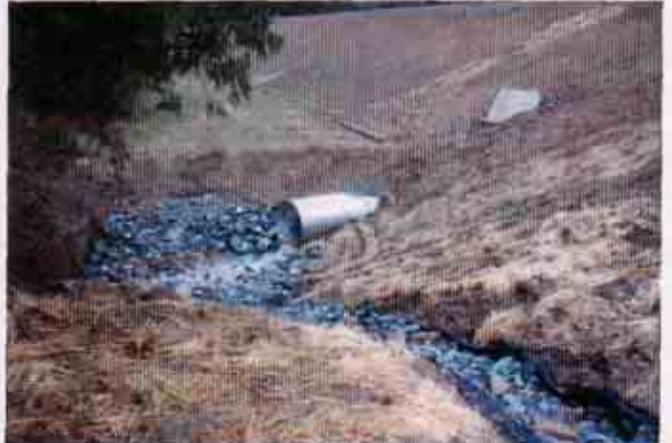
**Figure 4:** Turbid storm water discharging into the eastern culvert

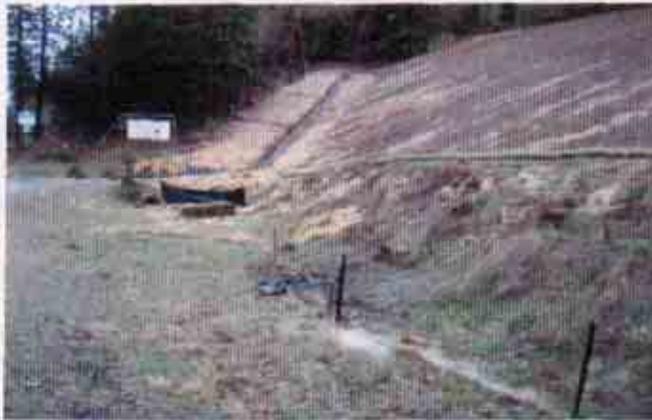
**Figure 7:** Storm water in the Caltrans right-of-way flowing to the western discharge location

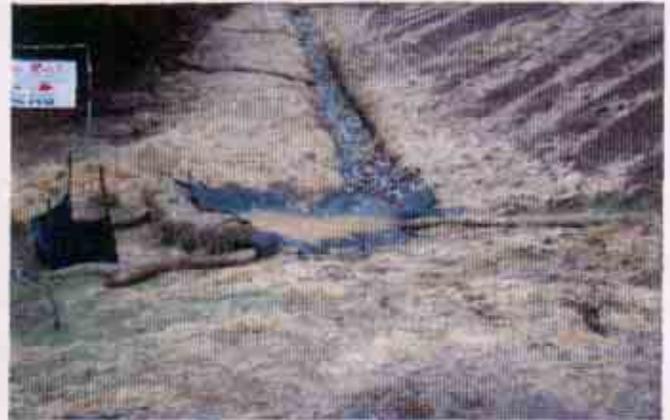
**Figure 8:** Turbid storm water flowing down to the western discharge location

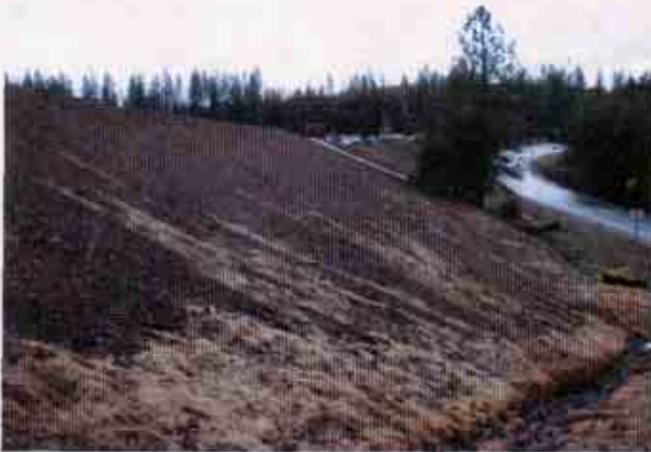
**Figure 9:** Lack of an effective combination of erosion and sediment control BMPs on the slope adjacent to Highway 88

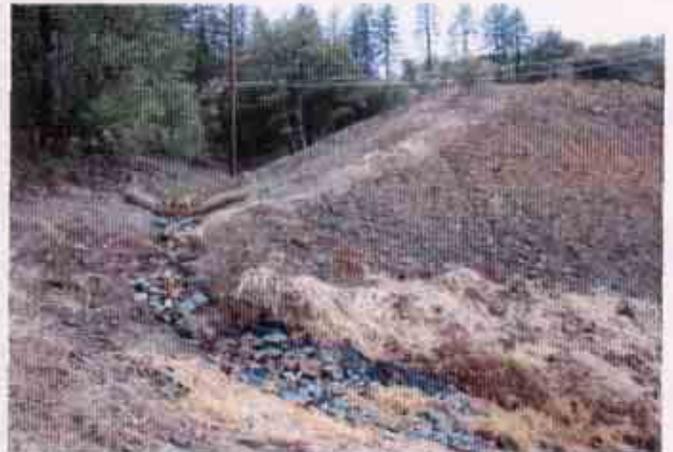
**Figure 10:** Lack of effective BMPs upslope of the western discharge location. Note: the large rill that is forming at the top of the slope

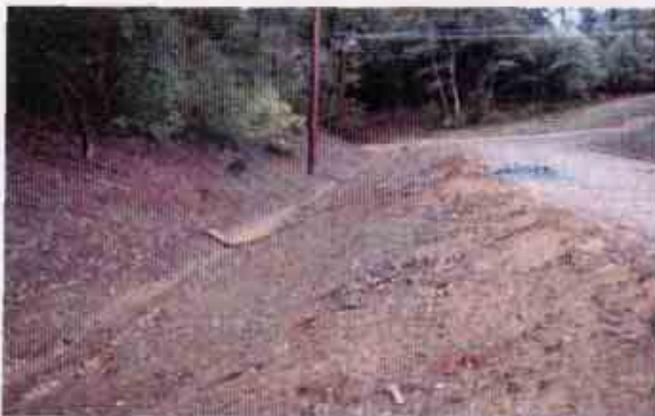
**Figure 11:** Lack of effective BMPs on top of the slope above the western discharge location

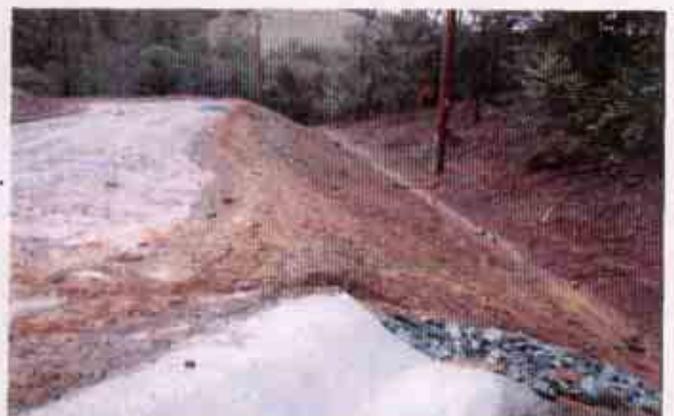
**Figure 12:** Area where concrete drain along the slope discharges into the area that flows down to the western discharge location. Note: the lack of BMPs other than rip-rap

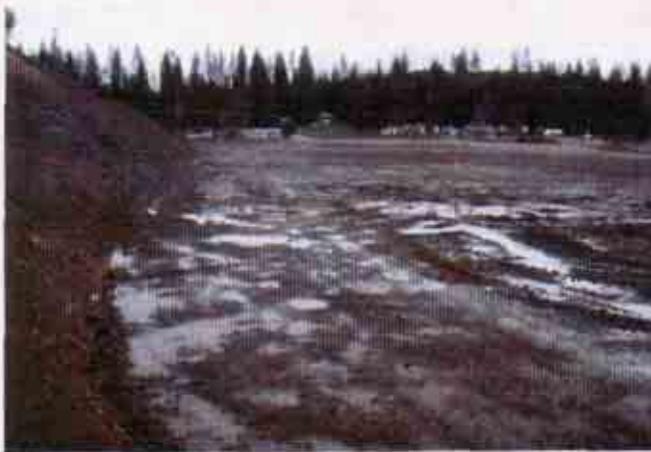
**Figure 13:** Lack of an effective combination of erosion and sediment control BMPs

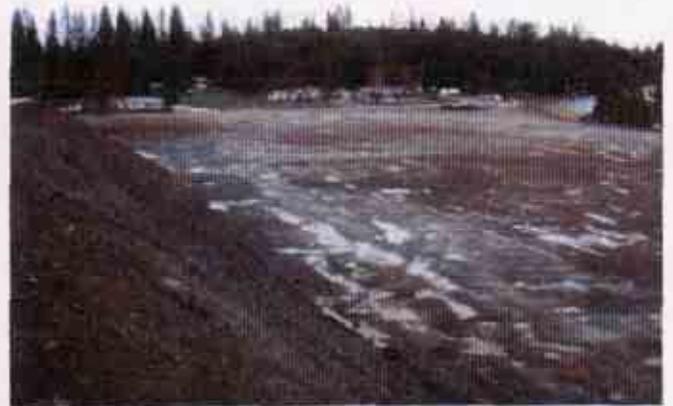
**Figure 14:** Lack of an effective combination of erosion and sediment control BMPs

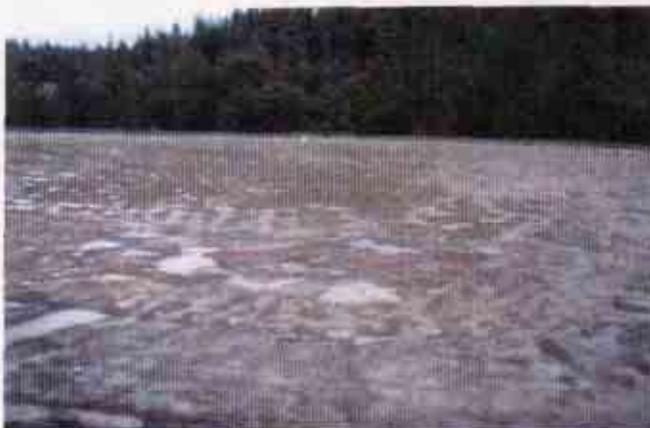
**Figure 15:** Lack of an effective combination of erosion and sediment control BMPs

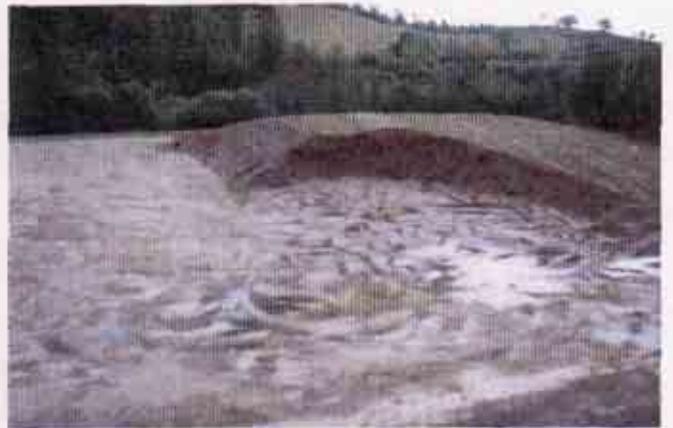
**Figure 16:** Lack of an effective combination of erosion and sediment control BMPs Note: the poorly stabilized stockpile
