# California Regional Water Quality Control Board Central Valley Region

1 March 2010

## **ADMINISTRATIVE CIVIL LIABILITY ORDER R5-2010-0508, DEL RAPINI CONSTRUCTION INC., PINE GROVE BLUFFS, AMADOR COUNTY**

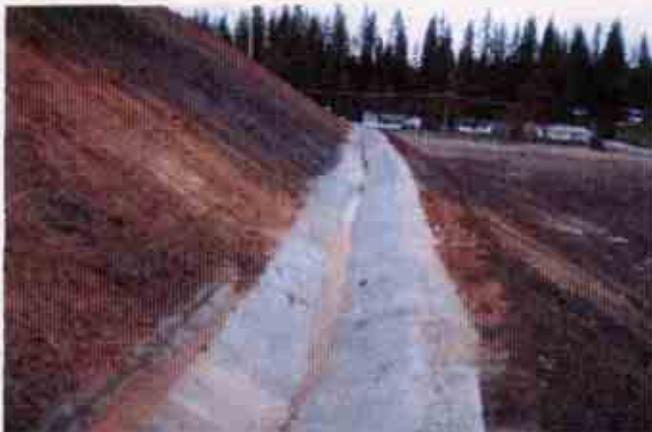
**Figure 17:** Turbid storm water in the concrete channel that runs along the slope on the northern side of the project

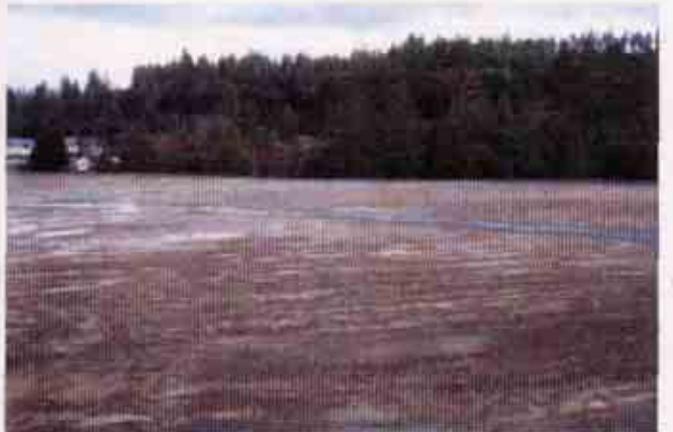
**Figure 18:** Lack of an effective combination of erosion and sediment control BMPs

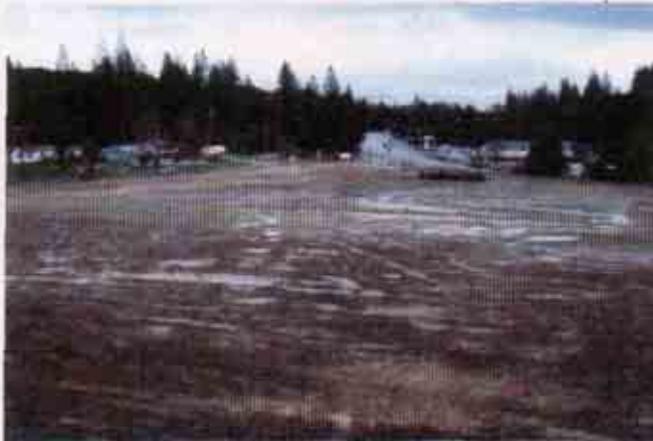
**Figure 19:** Lack of an effective combination of erosion and sediment control BMPs

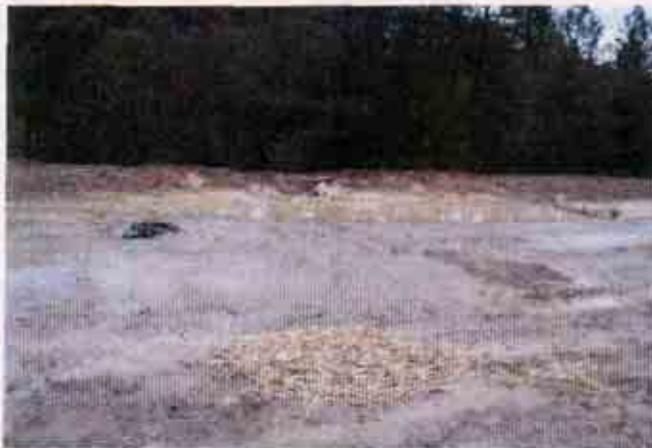
**Figure 20:** Lack of an effective combination of erosion and sediment control BMPs

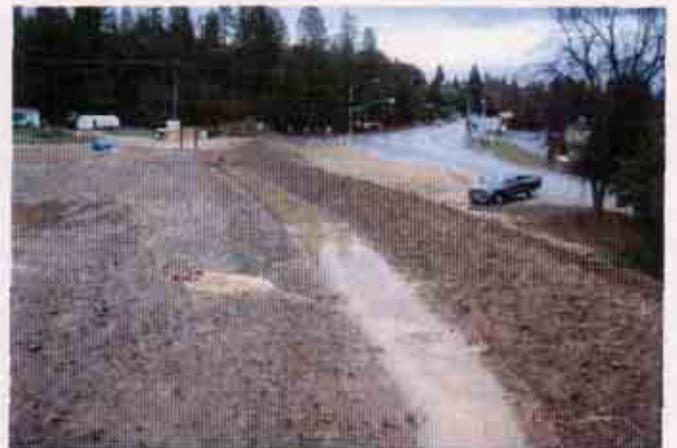
**Figure 21:** Lack of an effective combination of erosion and sediment control BMPs Note: the turbid storm water ponded adjacent to one of the discharge locations

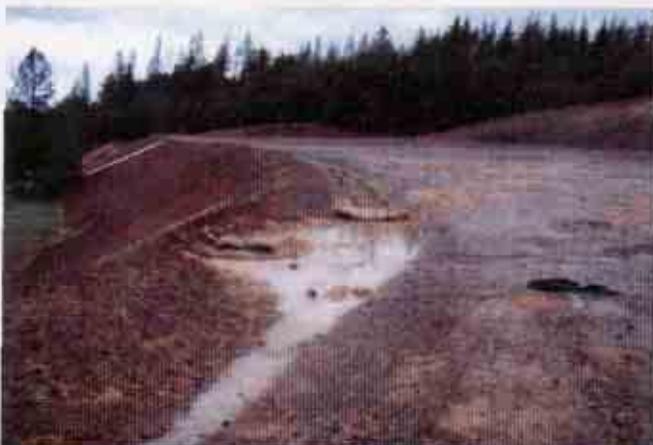
**Figure 22:** Turbid storm water flowing on the site Note: the lack of effective storm water management BMPs

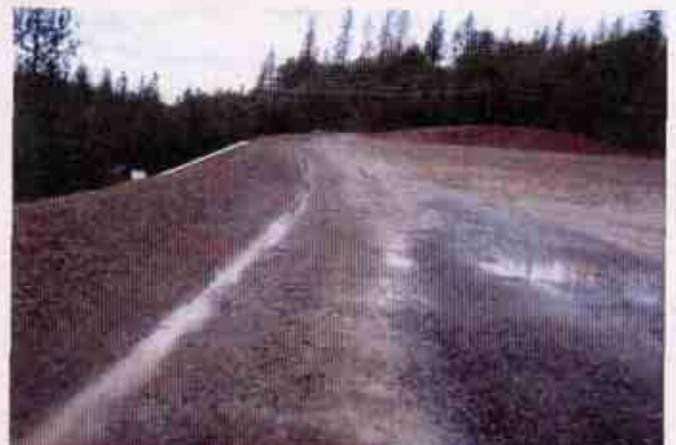
**Figure 23:** Turbid storm water ponded onsite just prior to discharge into the eastern culvert

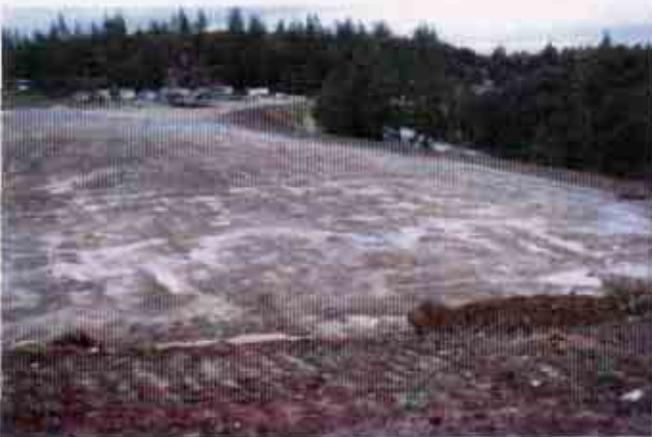
**Figure 26:** Lack of an effective combination of erosion and sediment control BMPs around one of the discharge locations

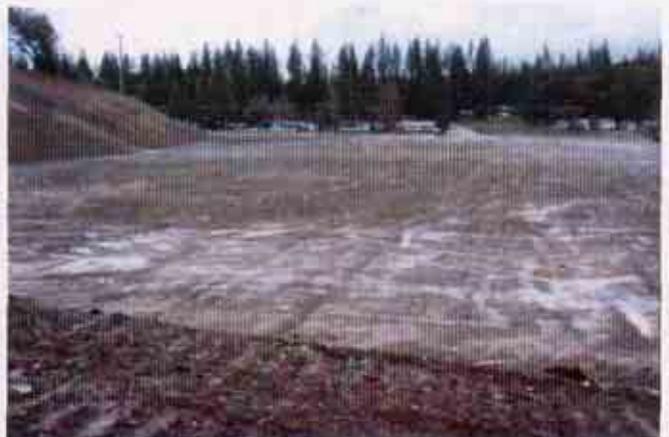
**Figure 27:** Lack of an effective combination of erosion and sediment control BMPs

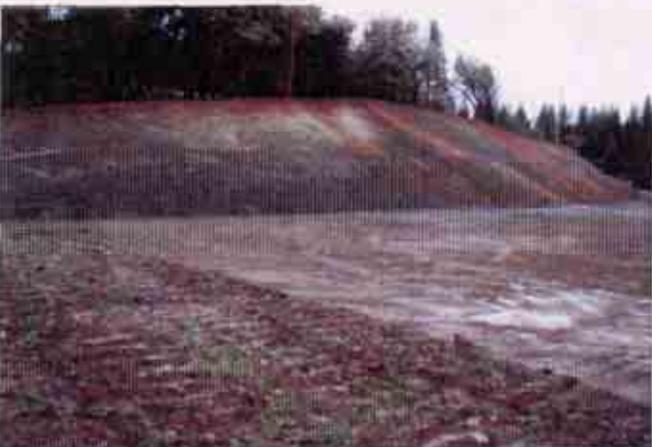
**Figure 28:** Lack of an effective combination of erosion and sediment control BMPs

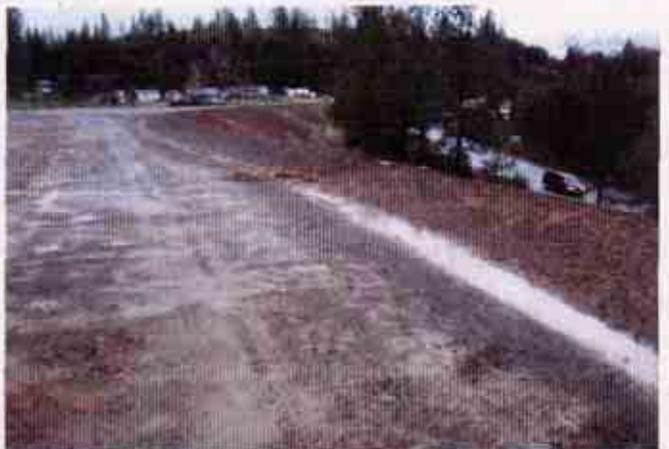
**Figure 29:** Lack of an effective combination of erosion and sediment control BMPs

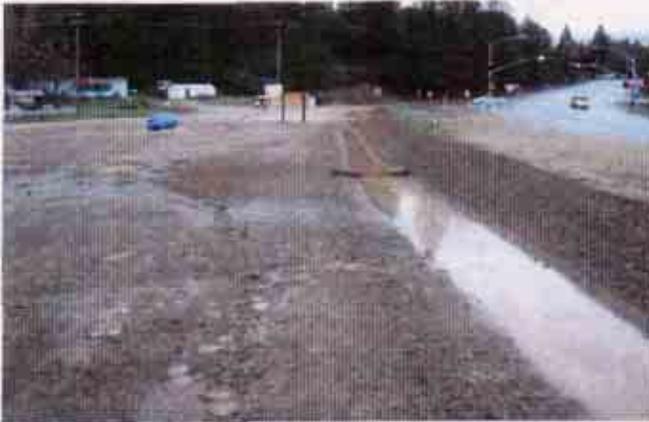
**Figure 30:** Lack of an effective combination of erosion and sediment control BMPs

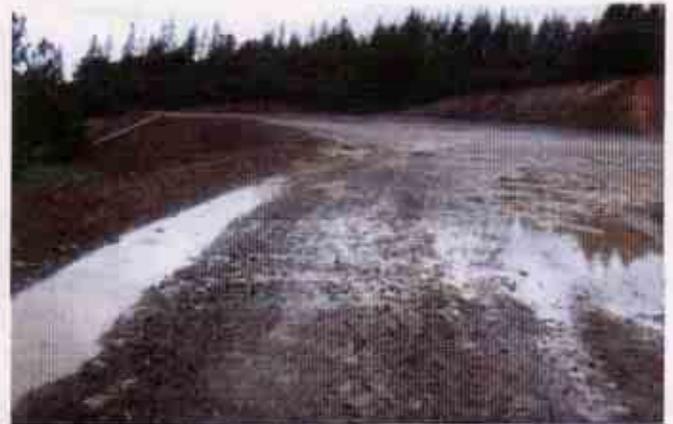
**Figure 31:** Lack of an effective combination of erosion and sediment control BMPs

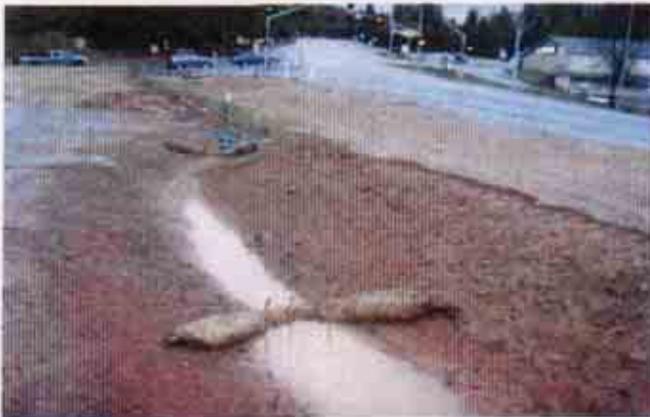
**Figure 32:** Lack of an effective combination of erosion and sediment control BMPs

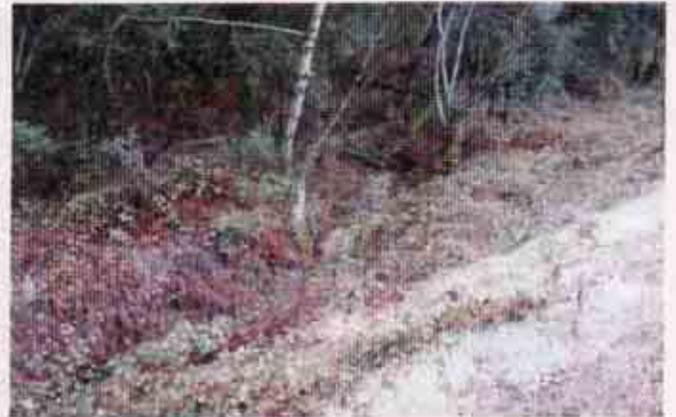
**Figure 33:** Turbid storm water discharging from the project

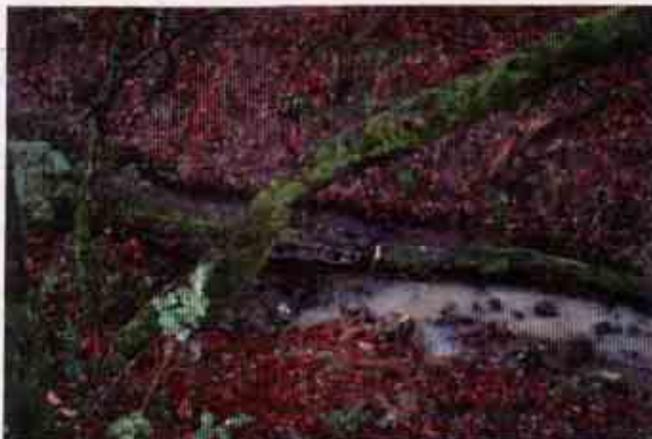
**Figure 34:** Turbid storm water from the site flowing into Jackson Creek

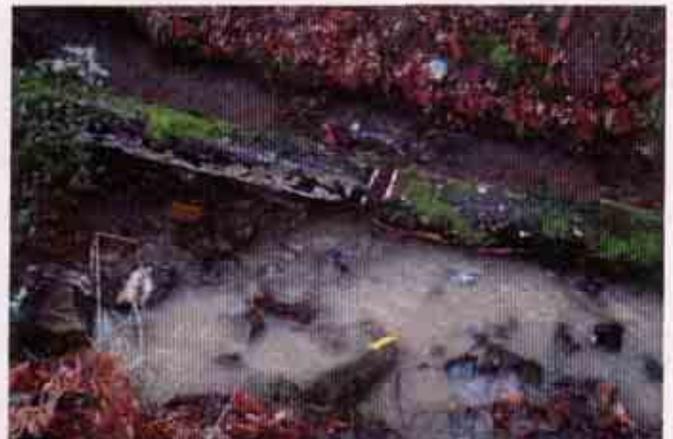
**Figure 35:** Turbid storm water from the site mixing with clean storm water in Jackson Creek

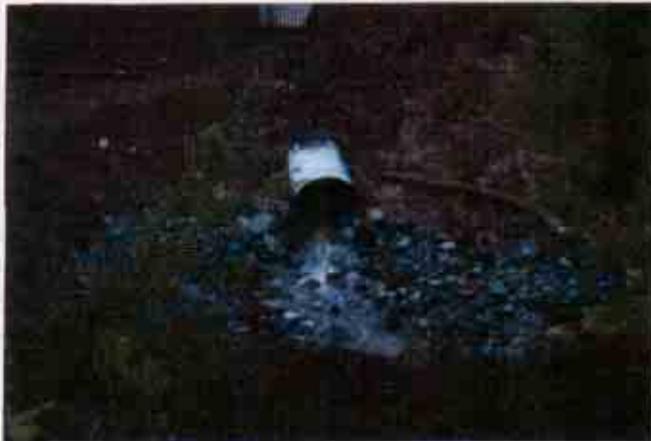
**Figure 36:** Turbid storm water from the site mixing with clean storm water in Jackson Creek

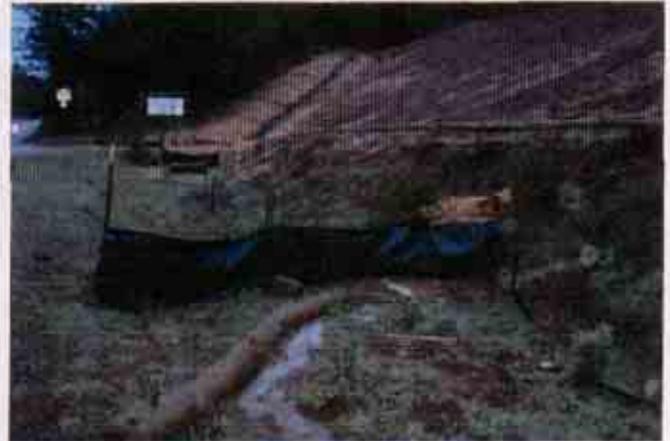
**Figure 1:** Turbid storm water discharging from the construction site

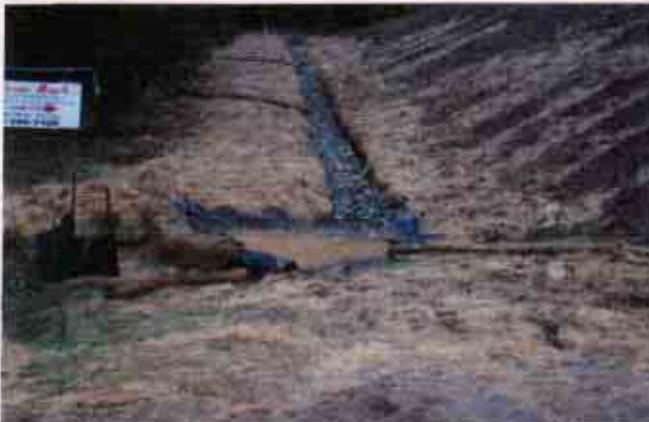
**Figure 2:** View of the western discharge location

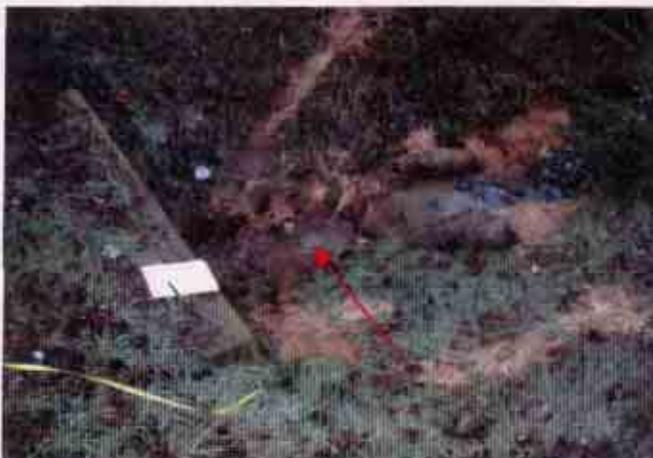
**Figure 4:** Turbid storm water flowing into the western culvert which discharges into Jackson Creek

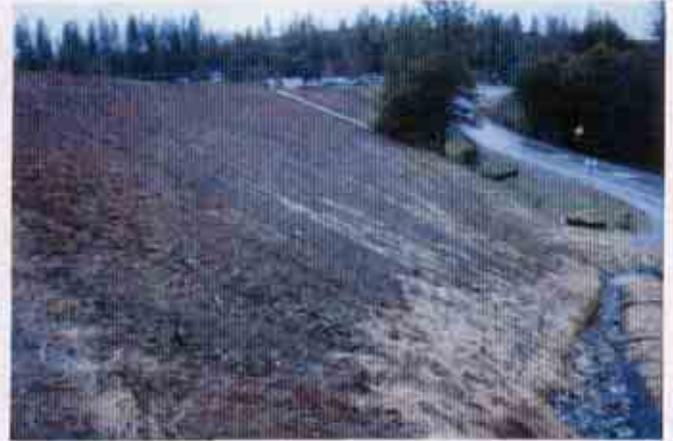
**Figure 7:** Area directly below the area shown in Figure 6

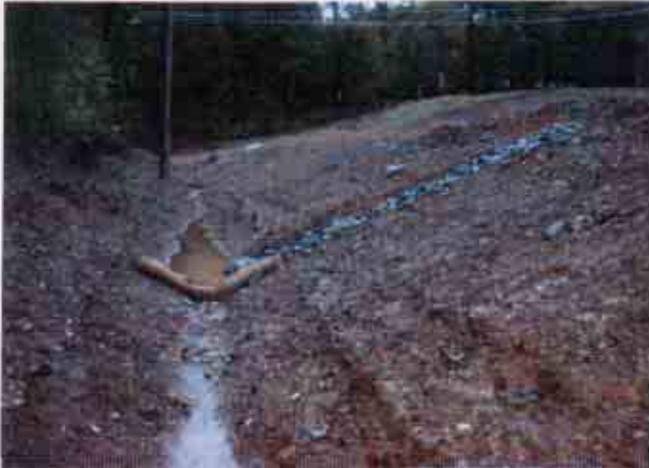
**Figure 8:** Same area Note: the general lack of BMPs on the slope

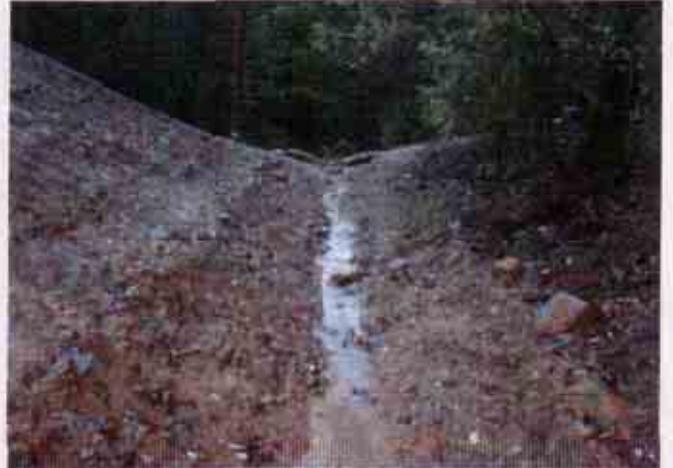
**Figure 9:** Area above the discharge location in Figure 8 Note: the lack of erosion control BMPs

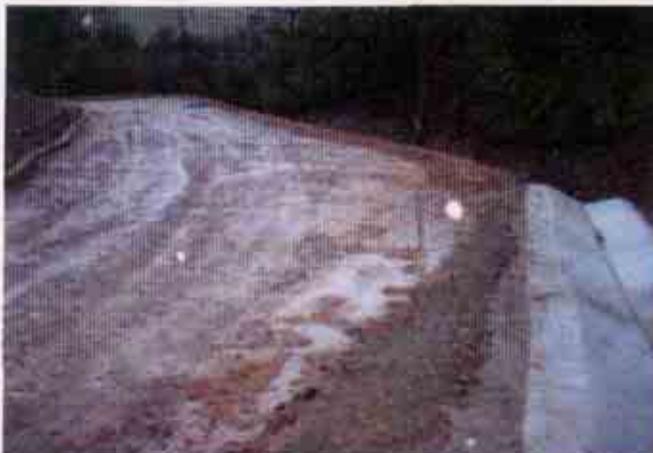
**Figure 10:** View of the same area

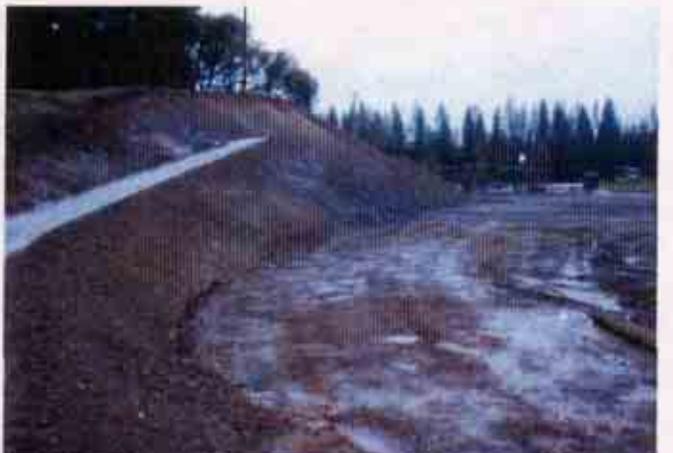
**Figure 11:** General lack of BMPs above the area in Figure 9

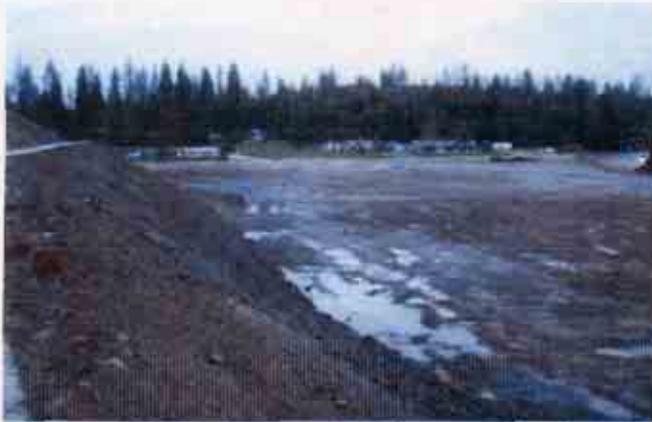
**Figure 12:** Lack of an effective combination of erosion and sediment control BMPs

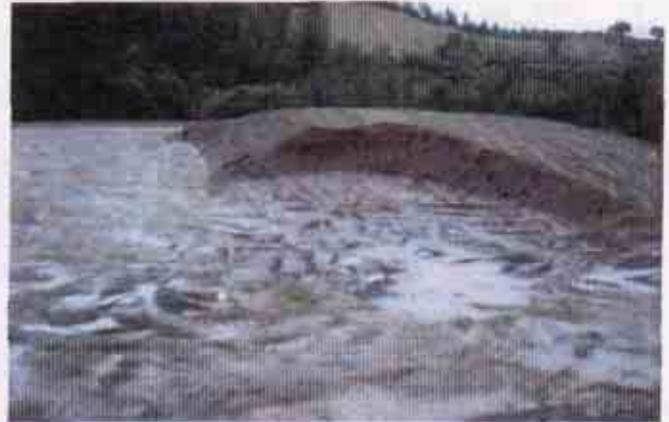
**Figure 13:** Lack of an effective combination of erosion and sediment control BMPs

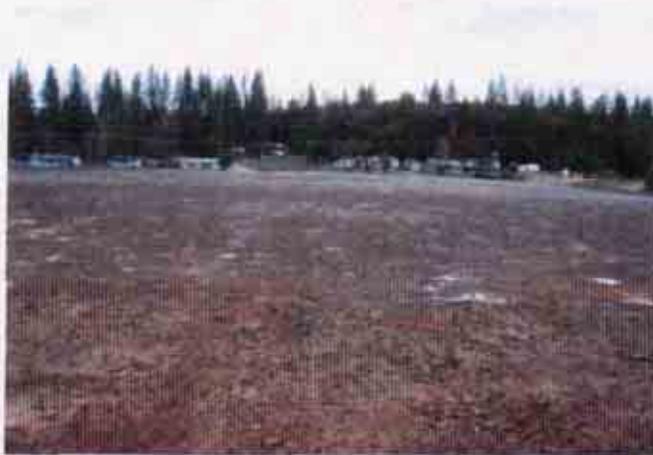
**Figure 14:** Poorly stabilized stockpile

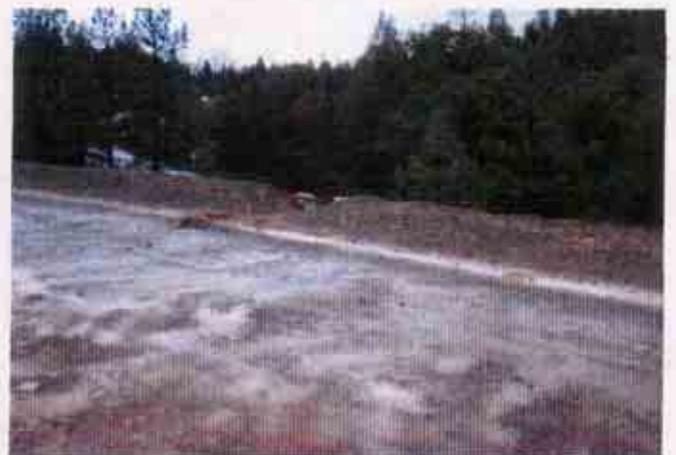
**Figure 15:** Lack of an effective combination of erosion and sediment control BMPs

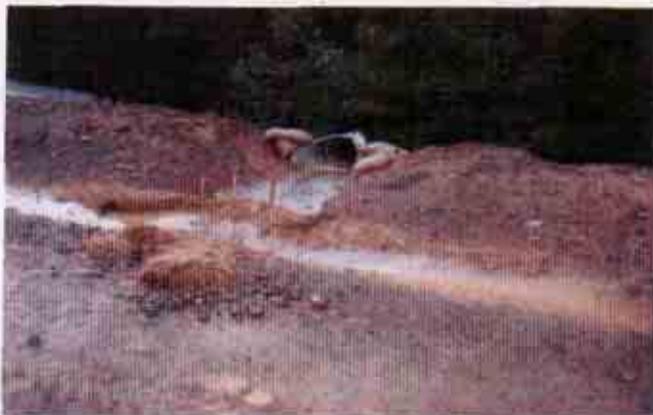
**Figure 16:** Lack of an effective combination of erosion and sediment control BMPs prior to one of the discharge locations

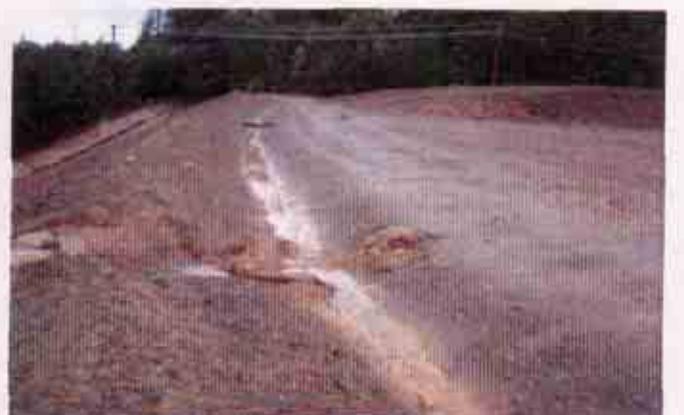
**Figure 17:** Fiber rolls installed prior to turbid stormwater discharge into the down drain

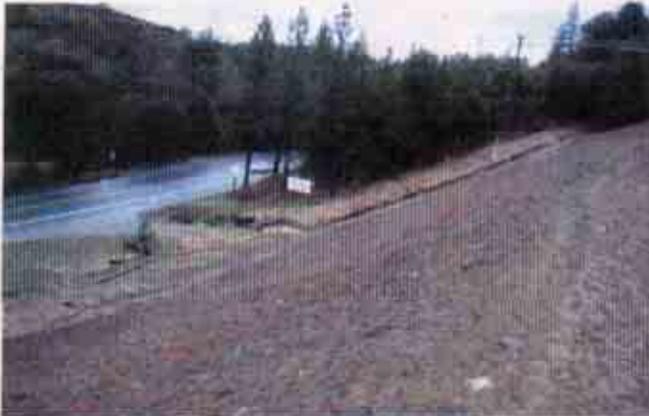
**Figure 18:** Another view of the fiber rolls installed prior to discharge into the down drain

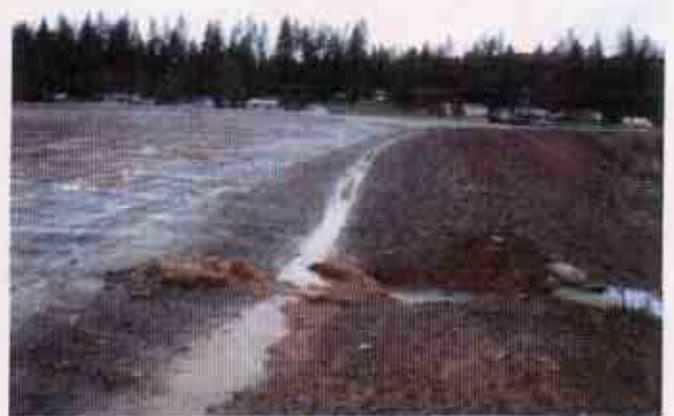
**Figure 19:** Poorly protected slope

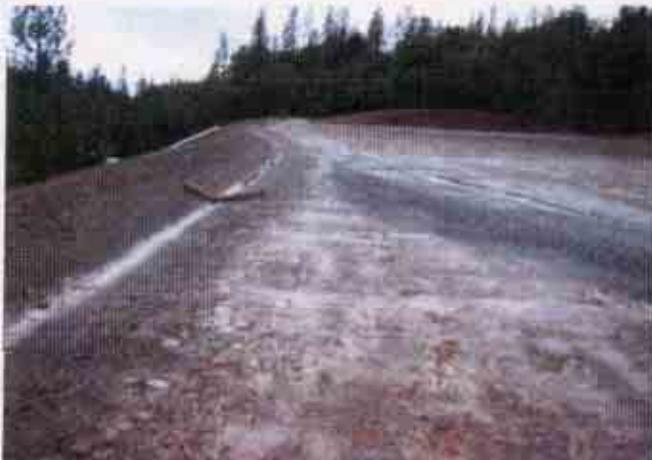
**Figure 20:** Lack of an effective combination of erosion and sediment control BMPs Note: the discharge into the down drain and the lack of effective BMPs prior to the down drain

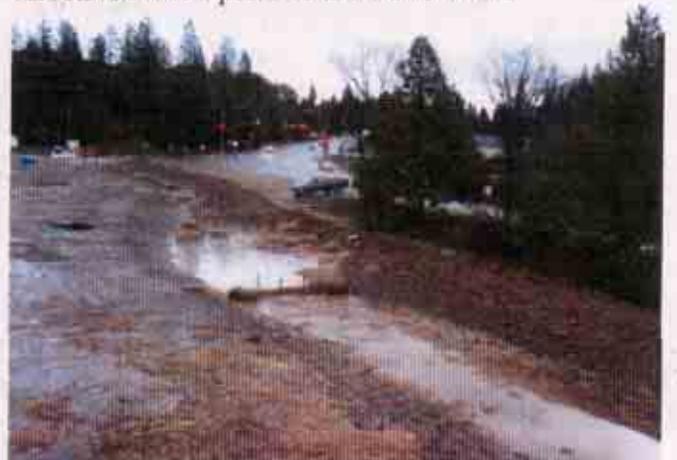
**Figure 21:** Lack of an effective combination of erosion and sediment control BMPs

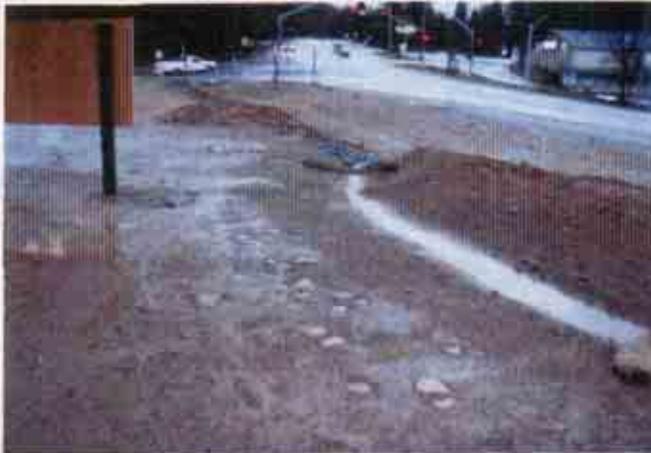
**Figure 24:** Lack of an effective combination of erosion and sediment control BMPs

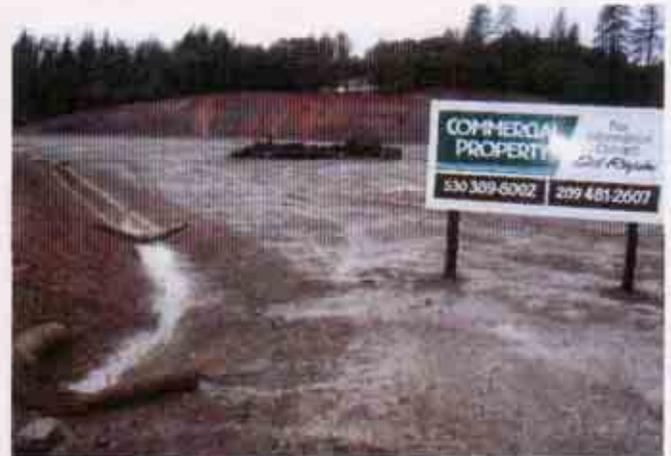
**Figure 25:** Lack of an effective combination of erosion and sediment control BMPs Note: the only BMP installed is a fiber roll

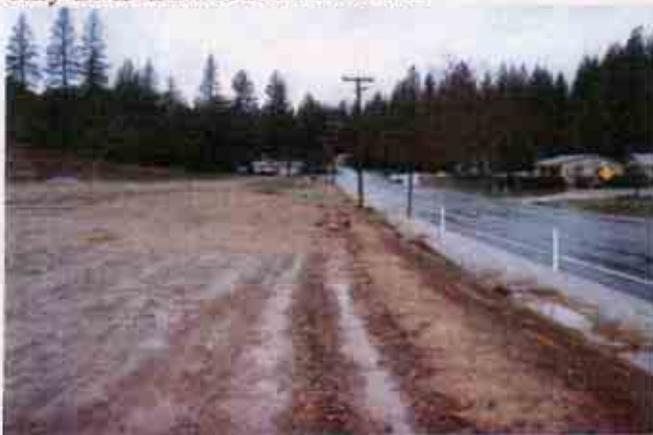
**Figure 26:** Another view of the same area Note: the lack of erosion control BMPs

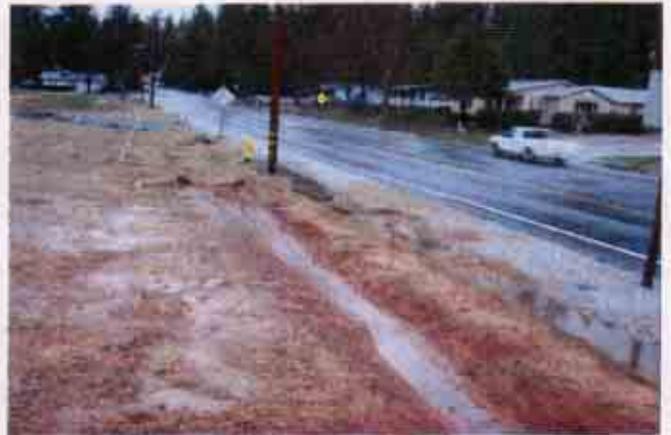
**Figure 27:** Light application of straw mulch along Ridge Road

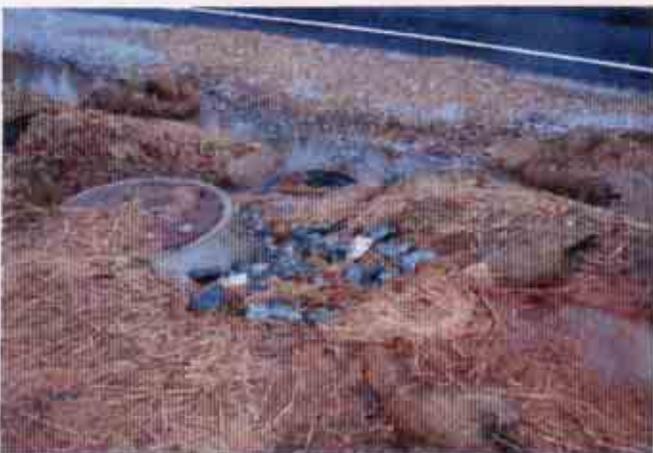
**Figure 28:** Sediment laden storm water flowing down to the drain inlet adjacent to Ridge Road

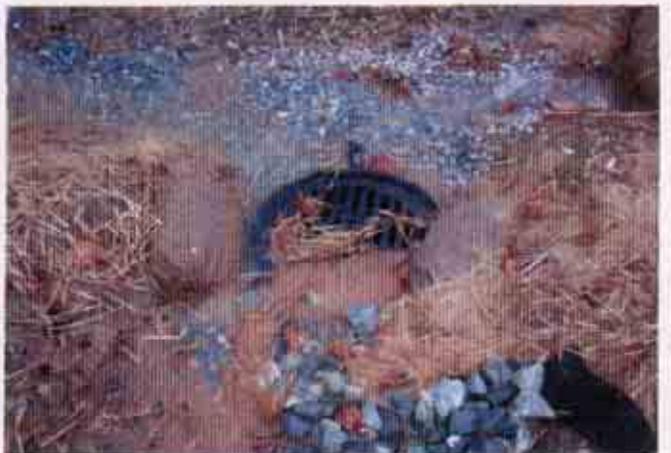
**Figure 30:** Another view of the drain inlet along Ridge Road
