**FINAL CONSTRUCTION  
QUALITY ASSURANCE REPORT  
WASTE PILE COMPOSTING PAD and  
SURFACE IMPOUNDMENT A and B**

**HAWES COMPOSTING FACILITY**

September 2012

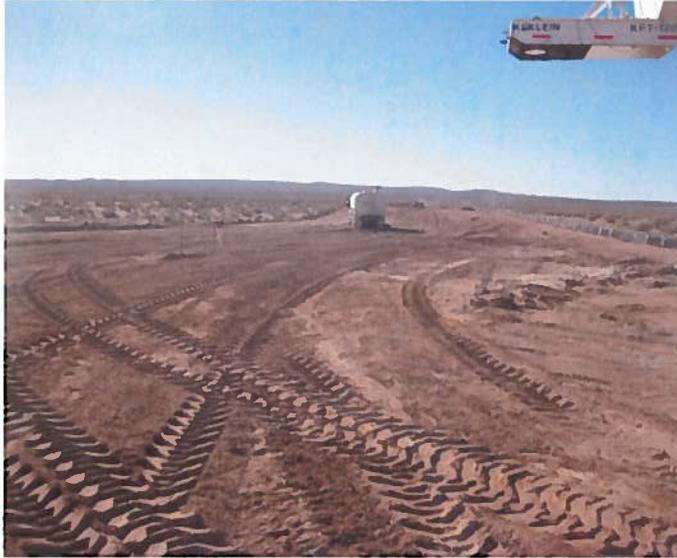
**Water truck moisture conditioning soil**

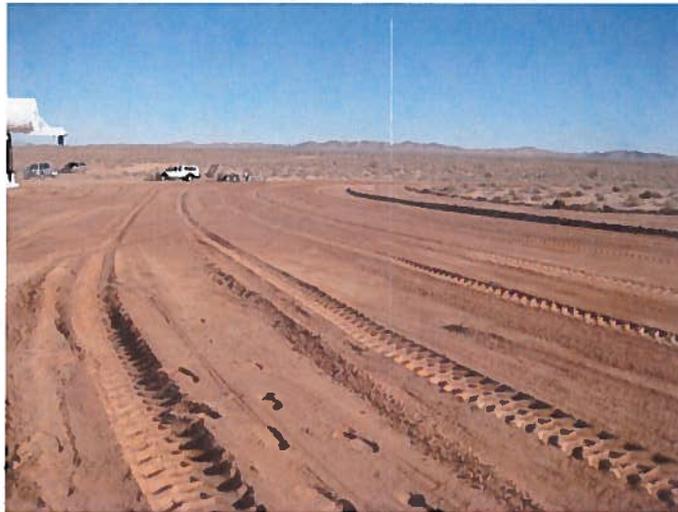
**Clear and Grubbing on Surface Impoundment Pond**

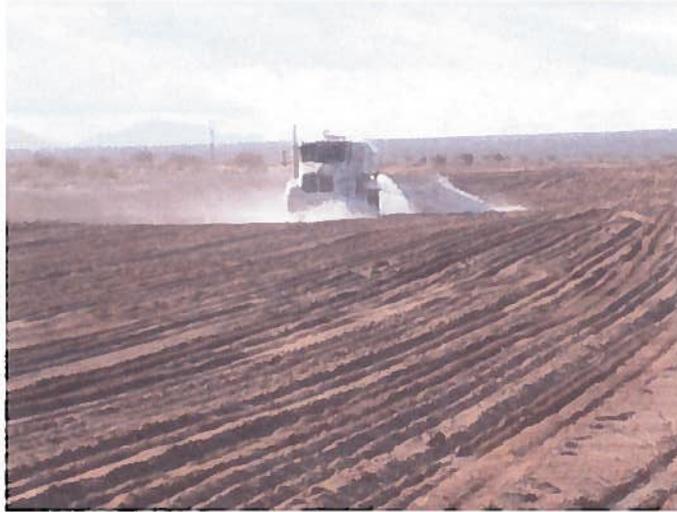
**Water truck moisture conditioning soil**

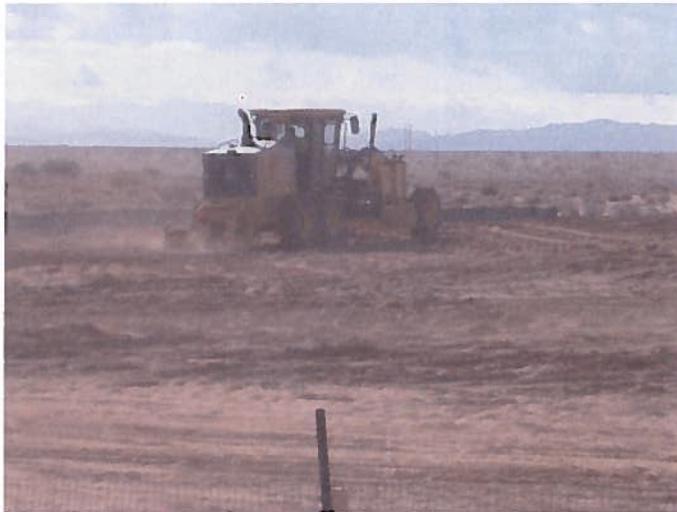
**Blade scarifying sub grade**

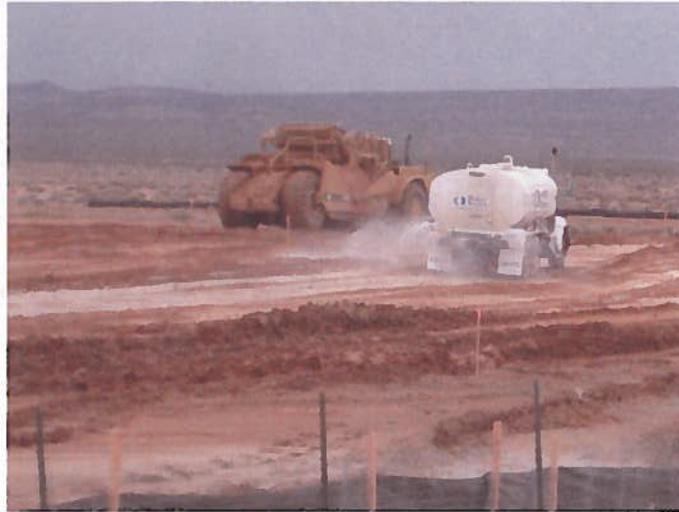
**Water truck moisture conditioning material and scraper is removing from pond B**

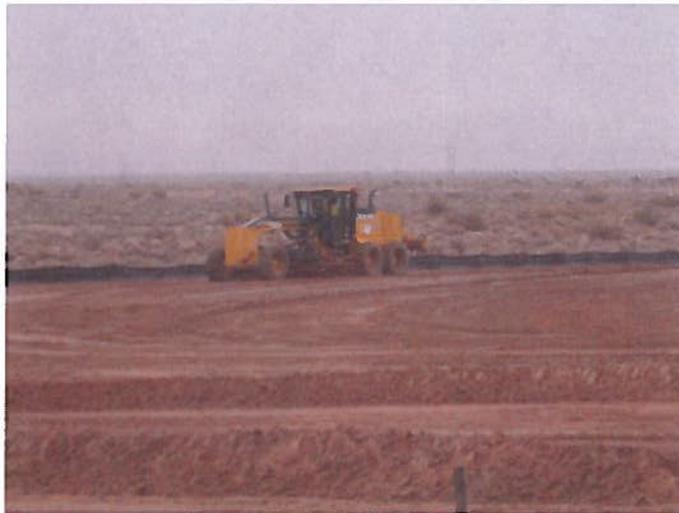
**Blade wind rolling material in east fill area**

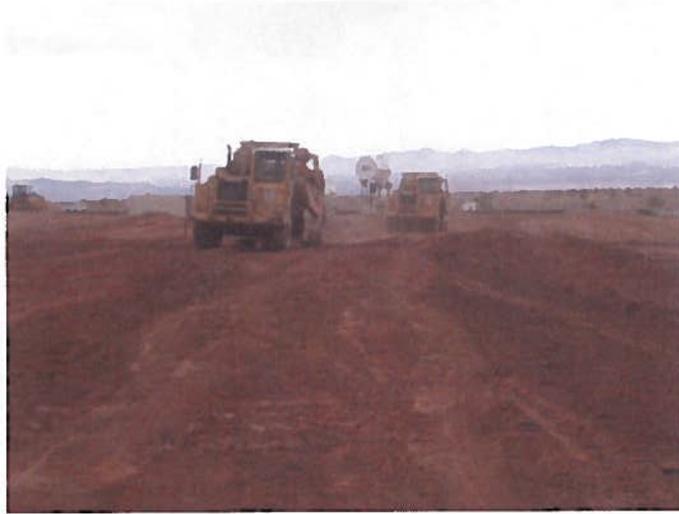
**Two 623 scrapers placing fill material on the East side**

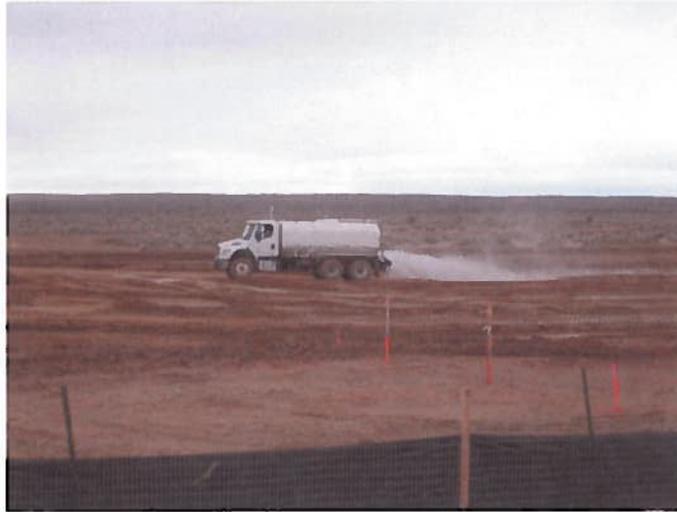
**Water truck moisture conditioning material in pond B**

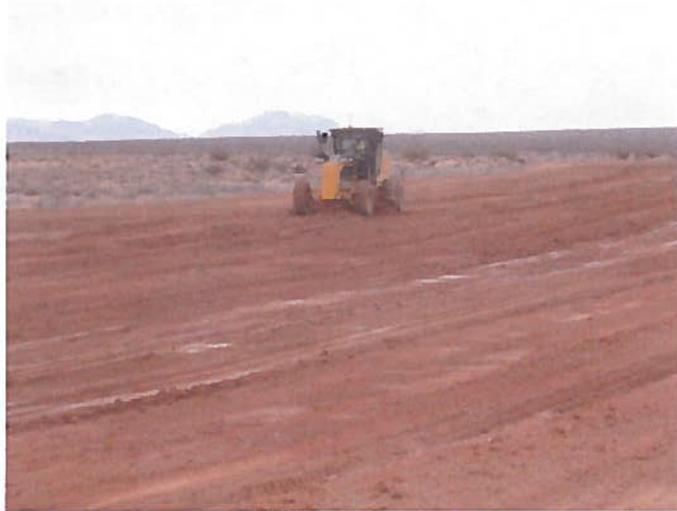
**Blade wind rolling material in East fill area**

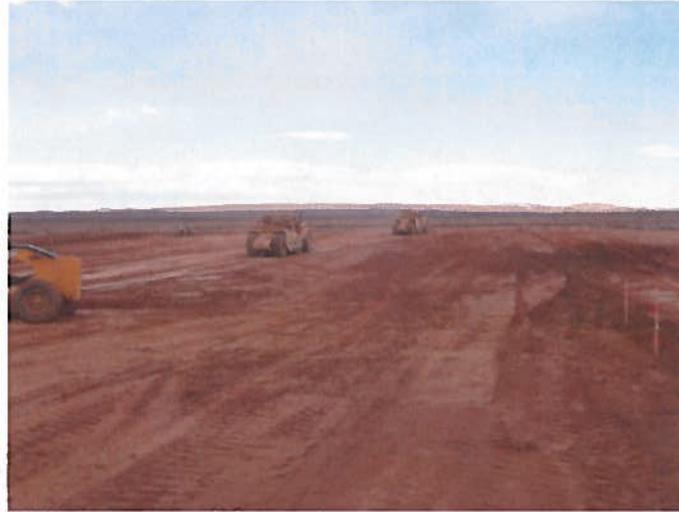
**Two 623 scrapers placing fill material on the East side**

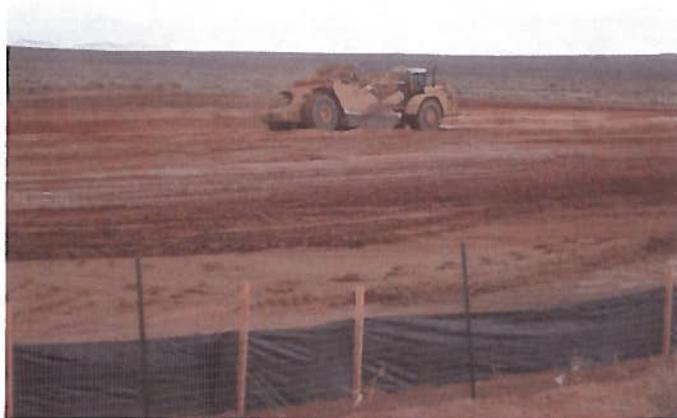
**623 scrapper removing material from pond B**

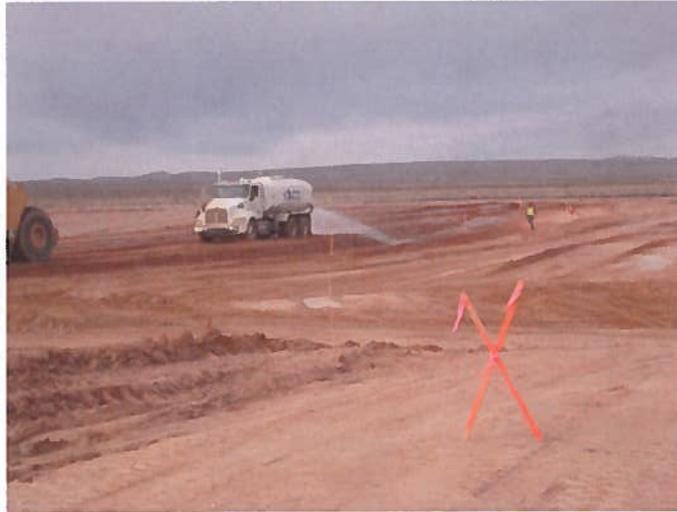
**Water truck moisture conditioning material in pond B**

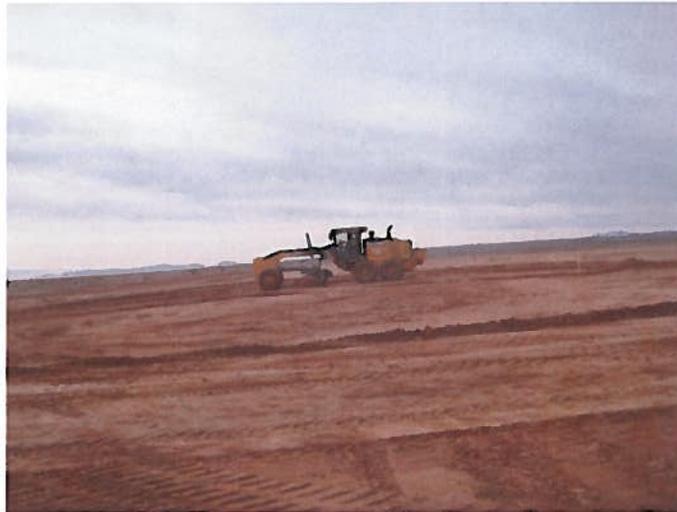
**Blade wind rolling material in East fill area**

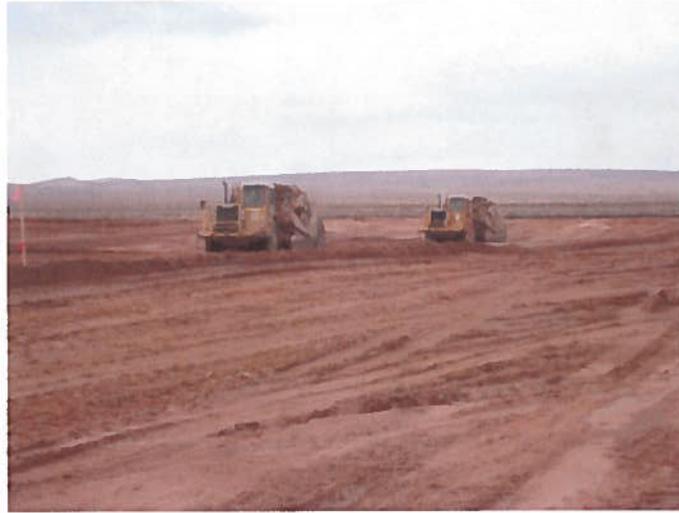
**Two 623 scrapers placing fill material on the East side**

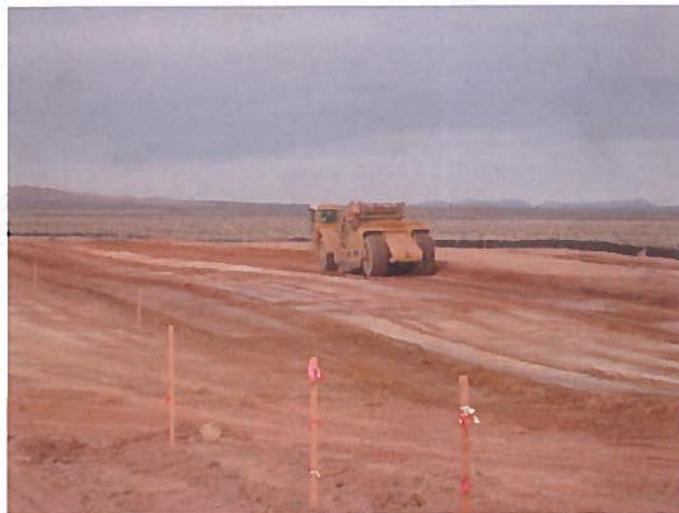
**623 scrapper removing material from pond B**

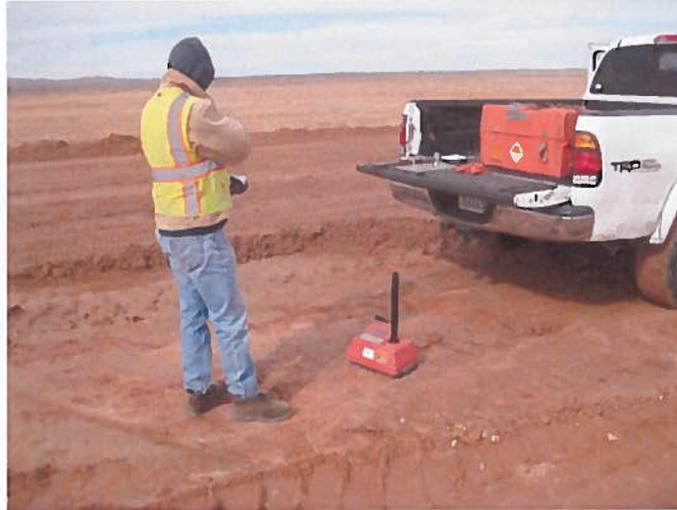
**Testing soil placed on the East side of composting area**

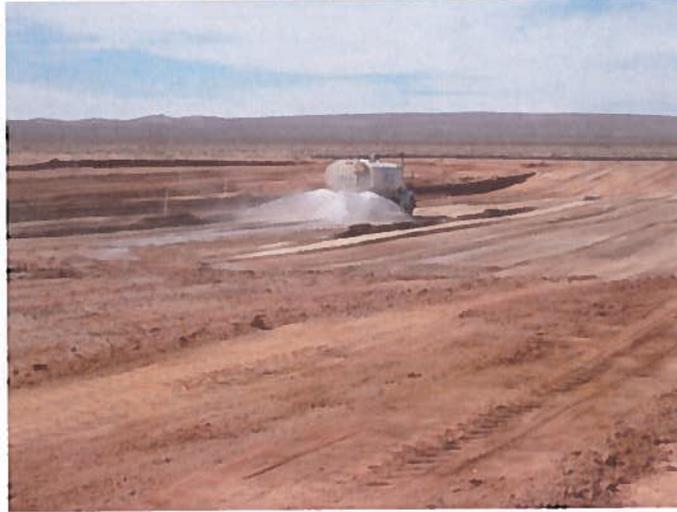
**Water truck moisture conditioning material in pond B**

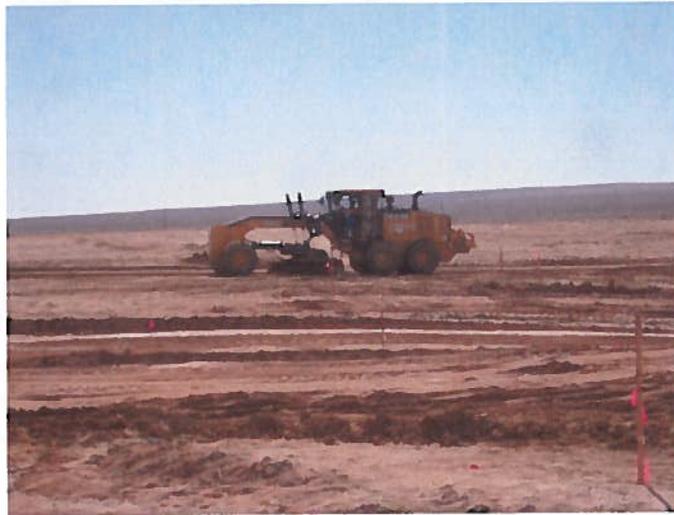
**Blade wind rolling material in East fill area**

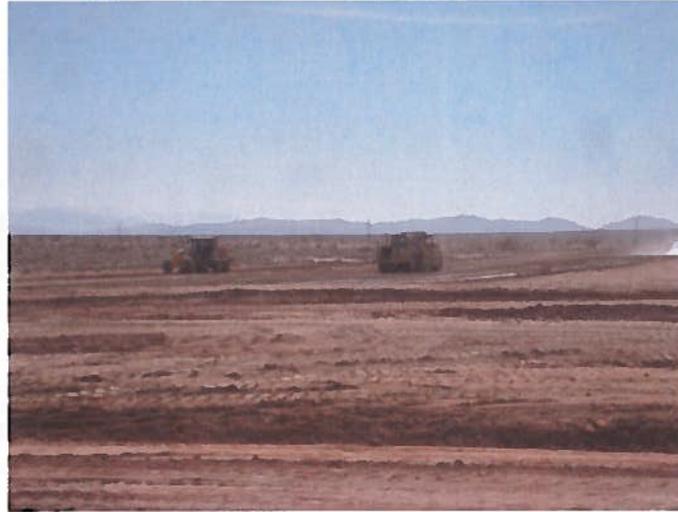
**Two 623 scrapers placing fill material on the East side**

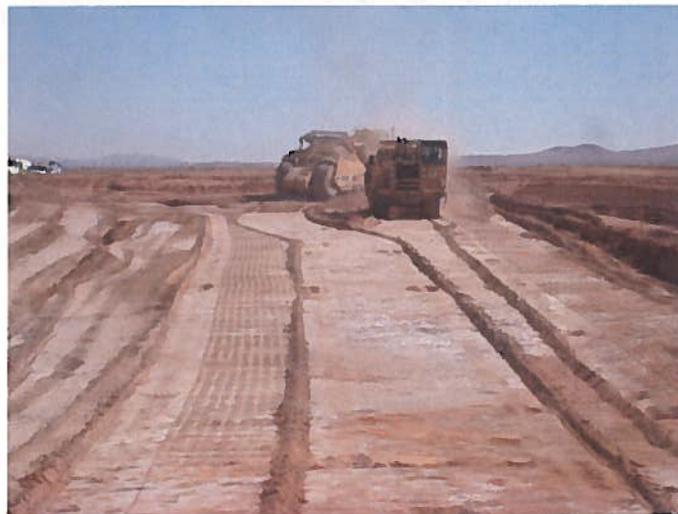
**623 scrapers removing material from pond B**

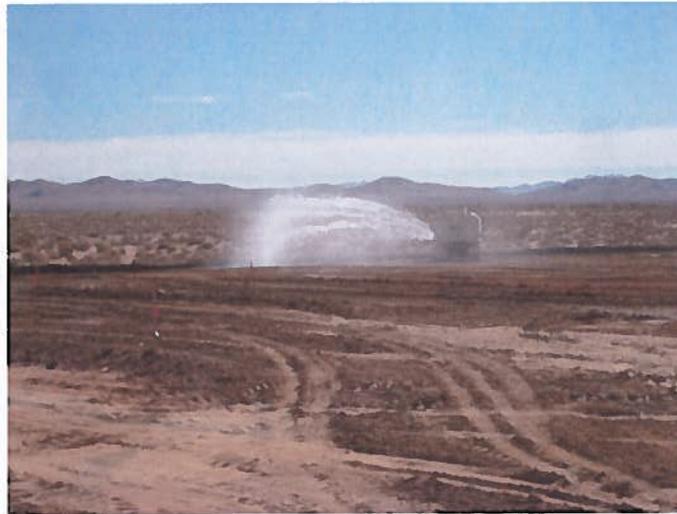
**Water truck moisture conditioning material placed on the east**

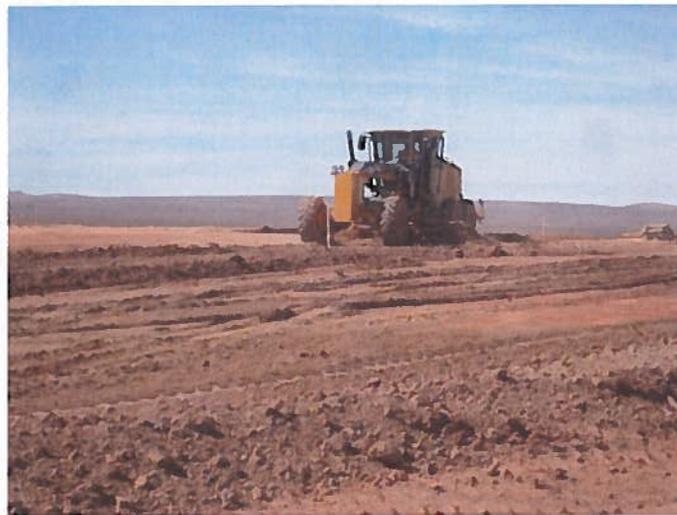
**Blade wind rolling material in East fill area**

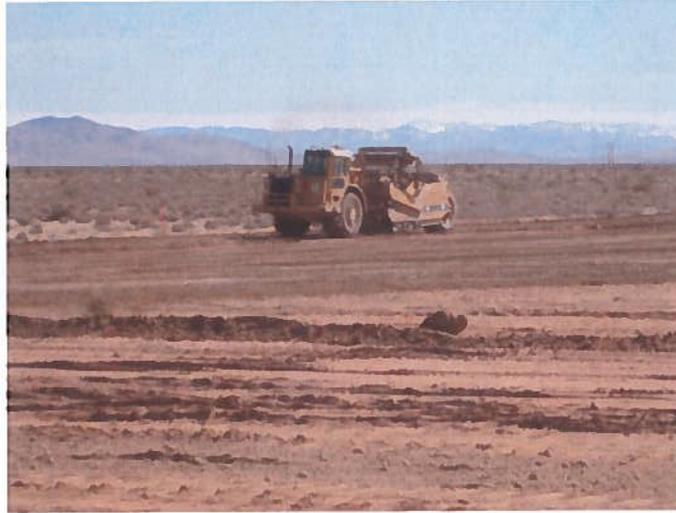
**Two 623 scrappers placing fill material on the East side**

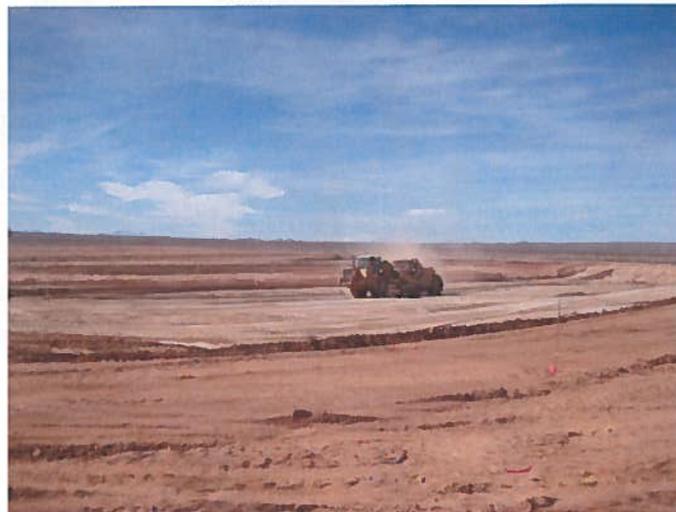
**623 scrappers removing material from pond B**

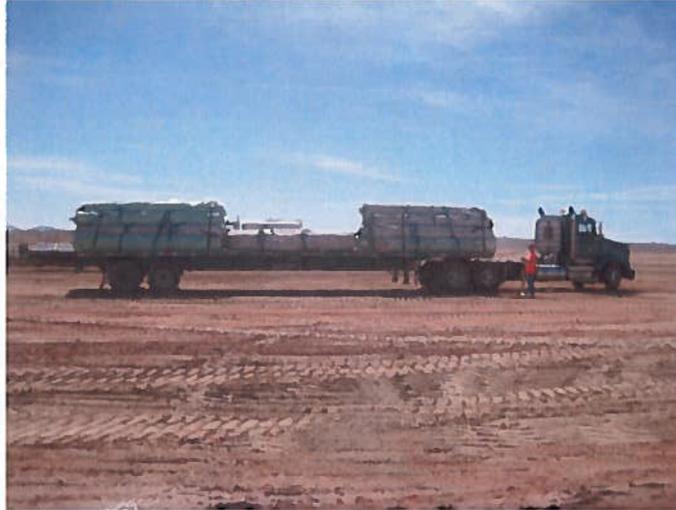
**Truck delivering GCL to site**

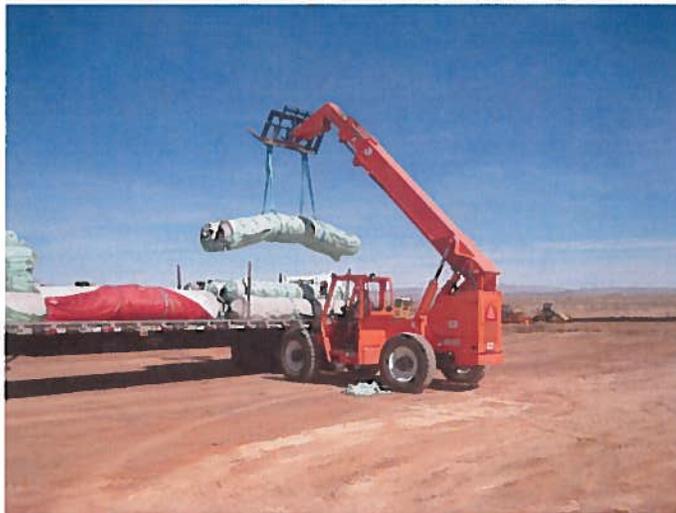
**Forklift unloading truck GCL**

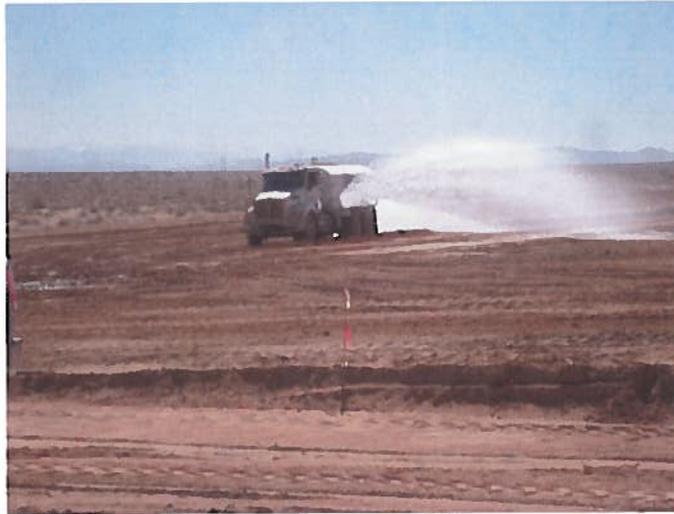
**Water truck moisture conditioning material placed on the east**

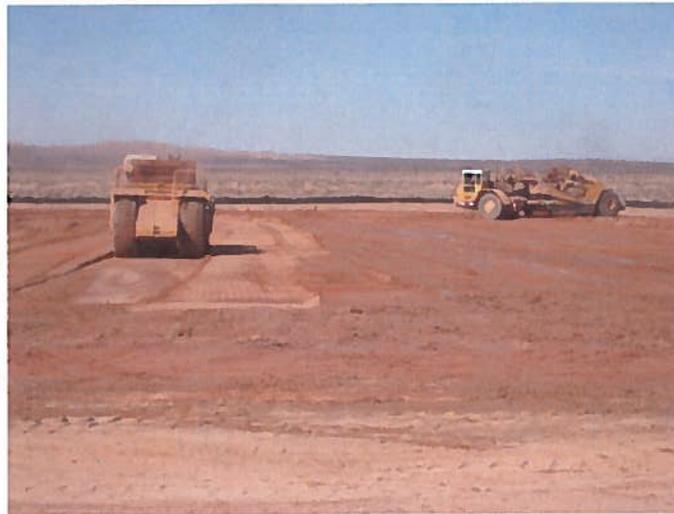
**623 scrapers removing material from pond A**

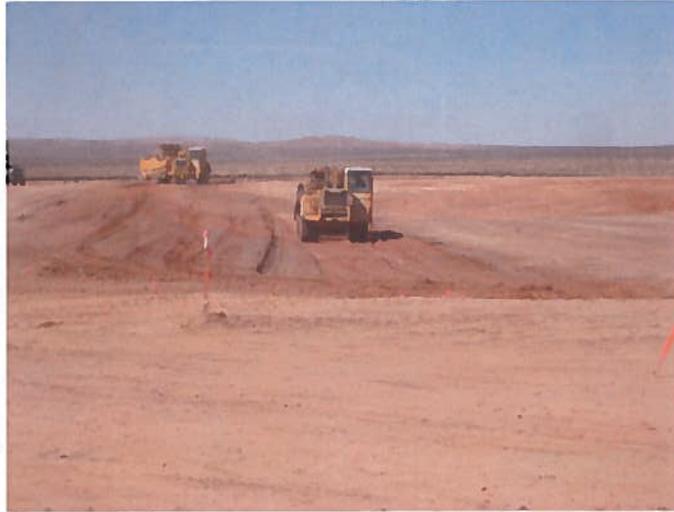
**Two 623 scrapers placing fill material on the East side**

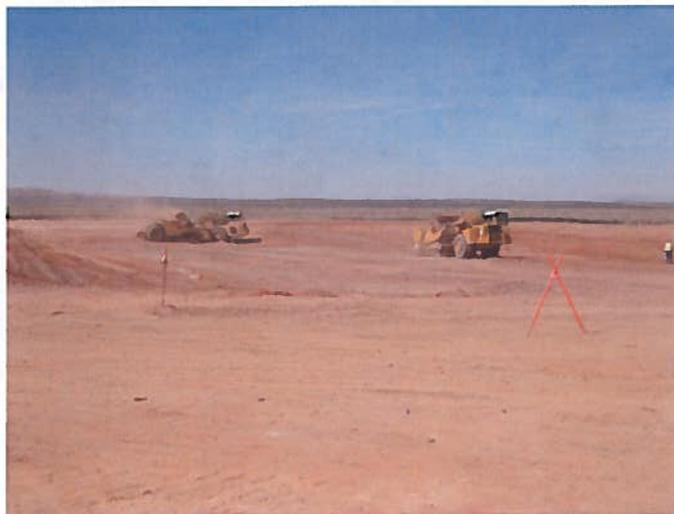
**623 scrapers removing material from pond B**

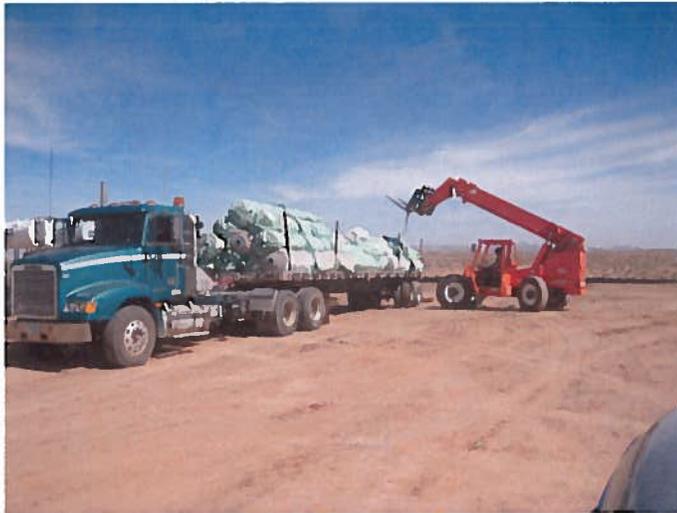
**Forklift unloading truck GCL**

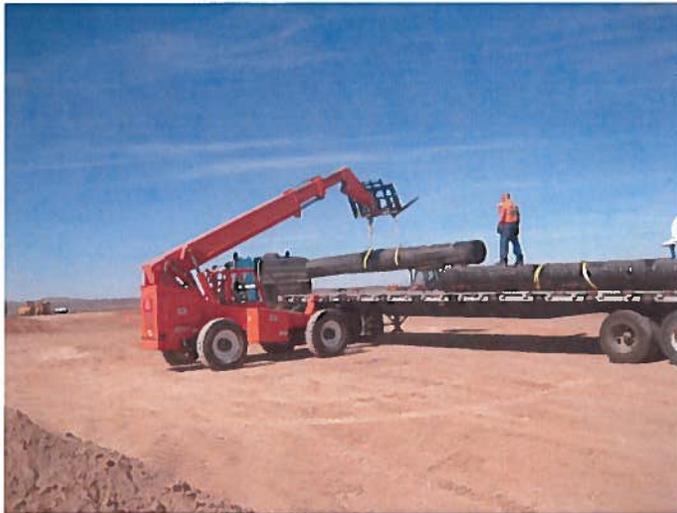
**Forklift unloading truck HDPE**

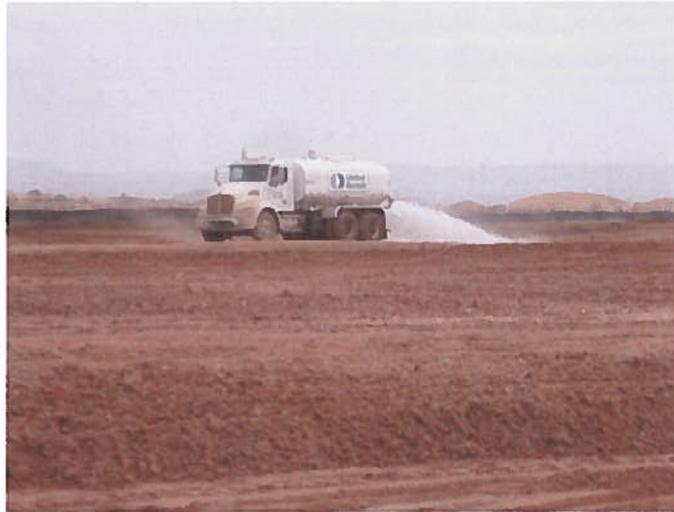
**Water truck moisture conditioning material placed on the east**

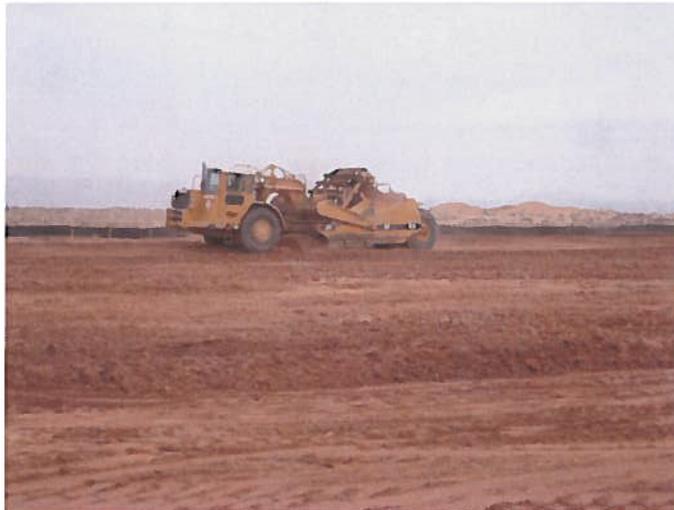
**623 scrapper removing material from pond A**

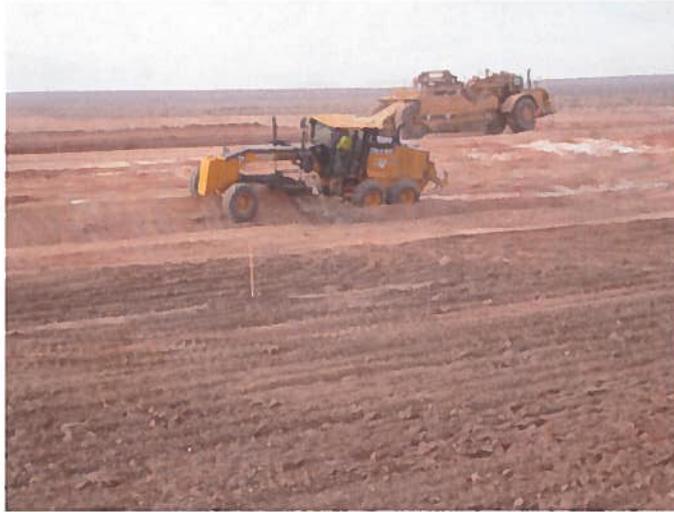
**Removing soil from slope of pond B**

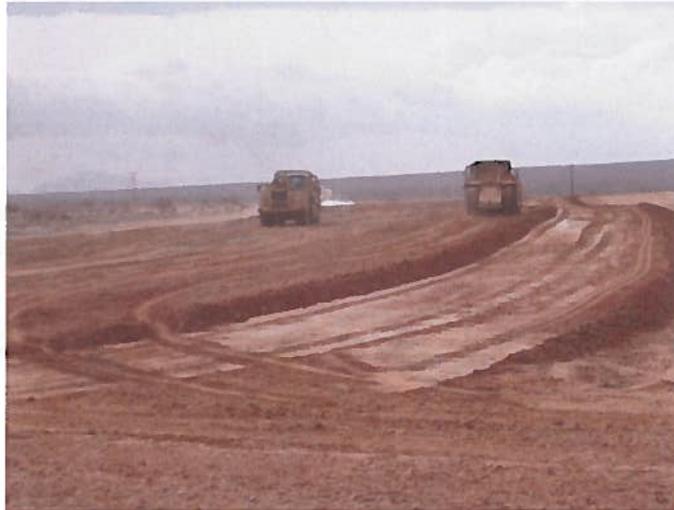
**Two 623 scrapers placing fill material on the East side**

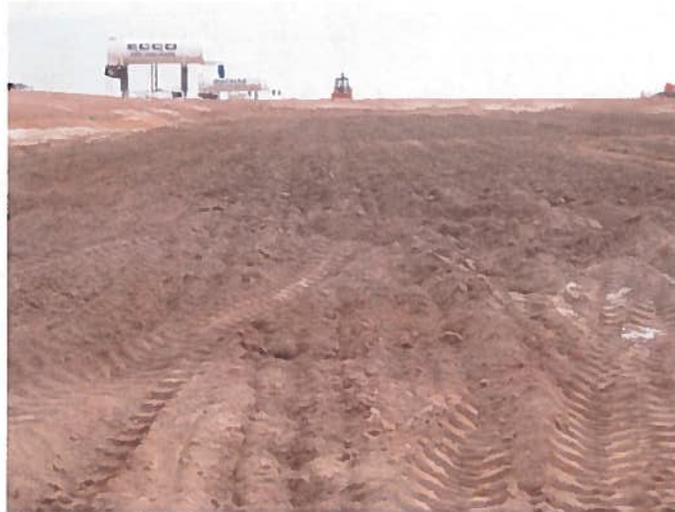
**Ripping cell floor of pond B**

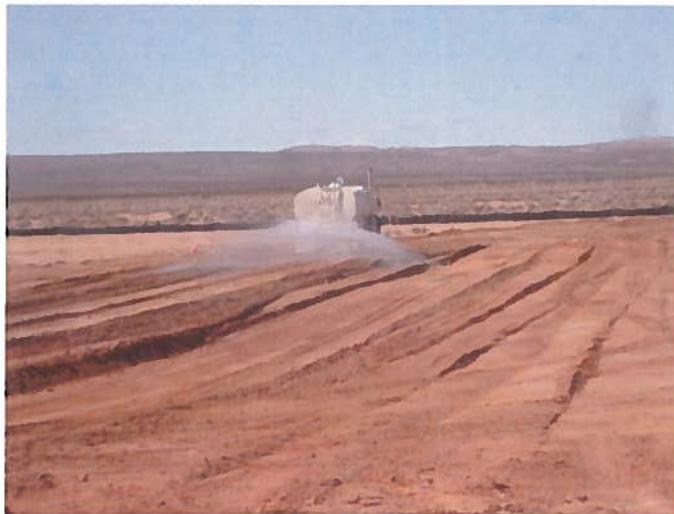
**Water truck moisture conditioning material in pond A**

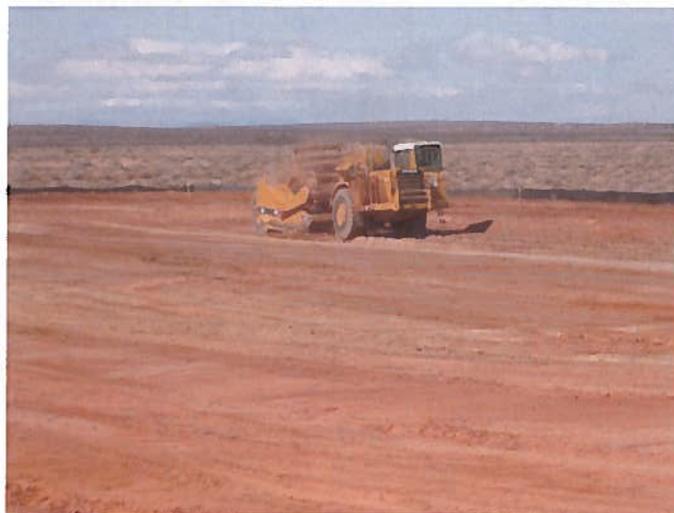
**623 scrapper removing material from pond A**

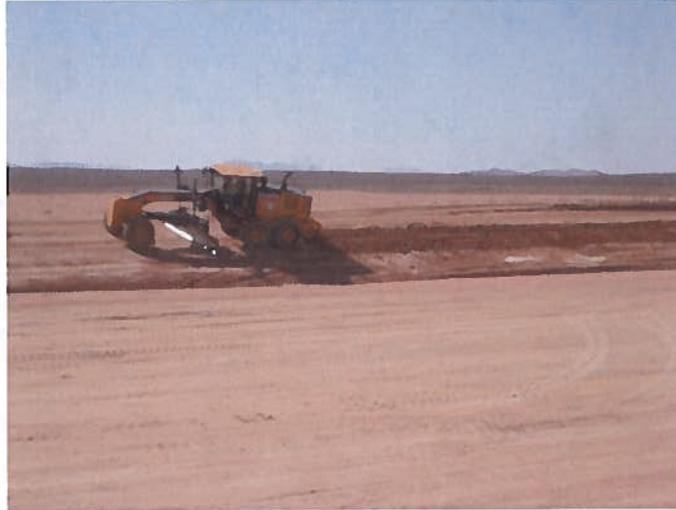
**Ripping slopes of pond B**

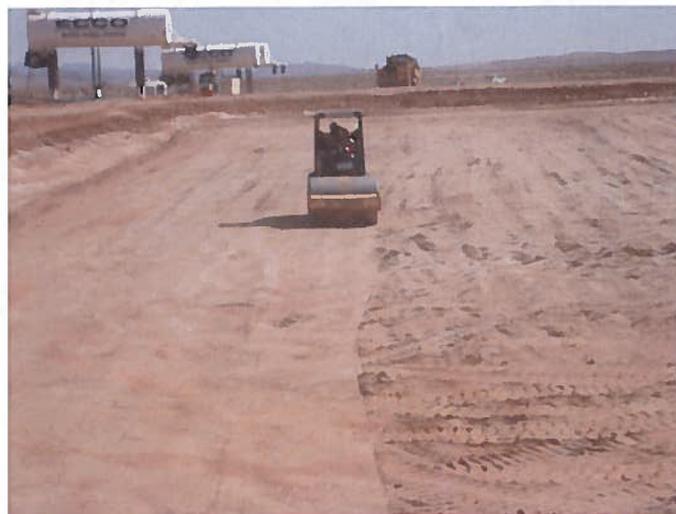
**Smooth drum rolling cell floor of pond B**

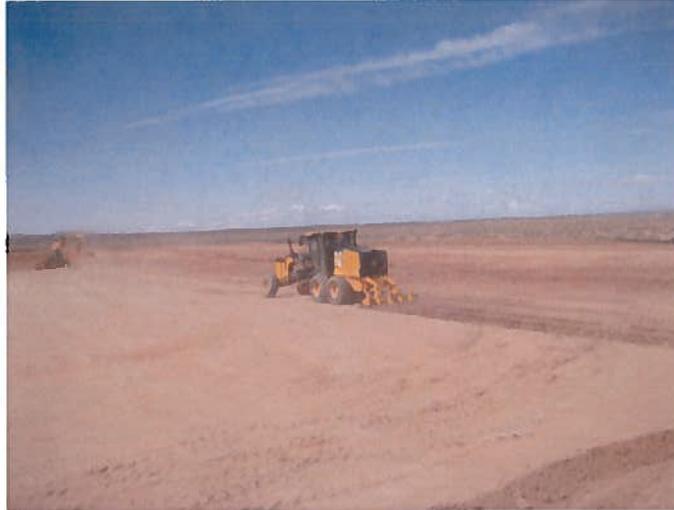
**Ripping cell floor of pond B**

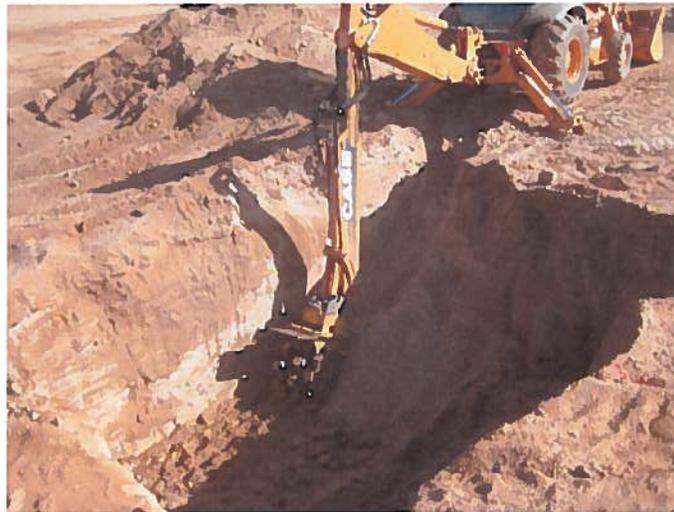
**Compacting soil under Lysimeter Sump in pond B**

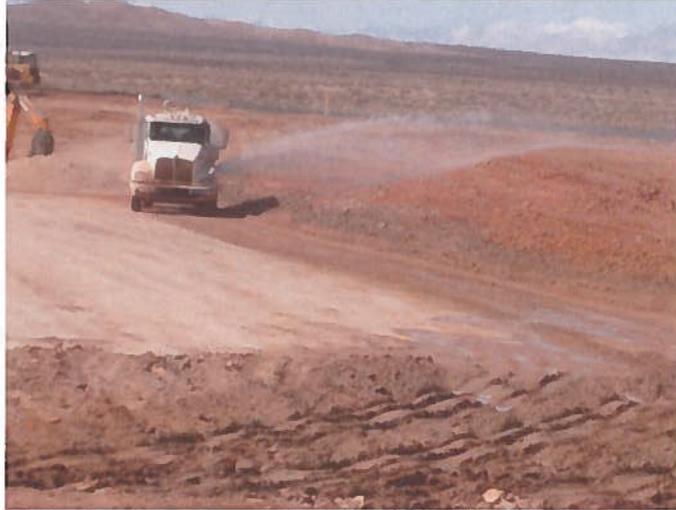
**Moisture conditioning slopes of pond B**

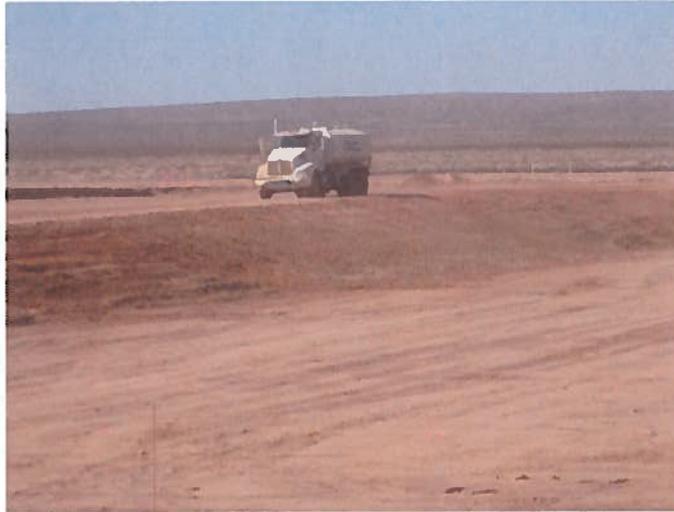
**Water truck moisture conditioning slopes of pond B**

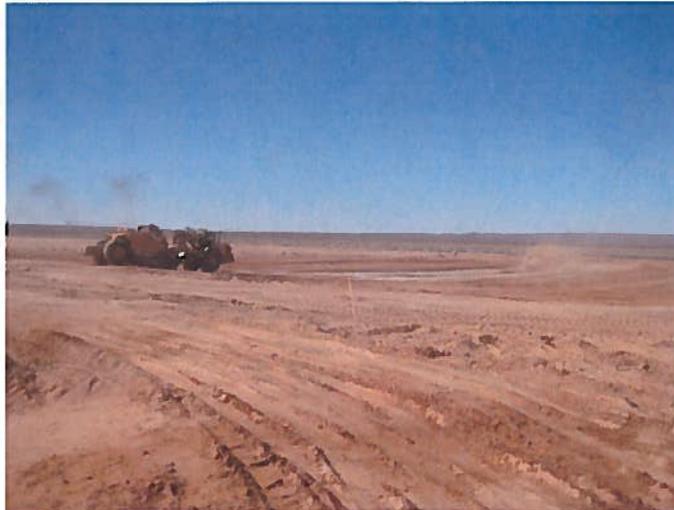
**623 scrapper removing material from pond A**

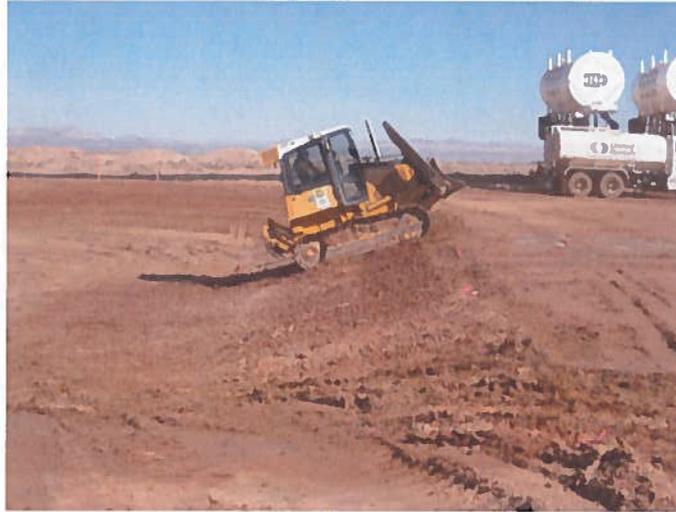
**Compacting slopes of pond B with D4 dozer**

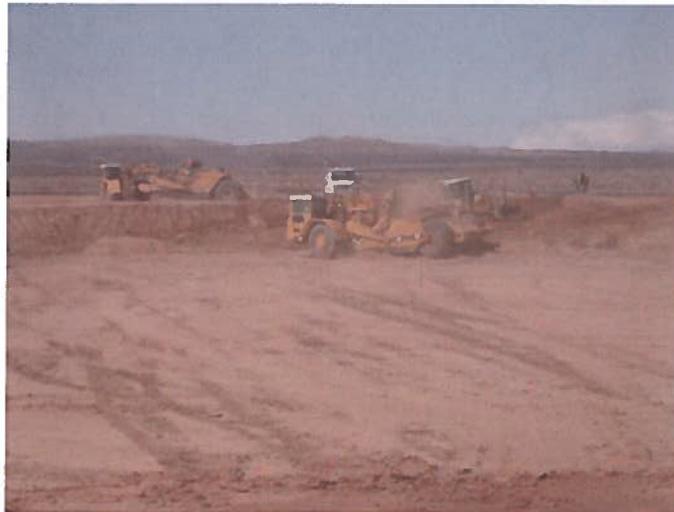
**Removing soil from Lysimeter sump in pond B**

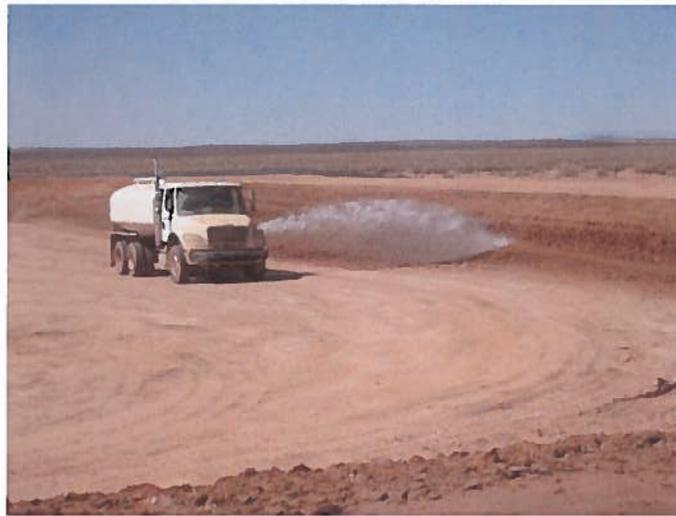
**Water truck moisture conditioning slopes of pond B**

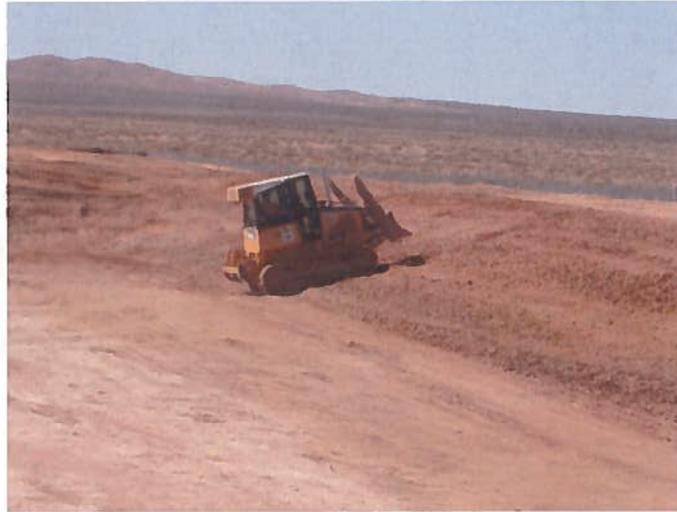
**Compacting slopes of pond B with D4 dozer**

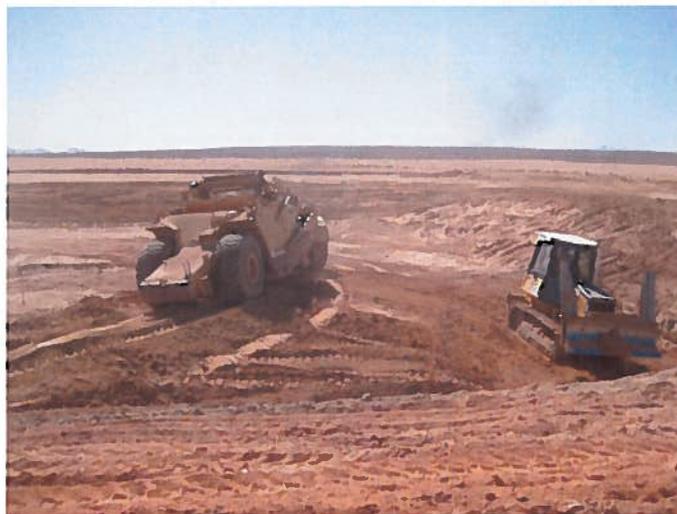
**Placing soil for Lysimeter sump back fill in pond B**

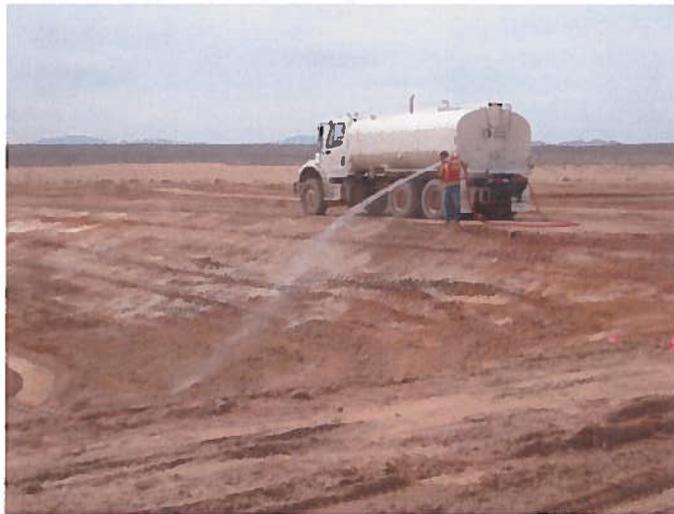
**Water truck moisture conditioning slopes of pond B**

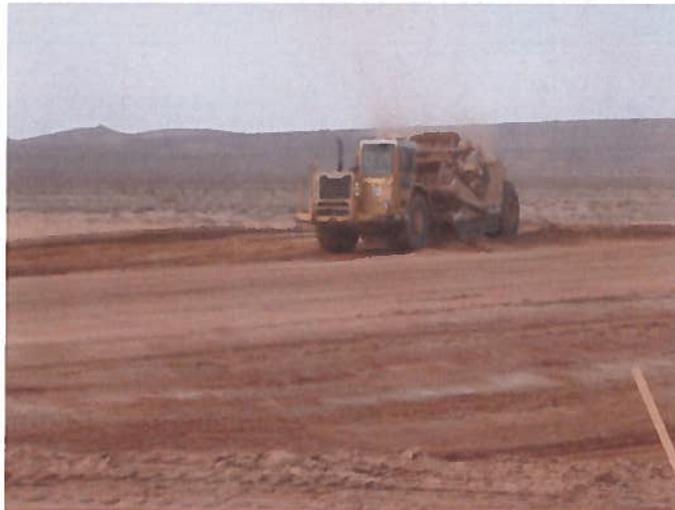
**623 scrapper removing material from pond A**

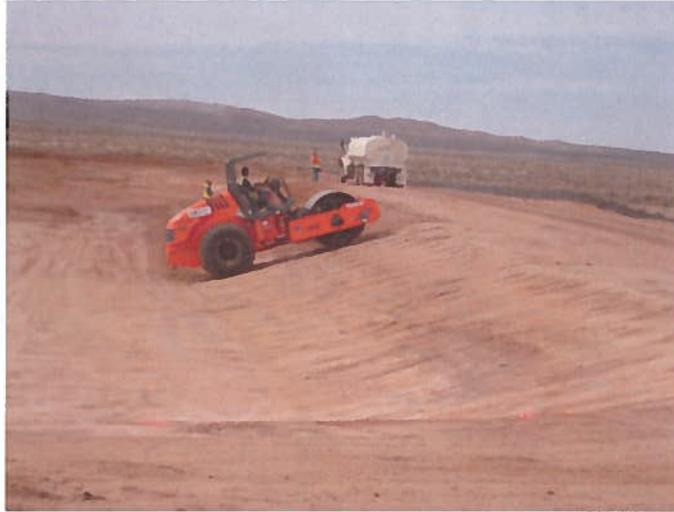
**Smooth drum rolling slopes of pond B**

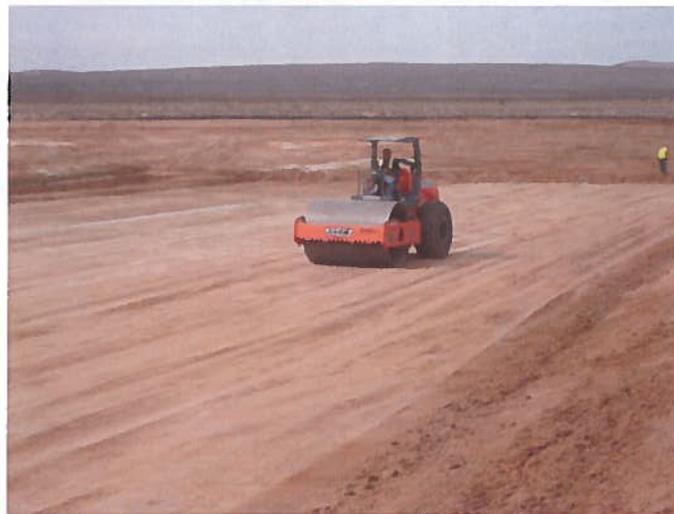
**Smooth drum rolling cell floor of pond B**

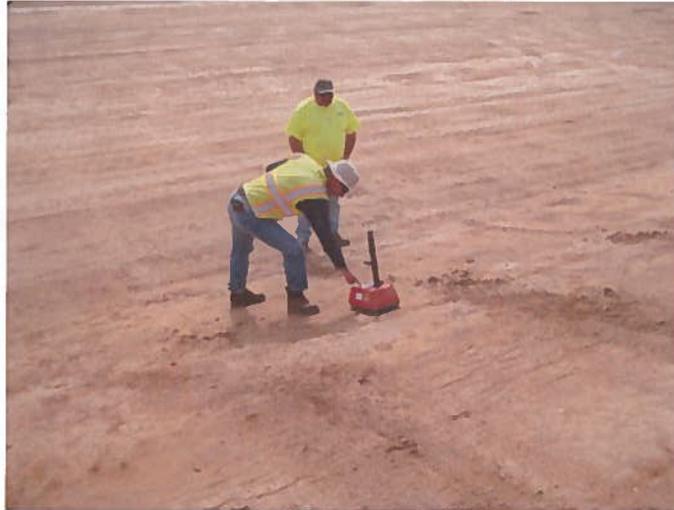
**Nuclear density testing slope of pond B**

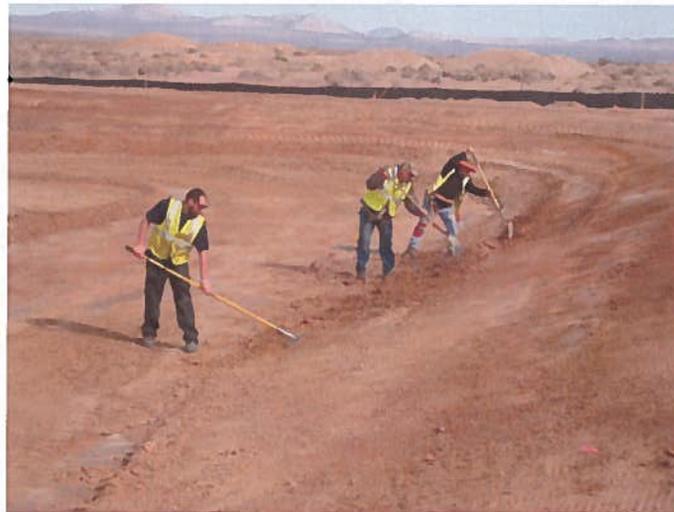
**Racking sub grade of pond B**

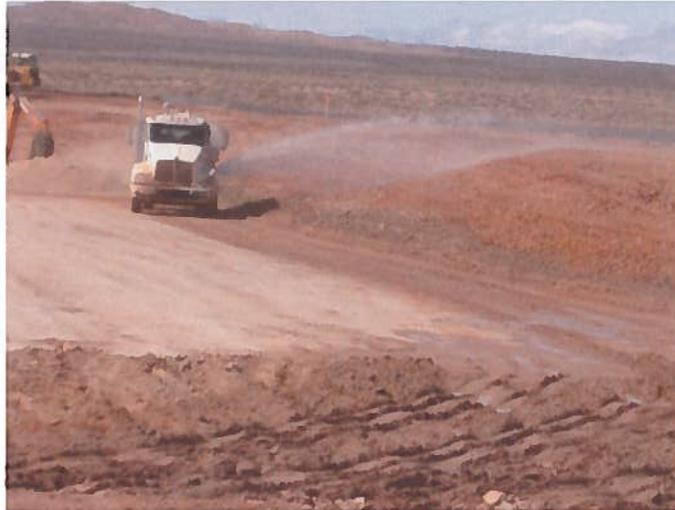
**Moisture conditioning slopes of pond B**

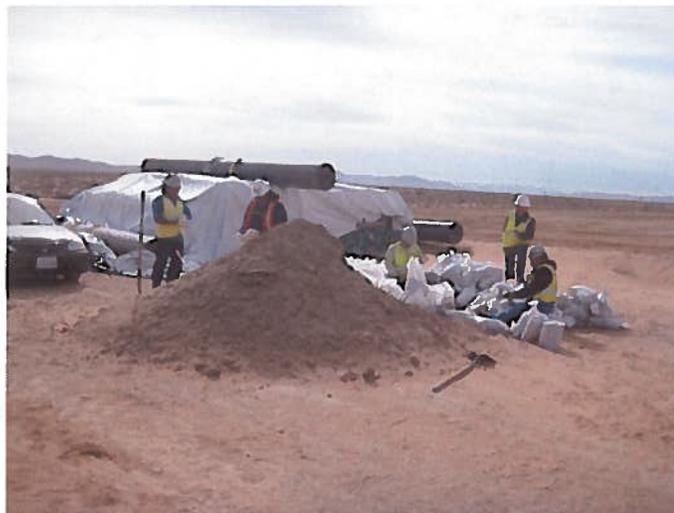
**Filling sandbags for HDPE deployment**

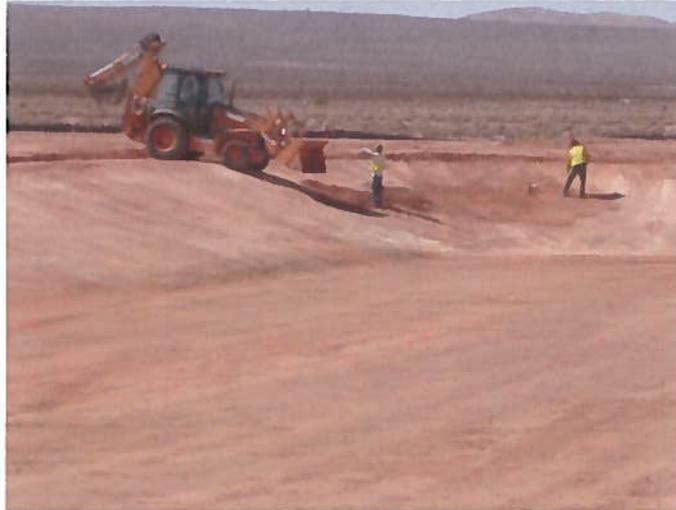
**Preparing sub grade of pond B**

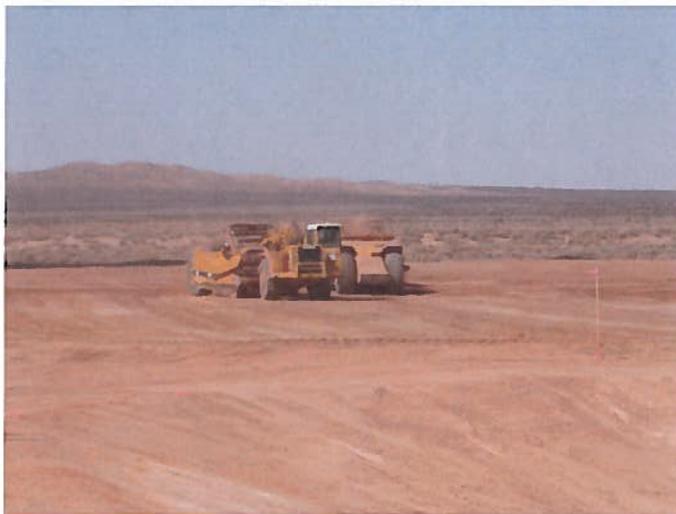
**623 scrapers removing material from pond A**

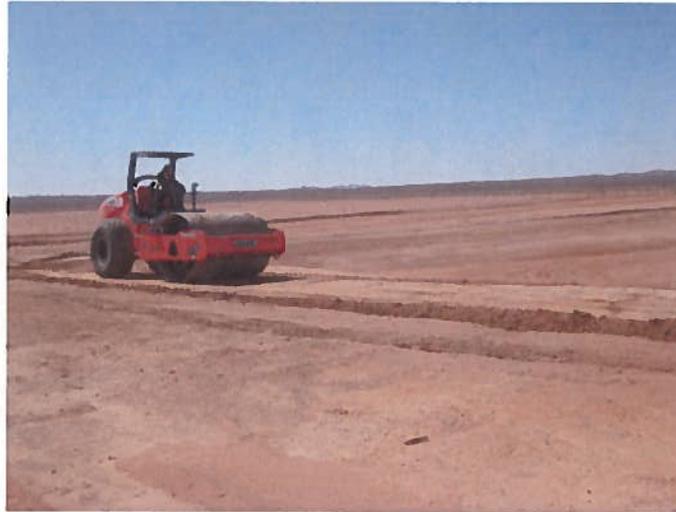
**Smooth drum rolling anchor trench of pond B**

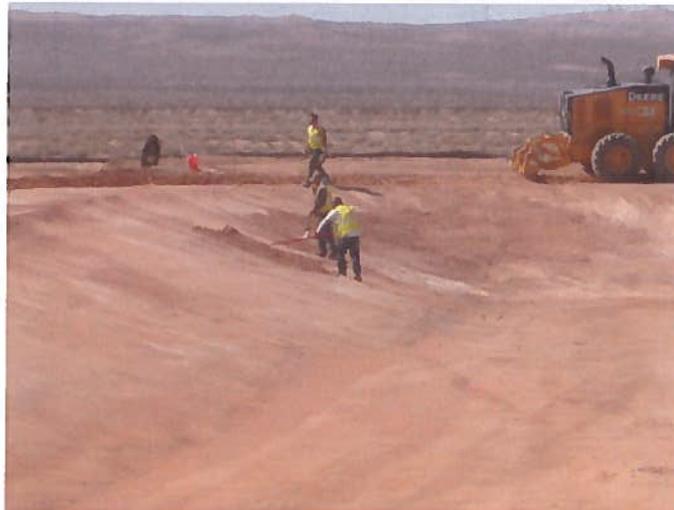
**Racking sub grade of pond B**

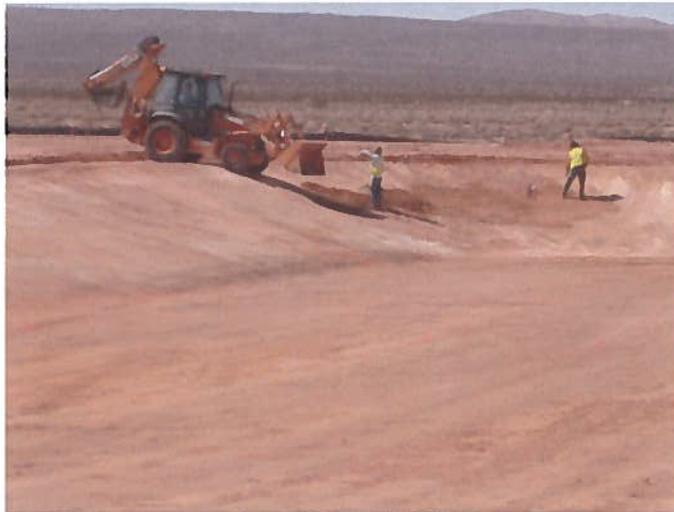
**Preparing sub grade of pond B**
