**FINAL CONSTRUCTION  
QUALITY ASSURANCE REPORT  
WASTE PILE COMPOSTING PAD and  
SURFACE IMPOUNDMENT A and B**

**HAWES COMPOSTING FACILITY**

September 2012

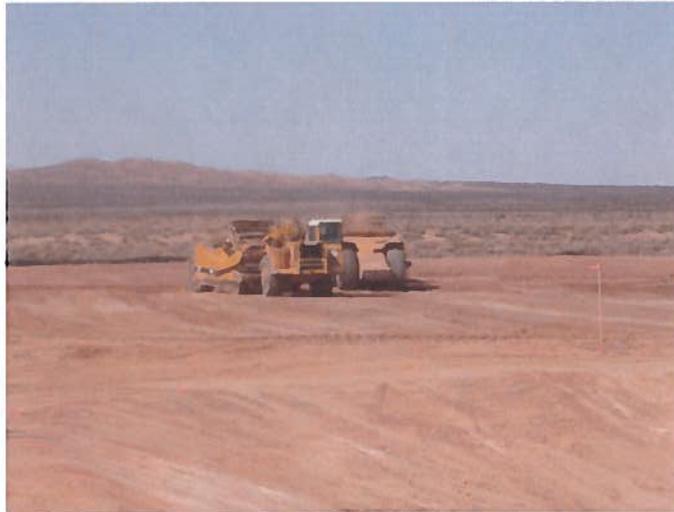
**623 scrapers removing material from pond A**

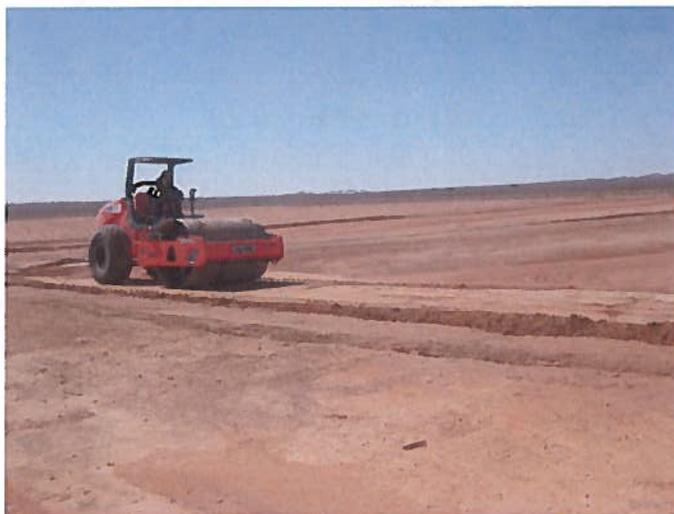
**Smooth drum rolling anchor trench of pond B**

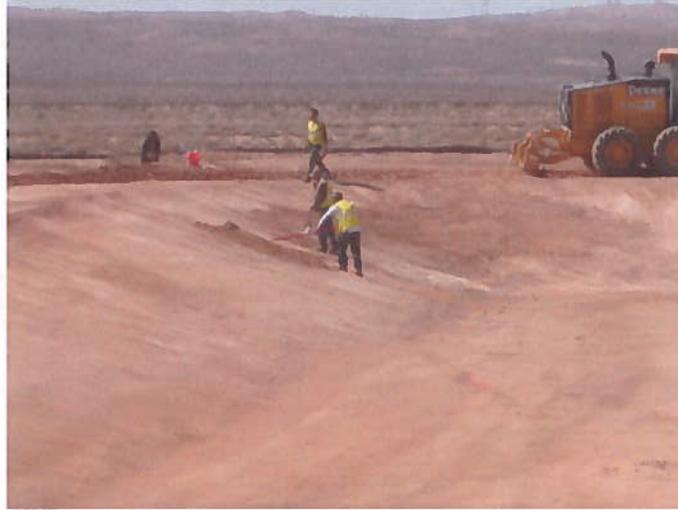
**Racking sub grade of pond B**

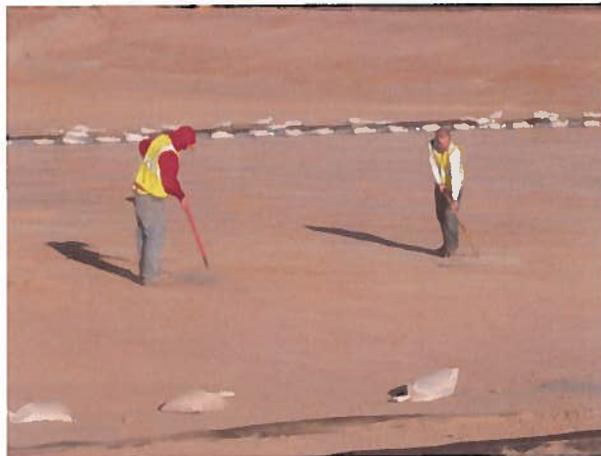
**Preparing sub grade of pond B**

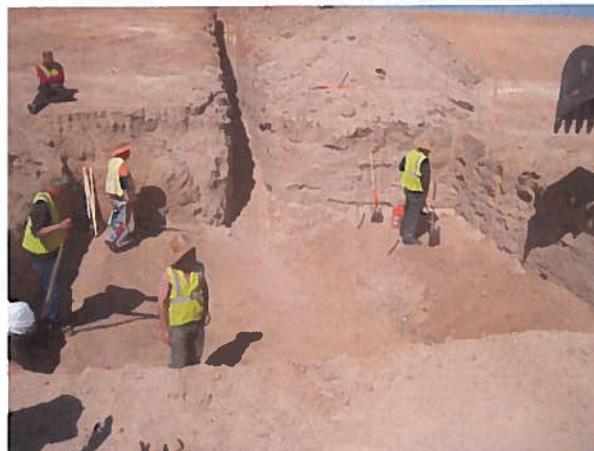
**Preparing subgrade of Lysimeter sump in pond B**

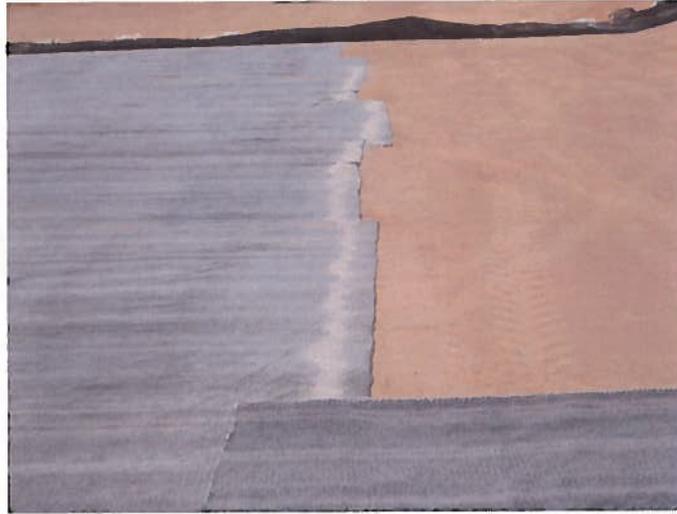
**Placing bentonite in butt seams of GCL placed in pond B**

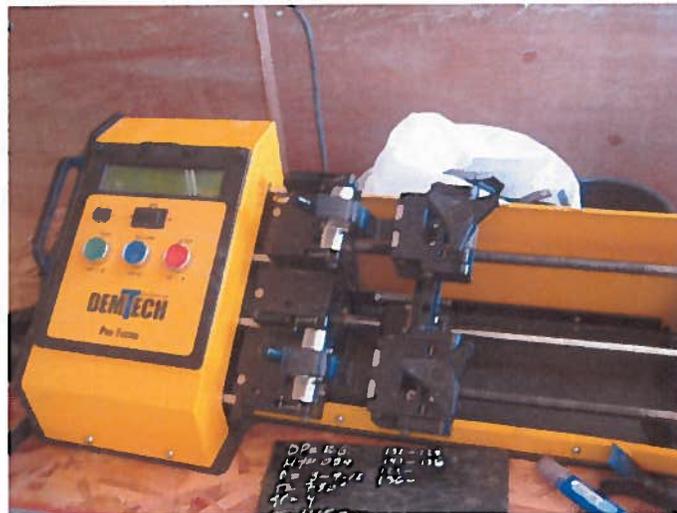
**Trial weld being pulled for fusion weld**

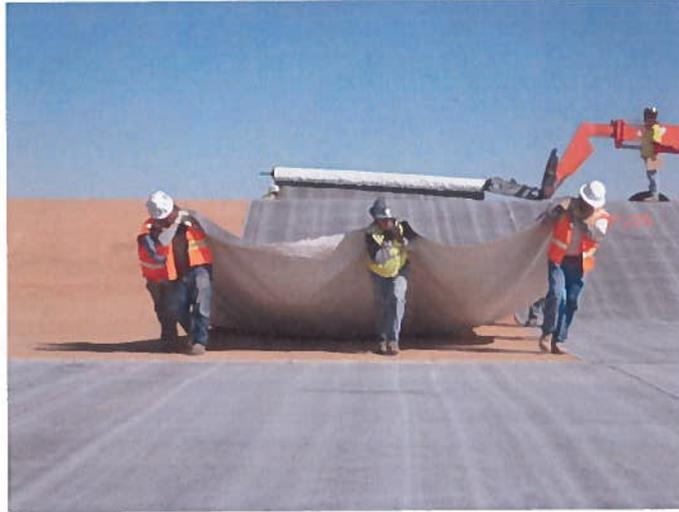
**Placing GCL on the east slope and cell floor in pond B**

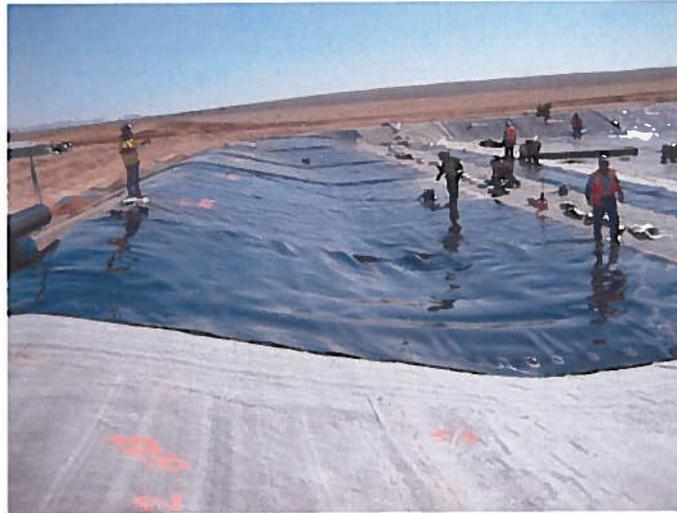
**Placing HDPE liner on top of GCL on the east slope and cell floor in pond B**

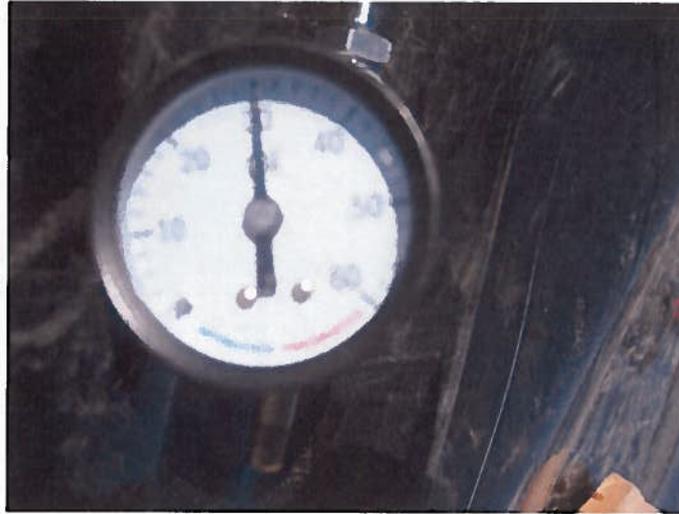
**Air pressure testing fusion welded seam of HDPE liner in pond B**

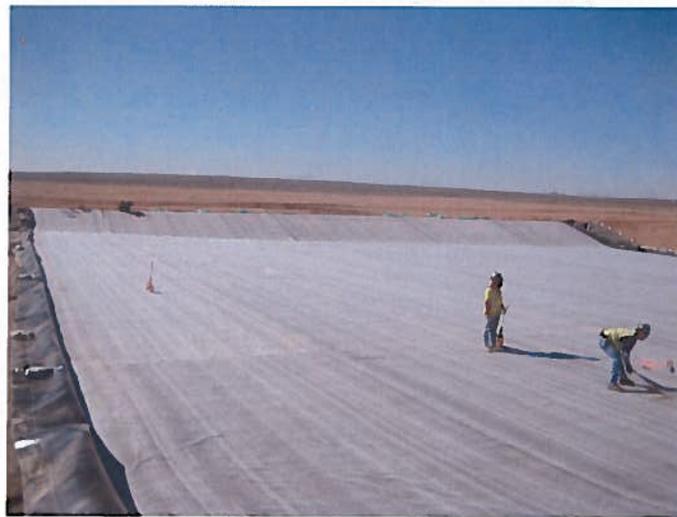
**Placing GCL on the North to South slope and cell floor between 1<sup>st</sup> and 2<sup>nd</sup> anchor trench in pond B**

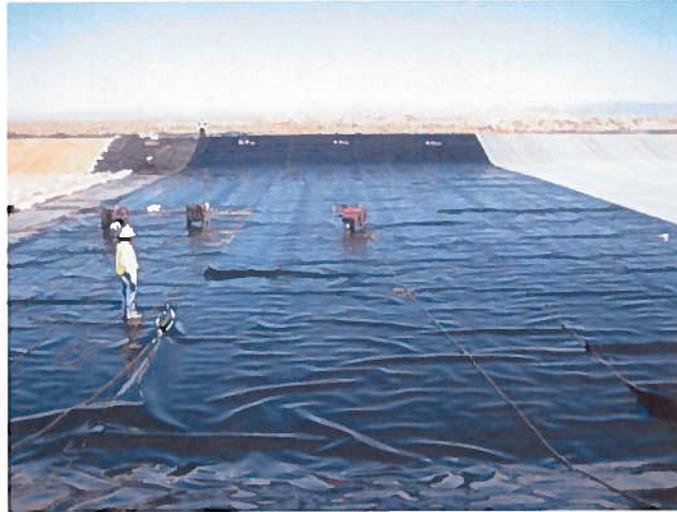
**Placing HDPE liner on top of GCL on the North to South slope and cell floor between 1<sup>st</sup> and 2<sup>nd</sup> anchor trench in pond B**

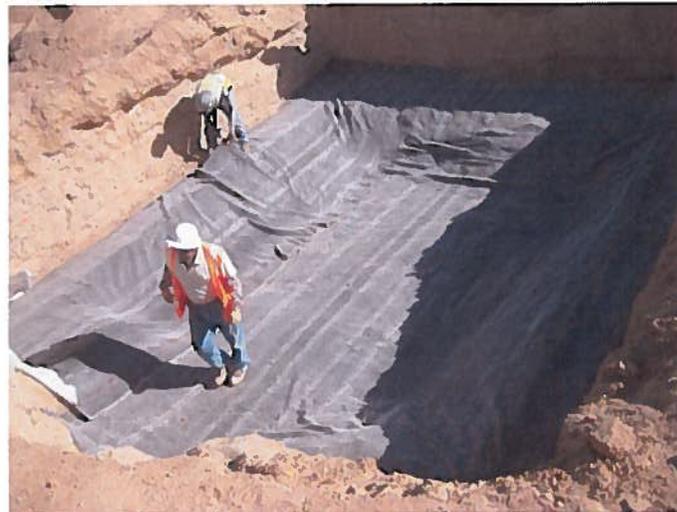
**Placing GCL in Lysimeter sump in pond B**

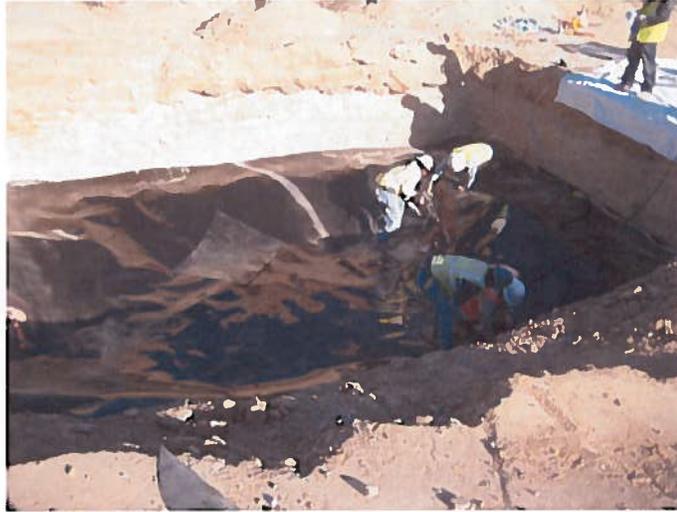
**Placing HDPE liner on top of GCL in Lysimeter sump in pond B**

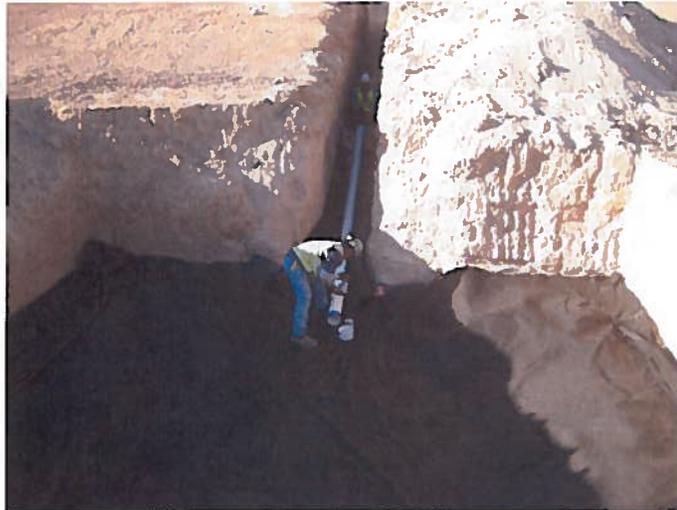
**Placing geotextile and pipe in Lysimeter sump in pond B**

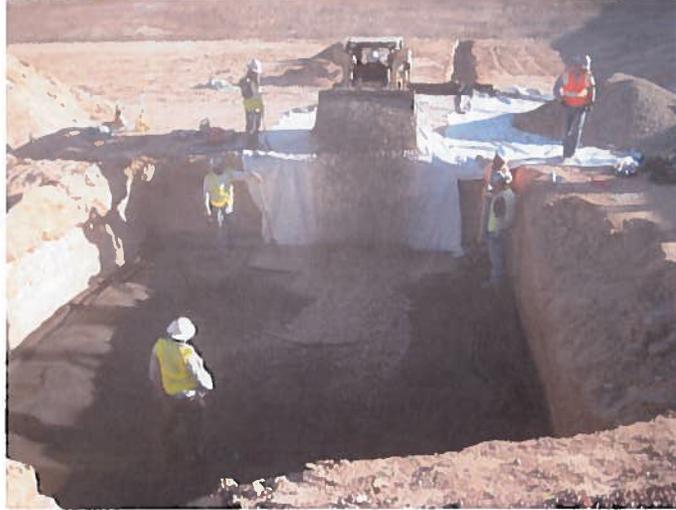
**Placing rock back fill on top of 12oz geotextile in Lysimeter sump in pond B**

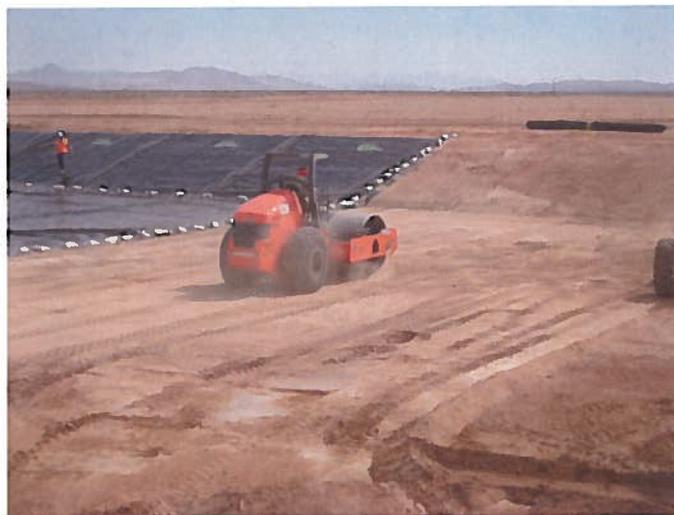
**Preparing sub grade of pond B**

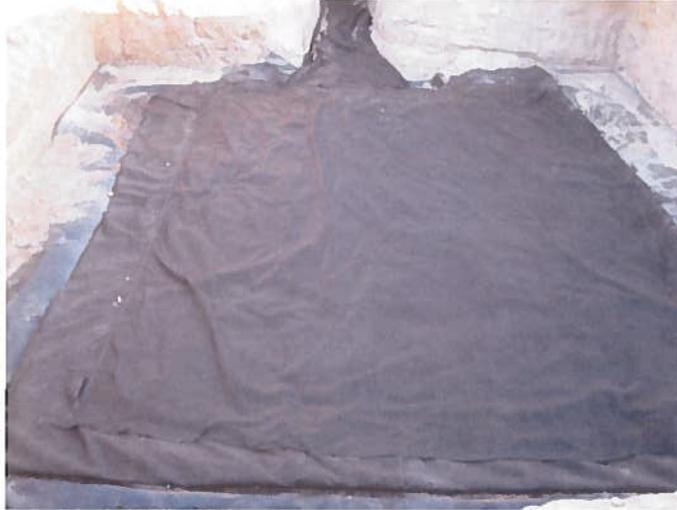
**Geotextile placed in Lysimeter sump in pond B**

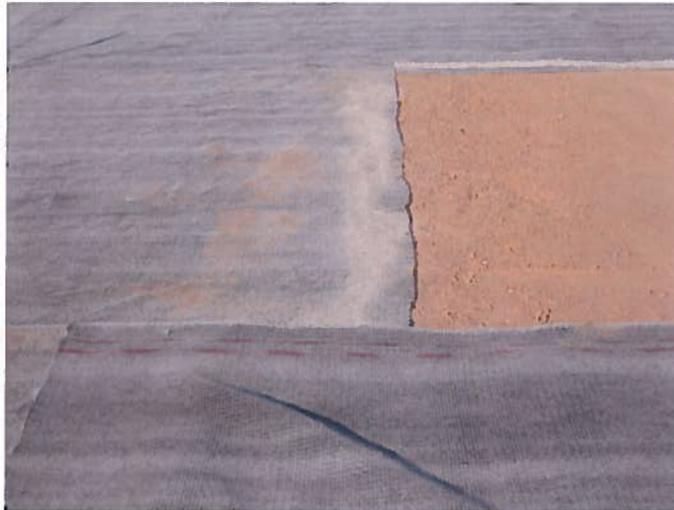
**Placing bentonite in butt seams of GCL placed in pond B**

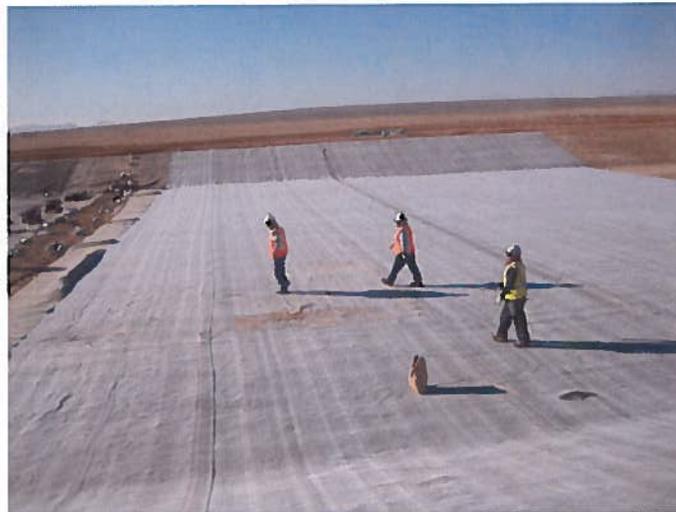
**Placing GCL on the North slope, South slope, cell floor between 2<sup>nd</sup> and 3<sup>rd</sup> anchor trench in pond B**

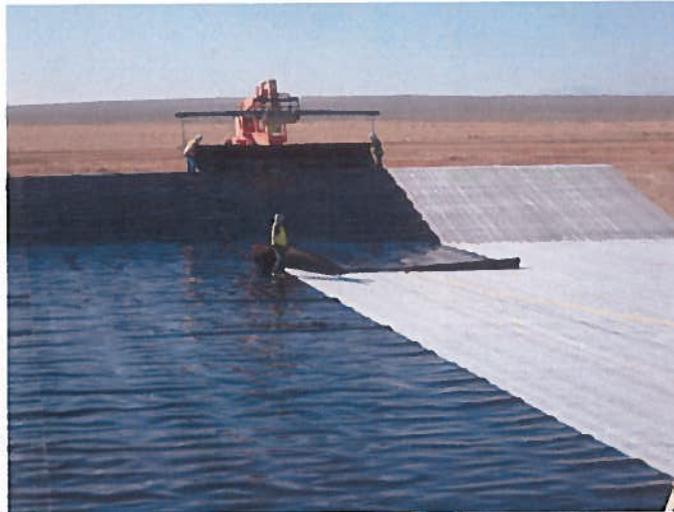
**Placing HDPE liner on the North slope, South slope, cell floor between 2<sup>nd</sup> and 3<sup>rd</sup> anchor trench in pond B**

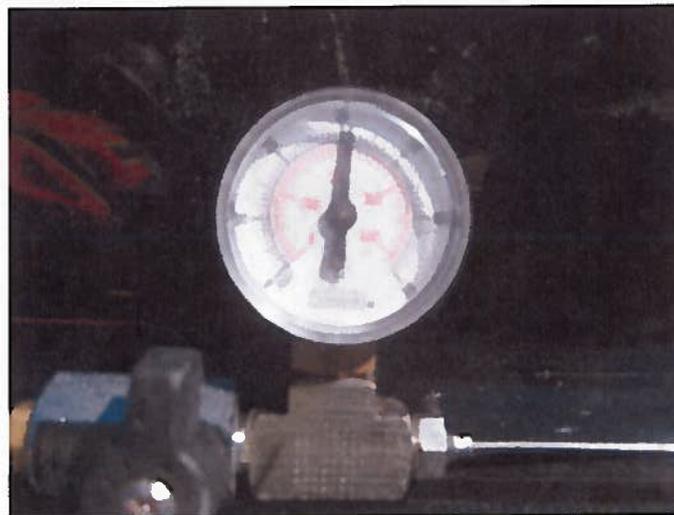
**Air pressure testing fusion welded seam of HDPE liner in pond B**

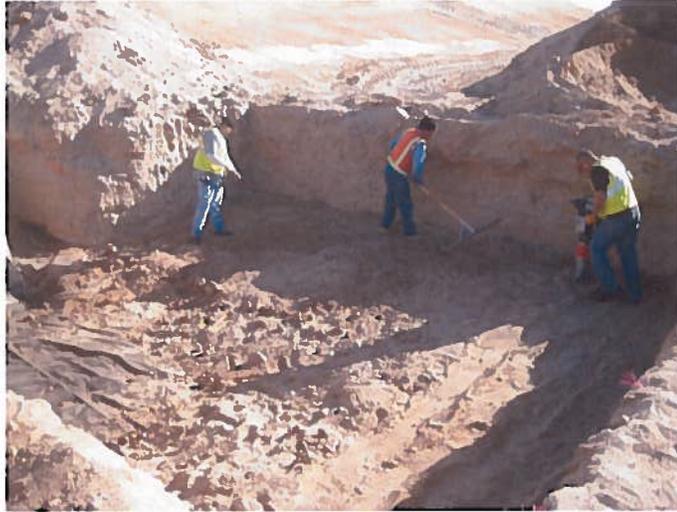
**Compacting material placed on top of geotextile in Lysimeter sump in pond B**

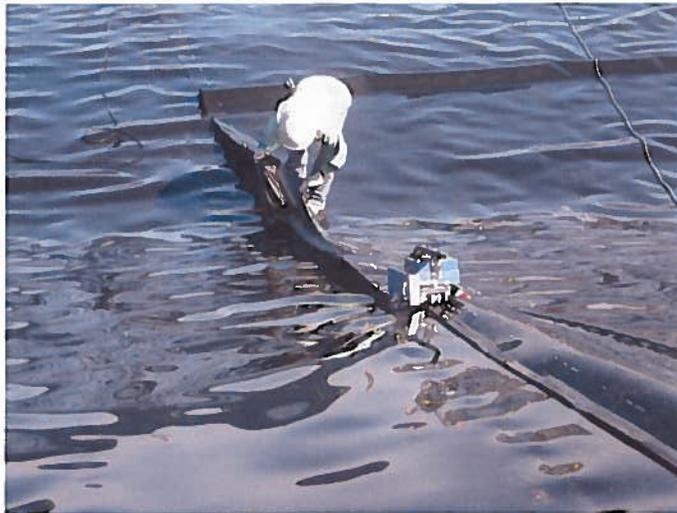
**Cleaning and fusion welding seam of HDPE liner in pond B**

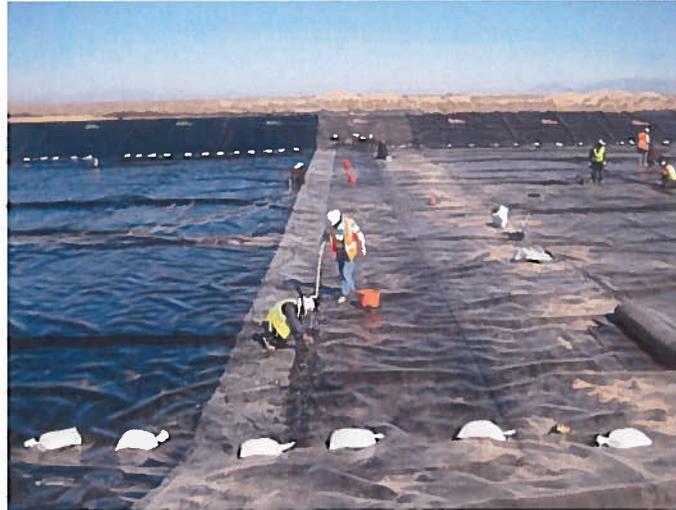
**Cap over anchor trench in pond B**

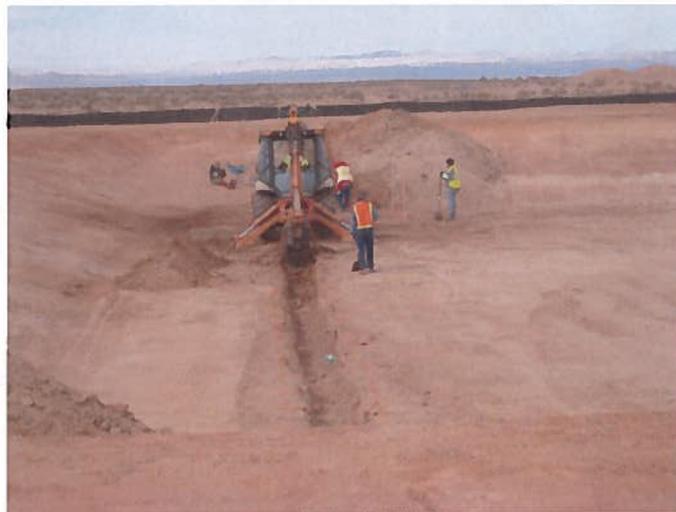
**Digging 3<sup>rd</sup> anchor trench in pond B**

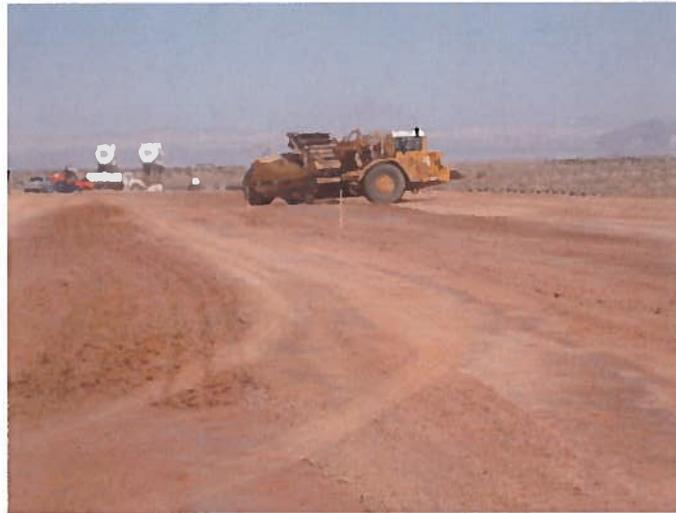
**623 scrapper placing fill material on the East side of compost area**

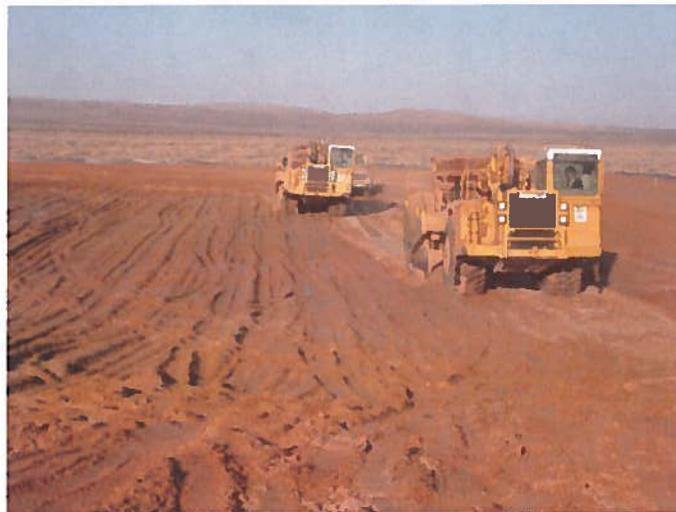
**Two 623 scrapper removing material from pond A**

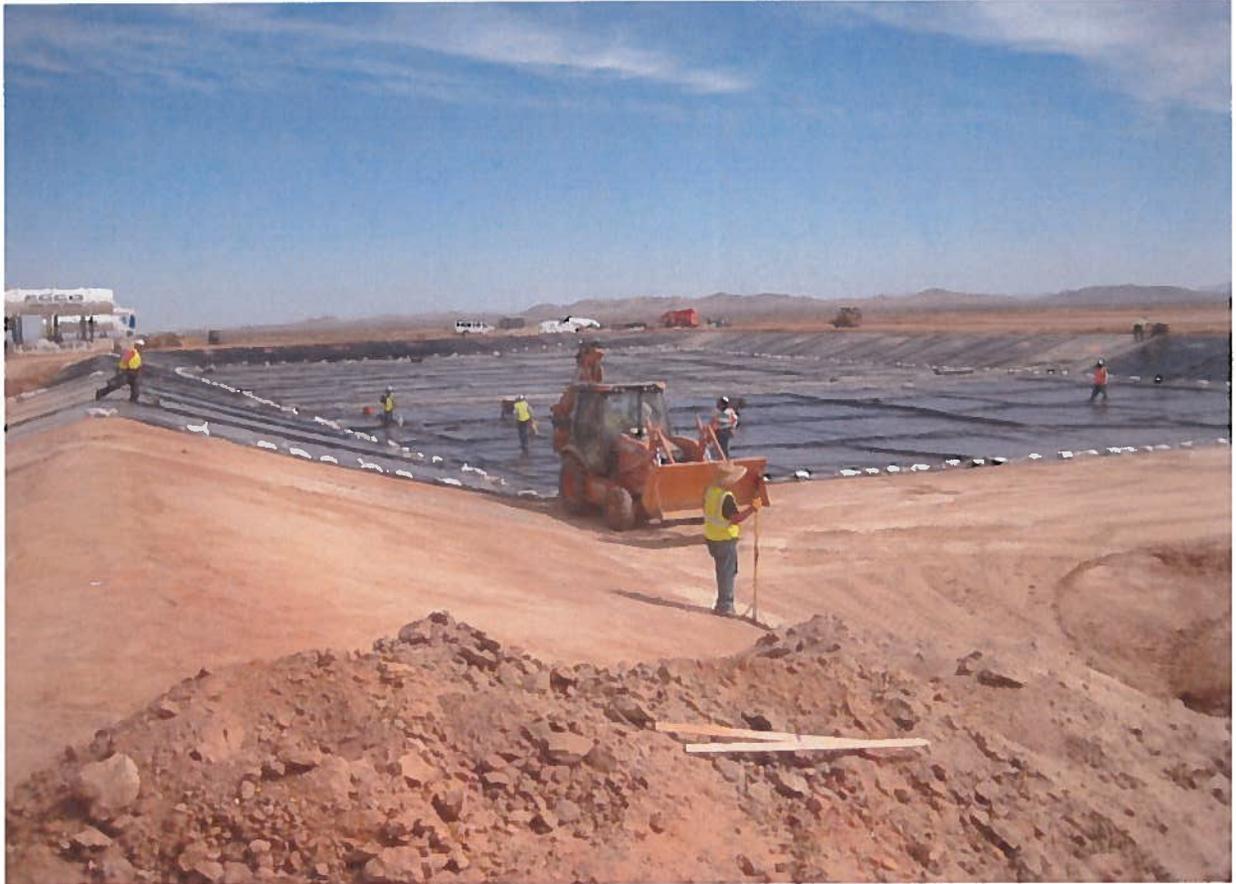
**Pond B picture from the West side looking to the East side.**

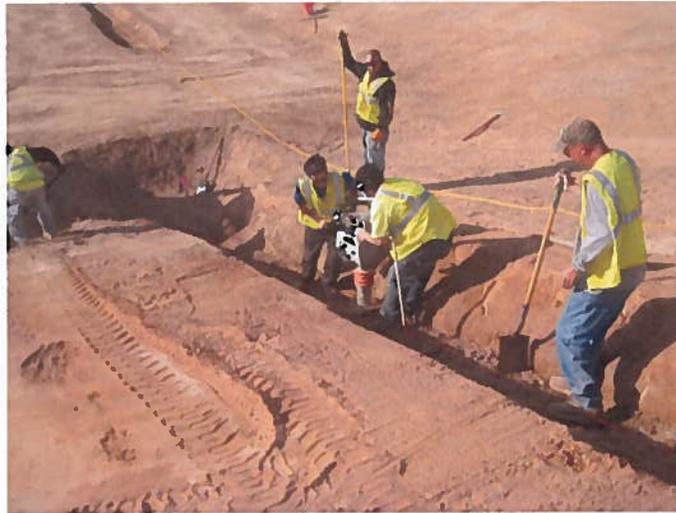
**Compacting and preparing subgrade of sump in pond B**

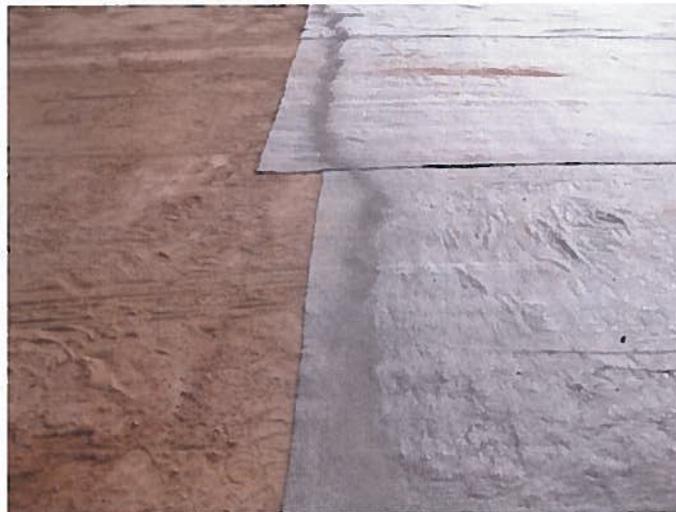
**Placing bentonite in butt seams of GCL placed in pond B**

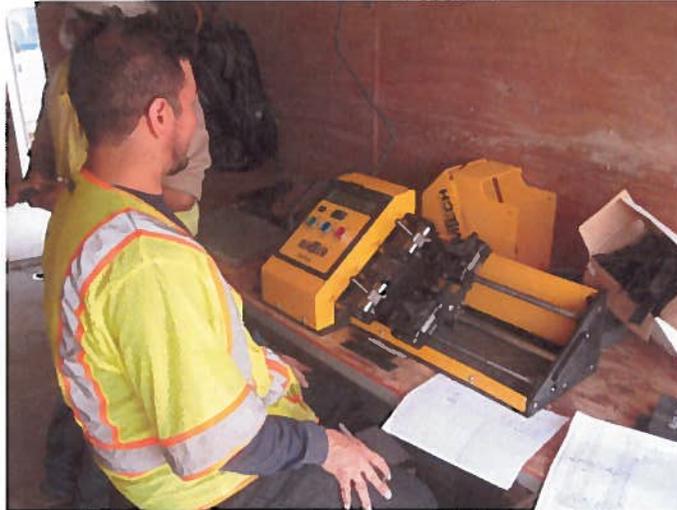
**Trial weld being pulled for fusion weld**

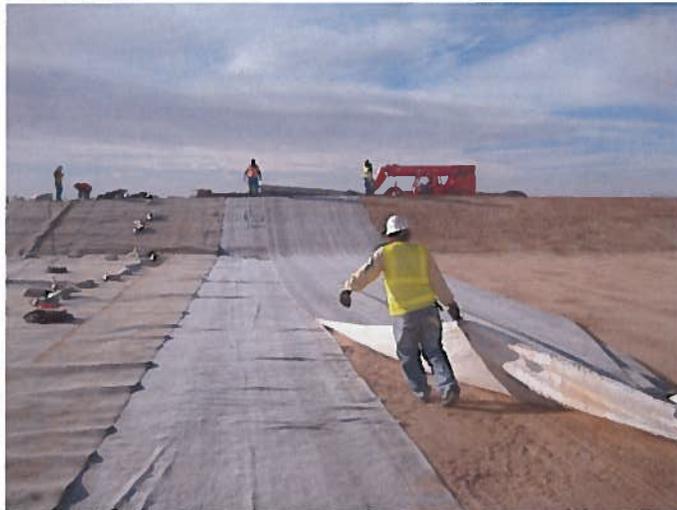
**Placing GCL on the North slope, South slope, cell floor between 2<sup>nd</sup> and 3<sup>rd</sup> anchor trench in pond B**

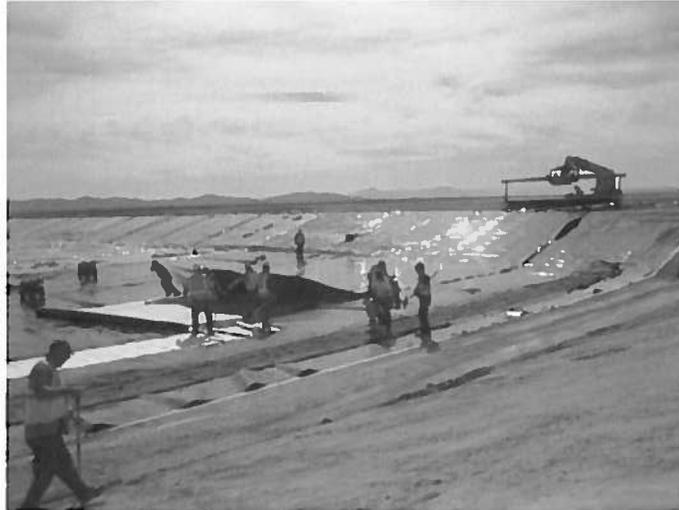
**Placing HDPE liner on the North slope, South slope, cell floor between 2<sup>nd</sup> and 3<sup>rd</sup> anchor trench in pond B**

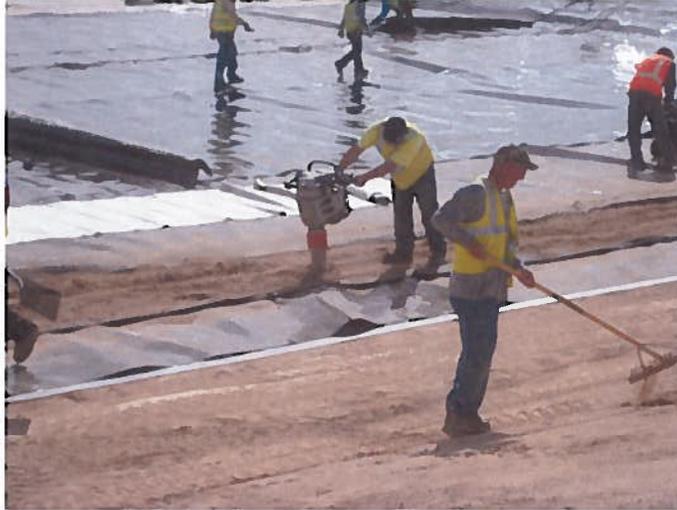
**Compacting back fill material in anchor trench # 3 in pond B**

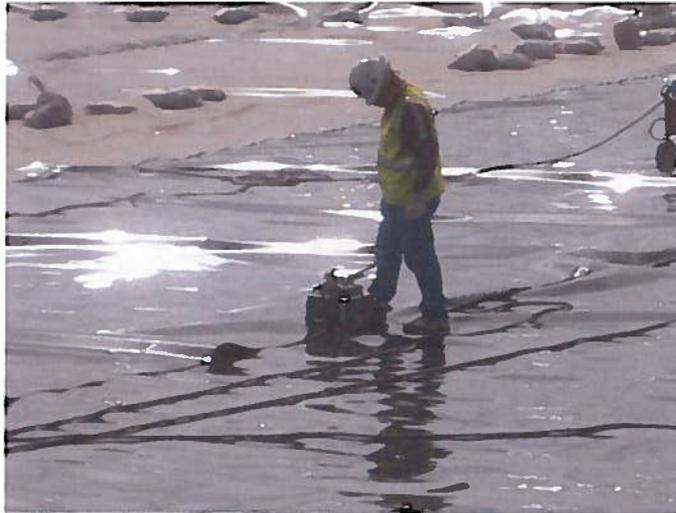
**Fusion welding seam of HDPE liner in pond B**

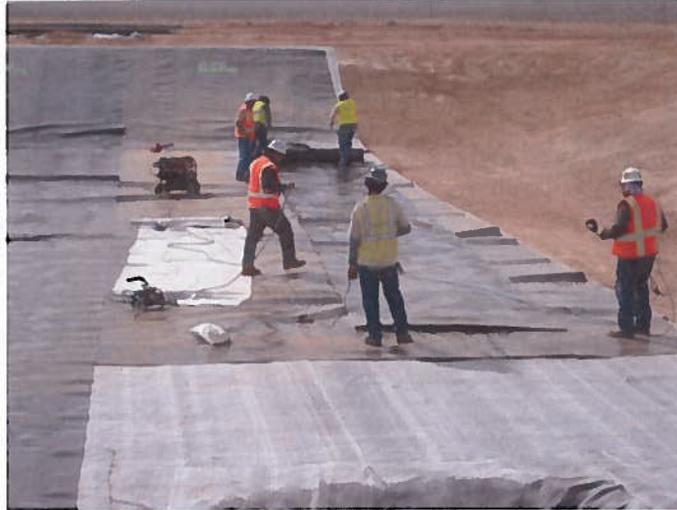
**Cap over anchor trench # 3 in pond B**

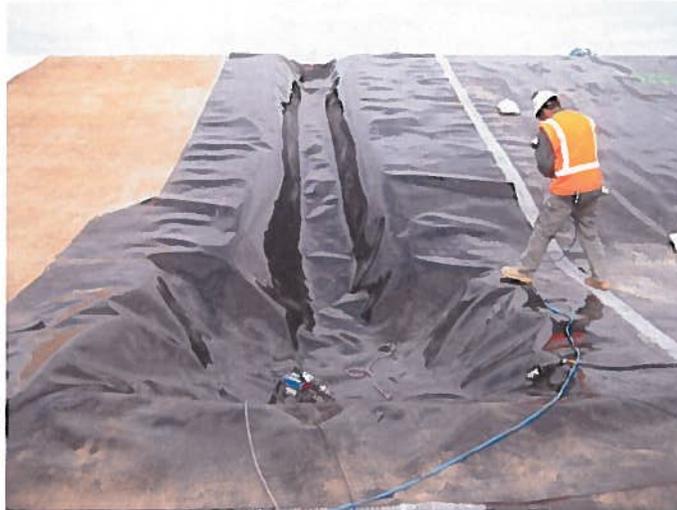
**HDPE liner placed in sump in pond B**

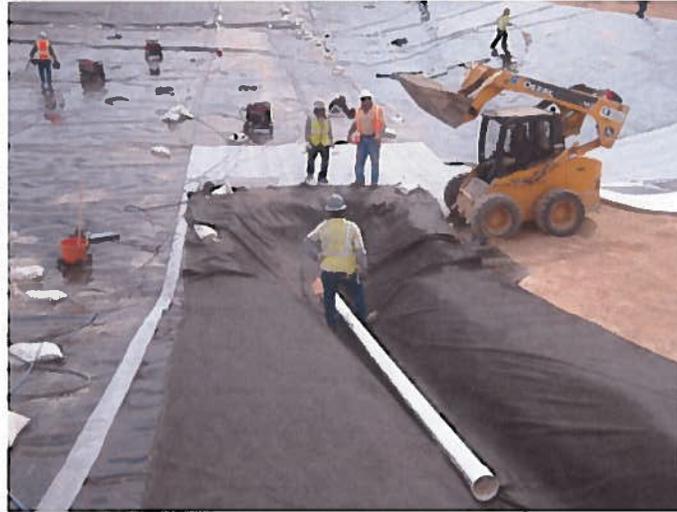
**Geotextile and pipe placed in sump in pond B**

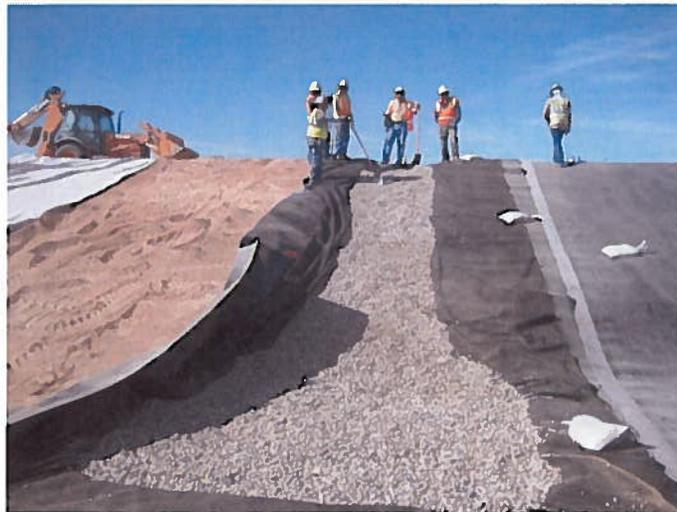
**Rock placed in sump in pond B**

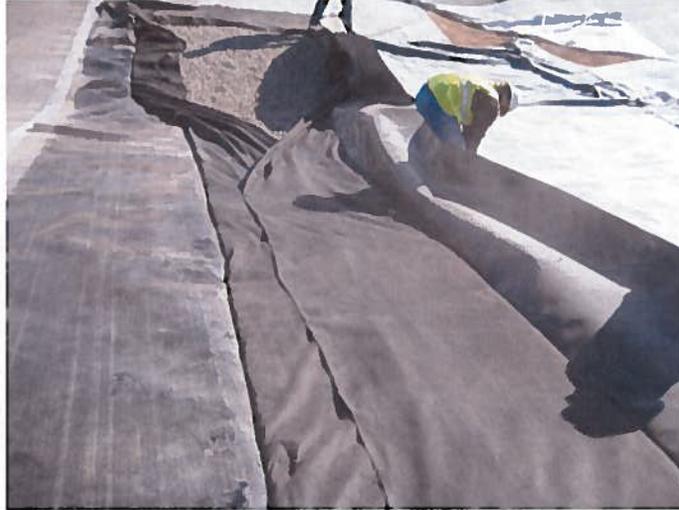
**Geotextile placed on top of rock in sump in pond B**

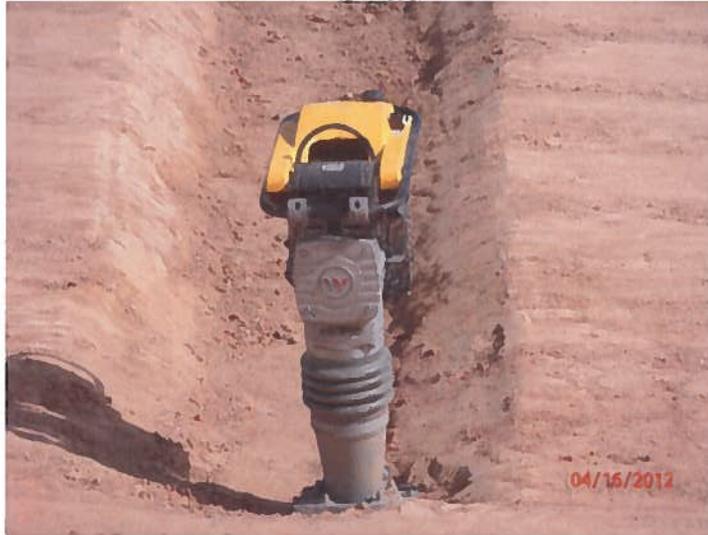
**Pond A Floor Ballast Trench Compacted Bottom**

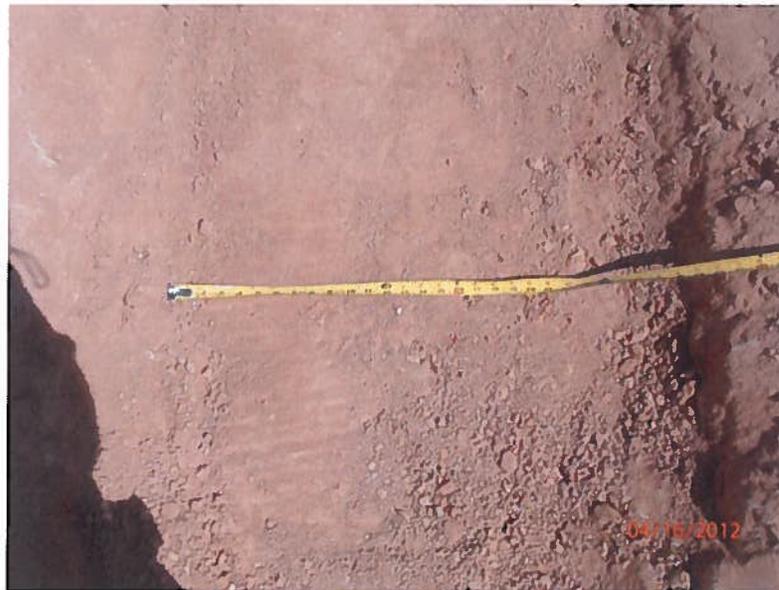
**Pond A Ballast System per plan**

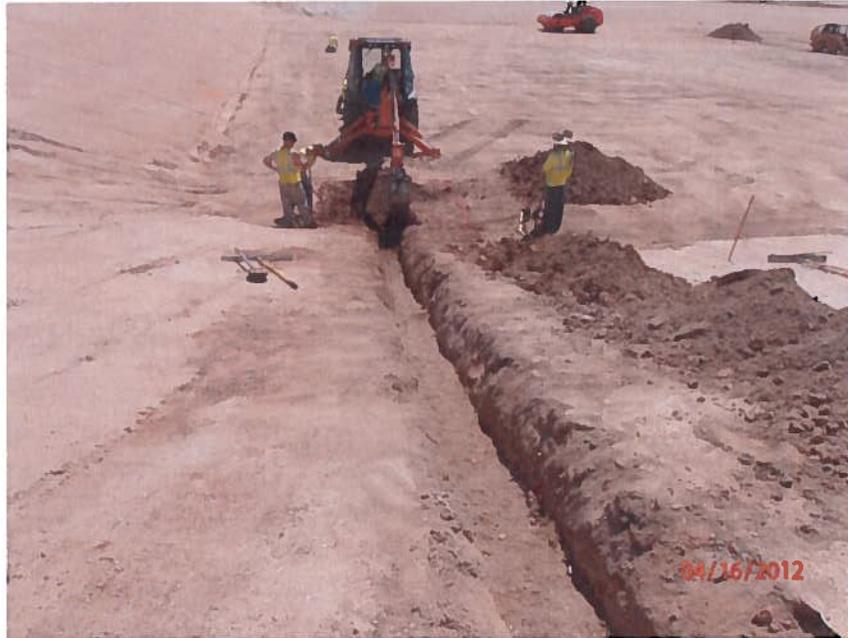
**Leak Detention Collection Trench Pond A**

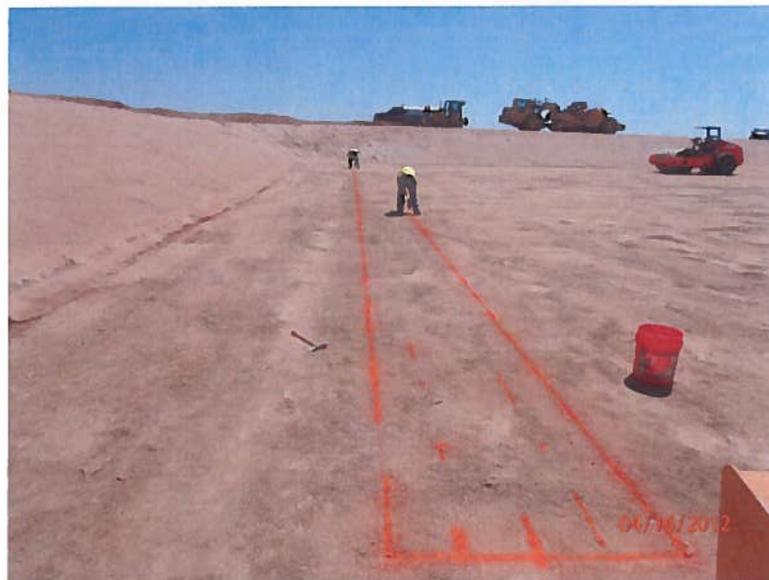
**Most Westerly Ballast Trench Pond A**

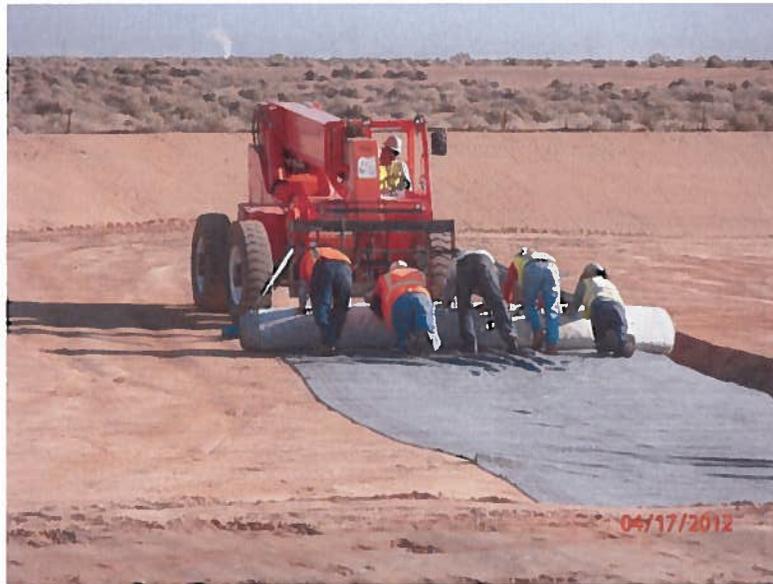
**Pond A GCL deployed at Ballast Trench**

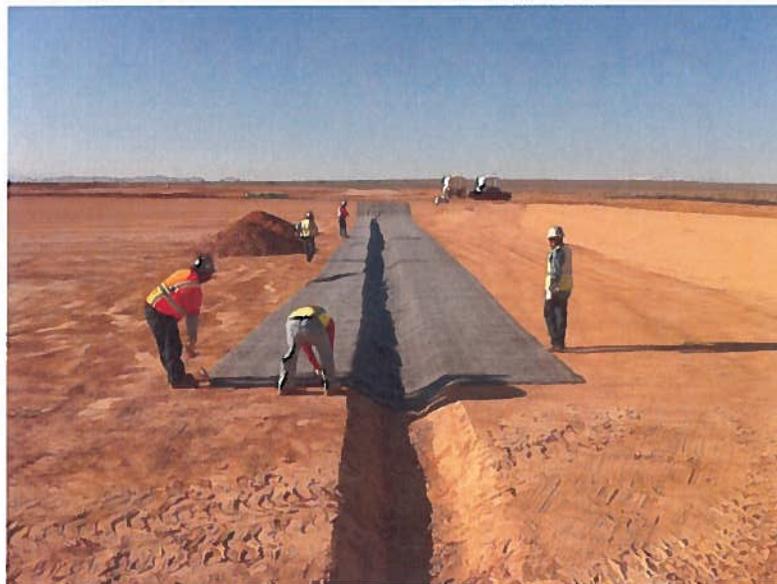
**Pond A Floor Ballast Anchor Trench GCL (looking south) most westerly trench**

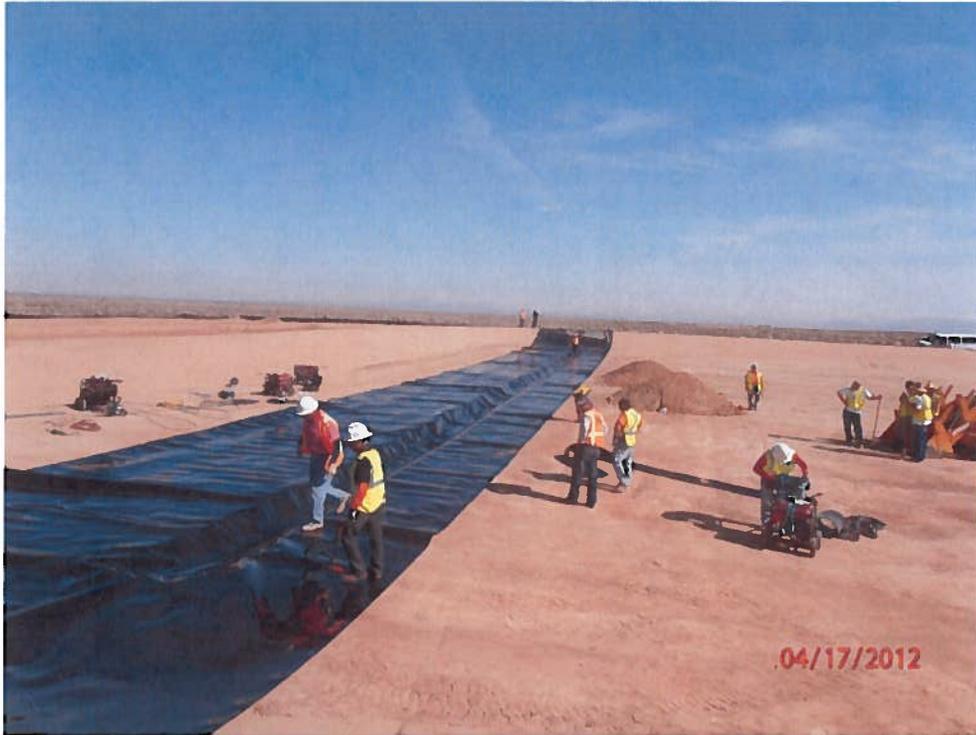
**Pond A Floor Ballast Trench 60-mil HDPE Liner above GCL (no exposed GCL)**

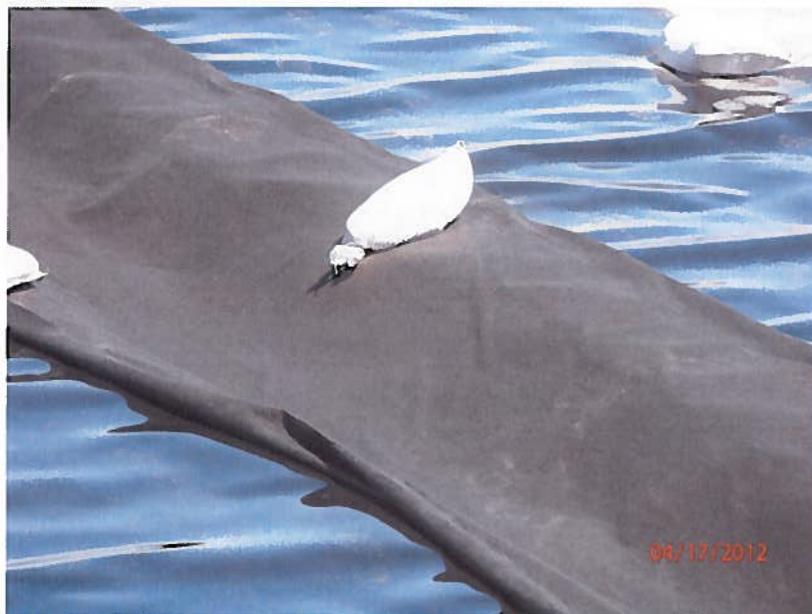
**Pond A Ballast System Geotextile above the HDPE for cushion and protection**

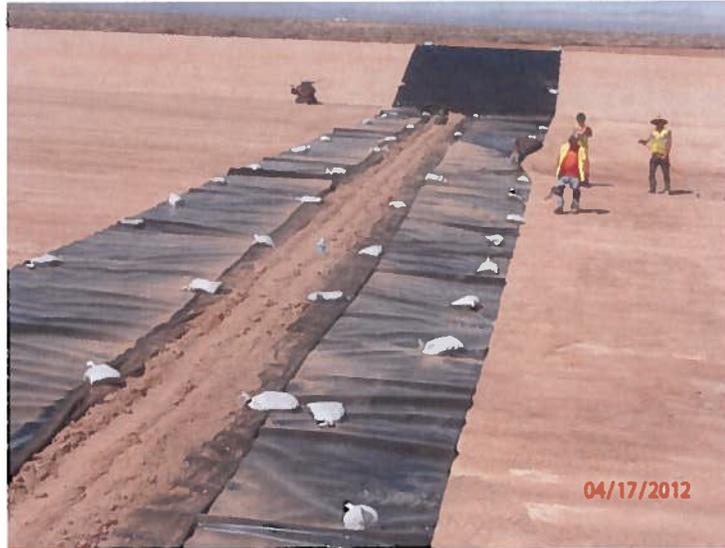
**Ballast fill above liner system**

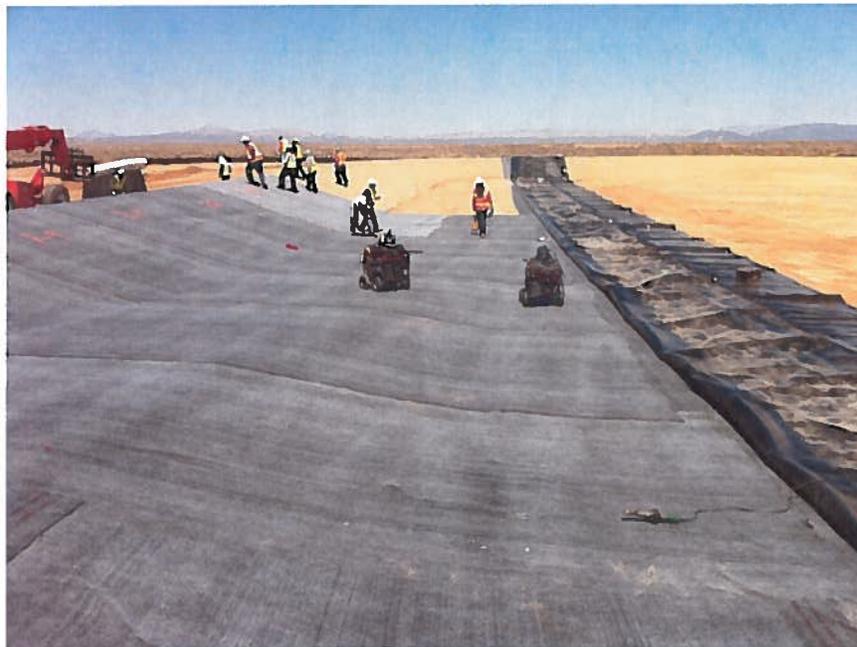
**Most Westerly Ballast Trench and Ramp area GCL Pond A**

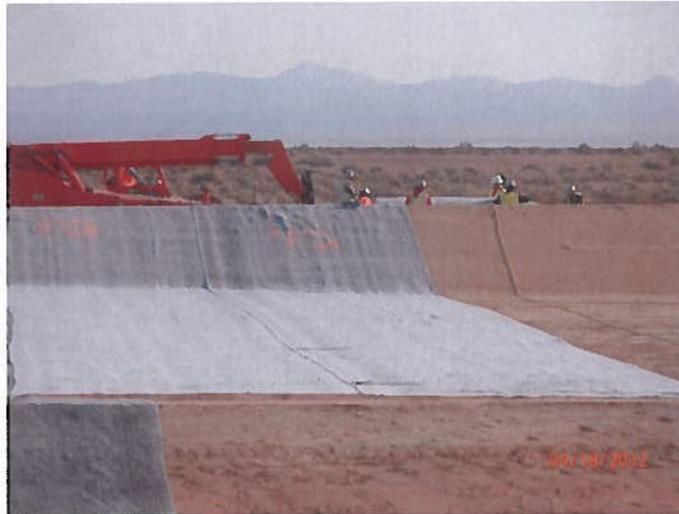
**Pond A GCL deployed north slope**

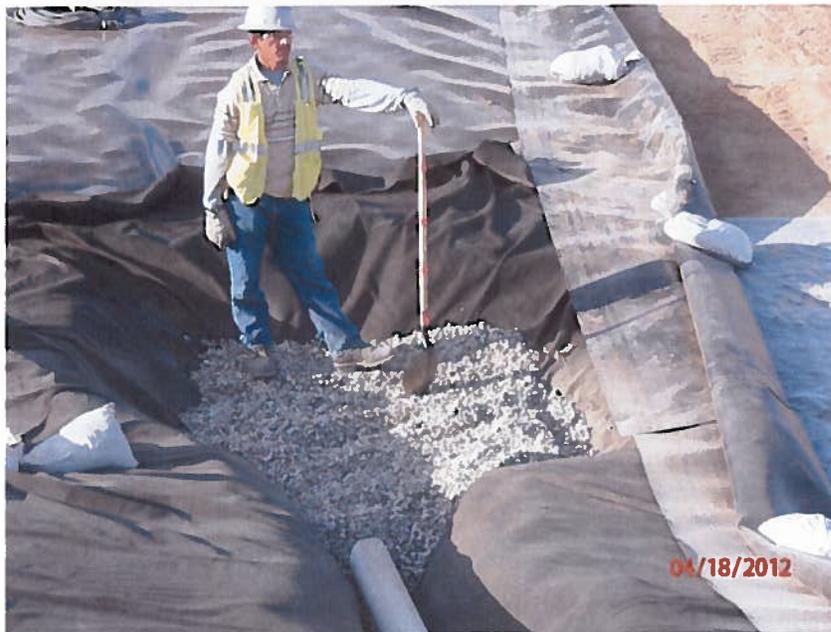
**Pond A Leak Detection Sump**

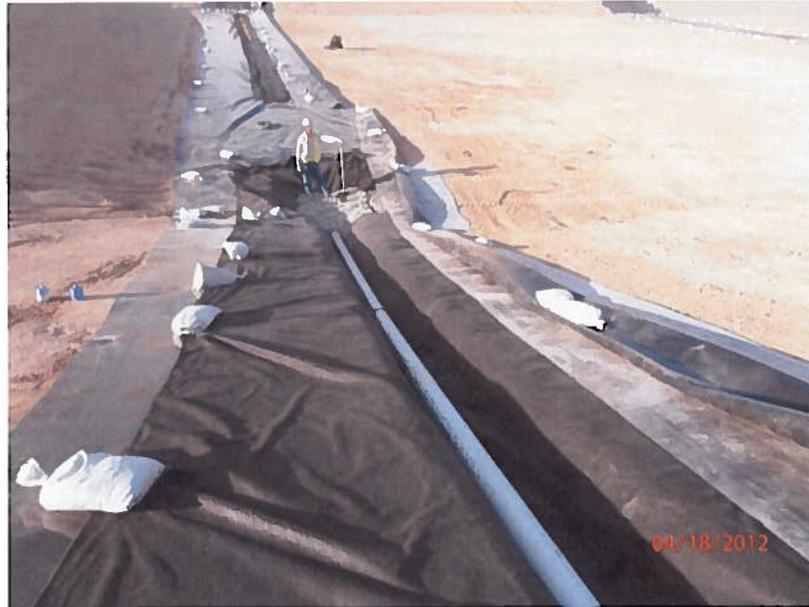
**Pond A Floor leak detection sump and riser pipe**

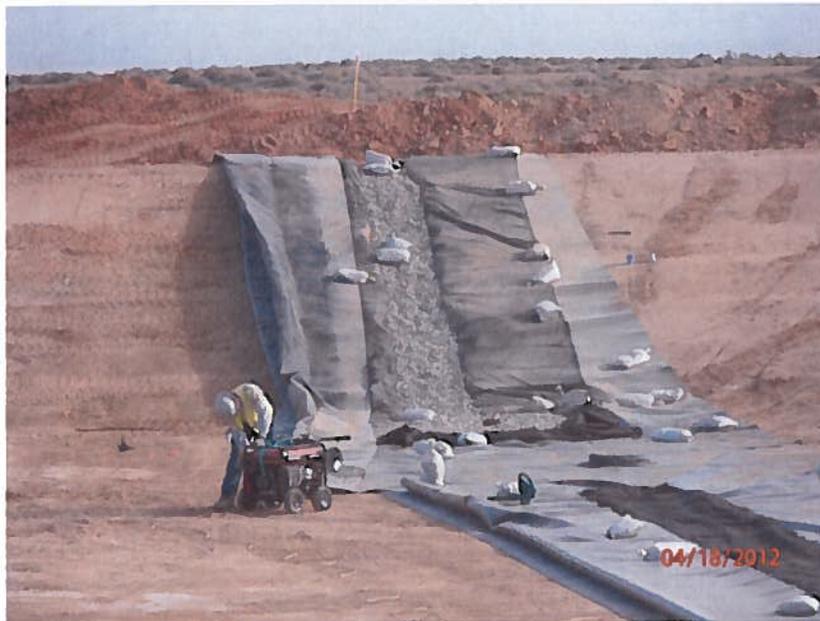
**Pond A leak detection sump system**

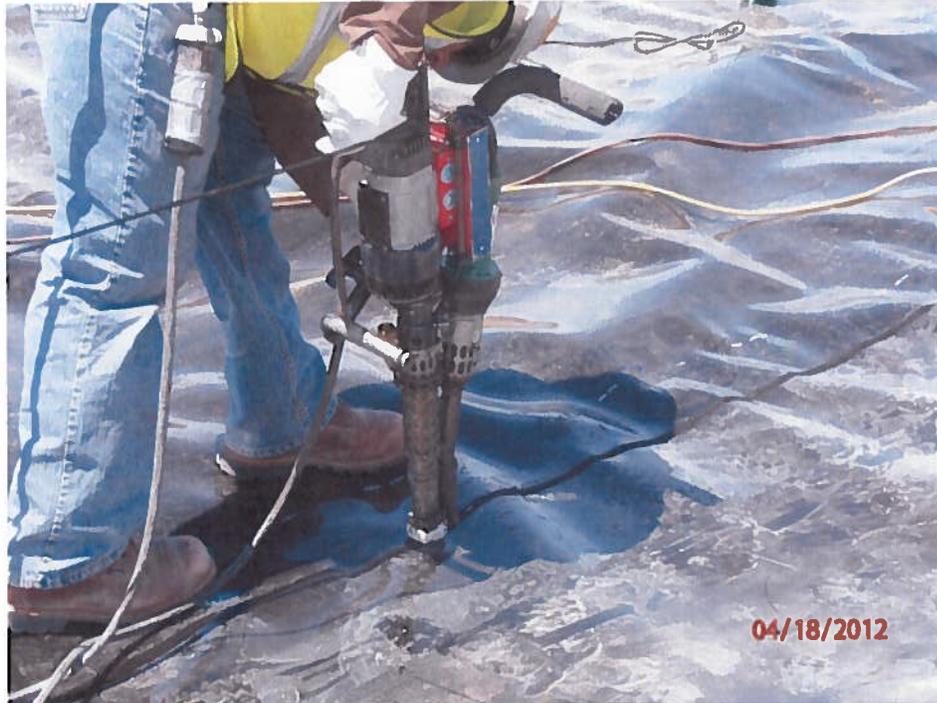
**Pond A Extrusion Weld Cap on Ballast Trench to Close System**
