**FINAL CONSTRUCTION  
QUALITY ASSURANCE REPORT  
WASTE PILE COMPOSTING PAD and  
SURFACE IMPOUNDMENT A and B**

**HAWES COMPOSTING FACILITY**

September 2012

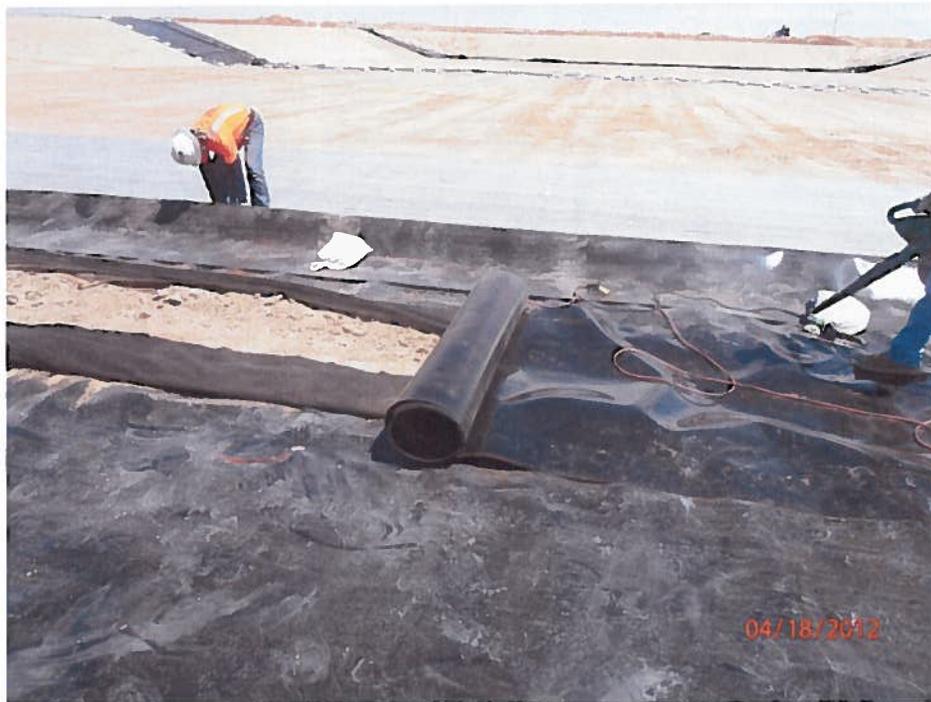
**Pond A ballast system closure**

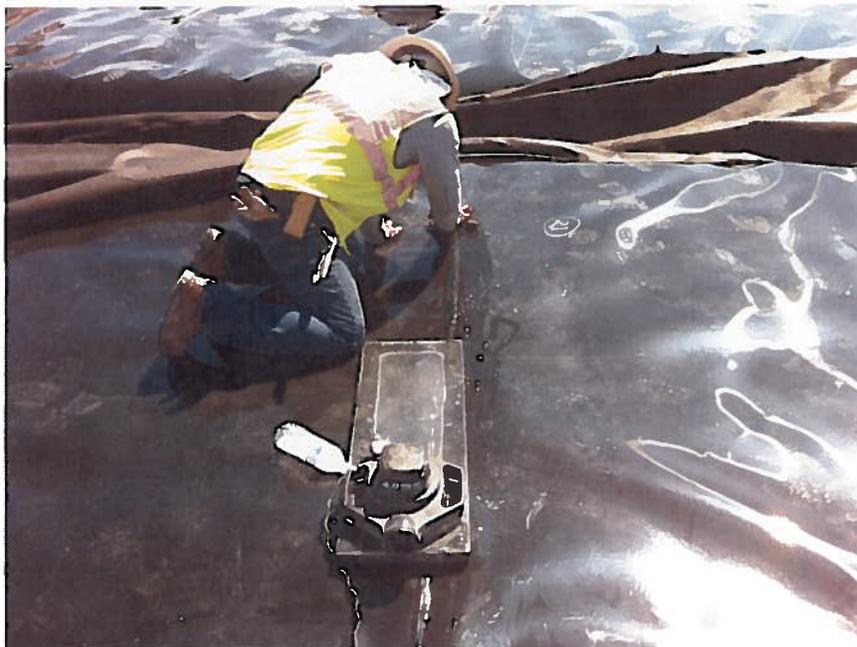
**Pond A Quality Control Vacuum Box Testing**

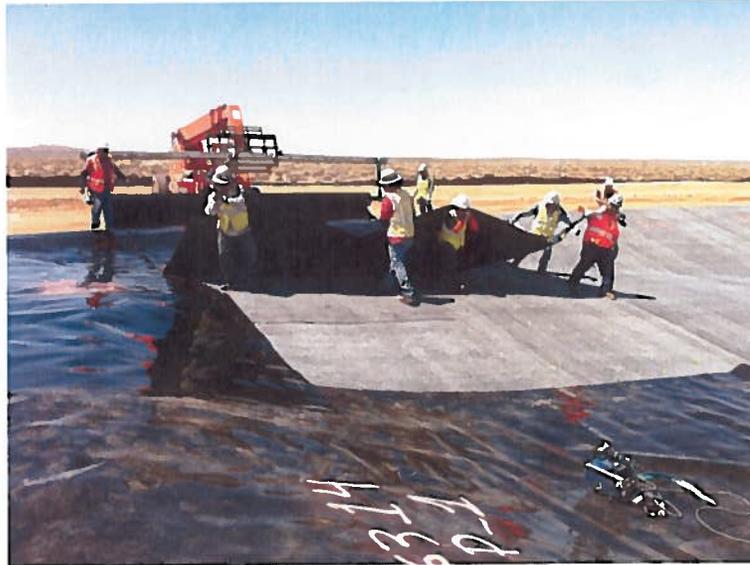
**Pond A HDPE Installation**

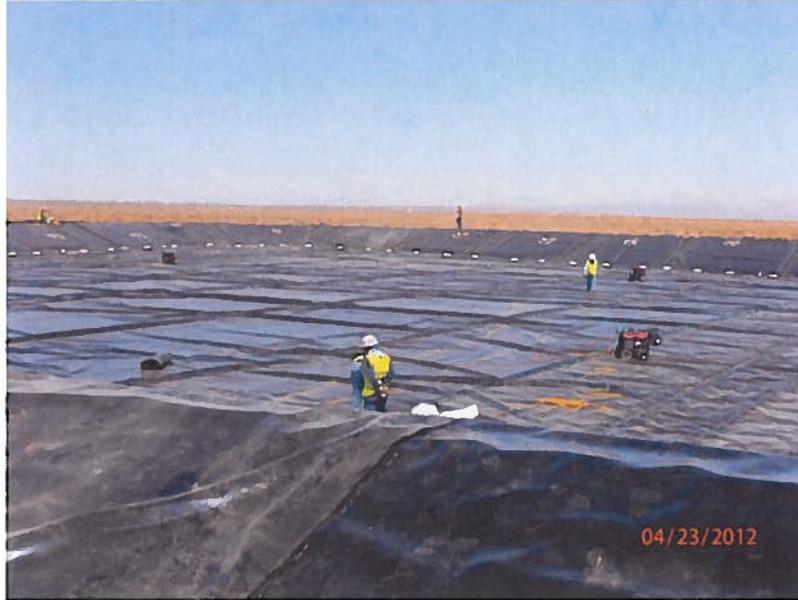
**Pond A Quality Control Destructive Seam Sampling**

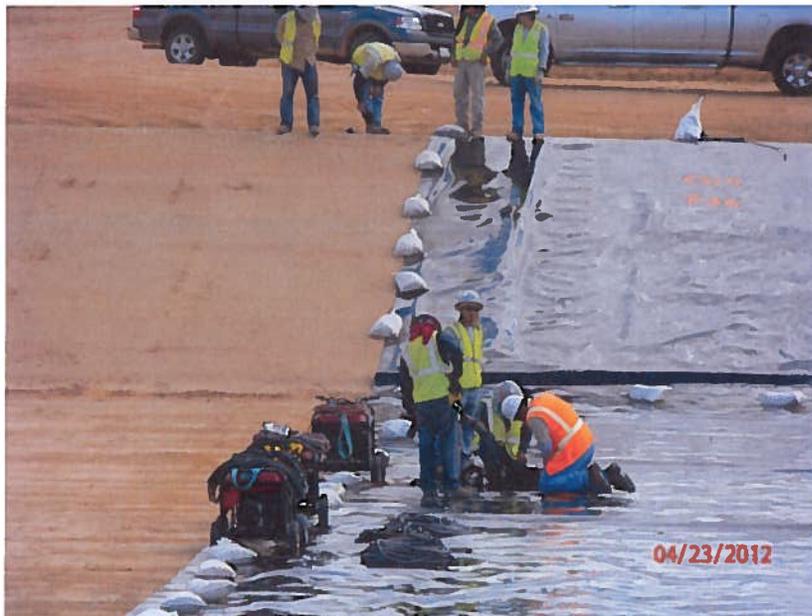
**Pond A HDPE Morning Trail "Pre-Weld" Samples**

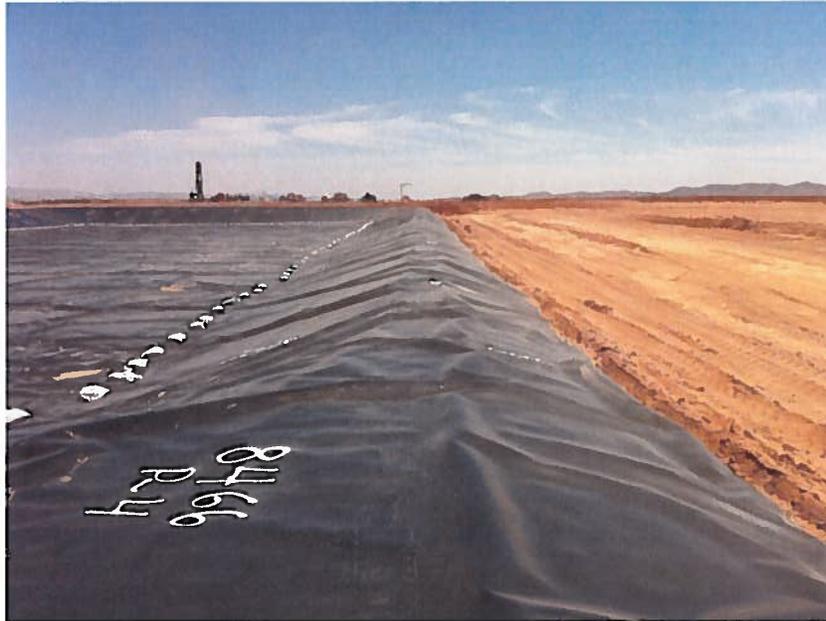
**Pond A Final Anchor Trench Backfill & Compaction**

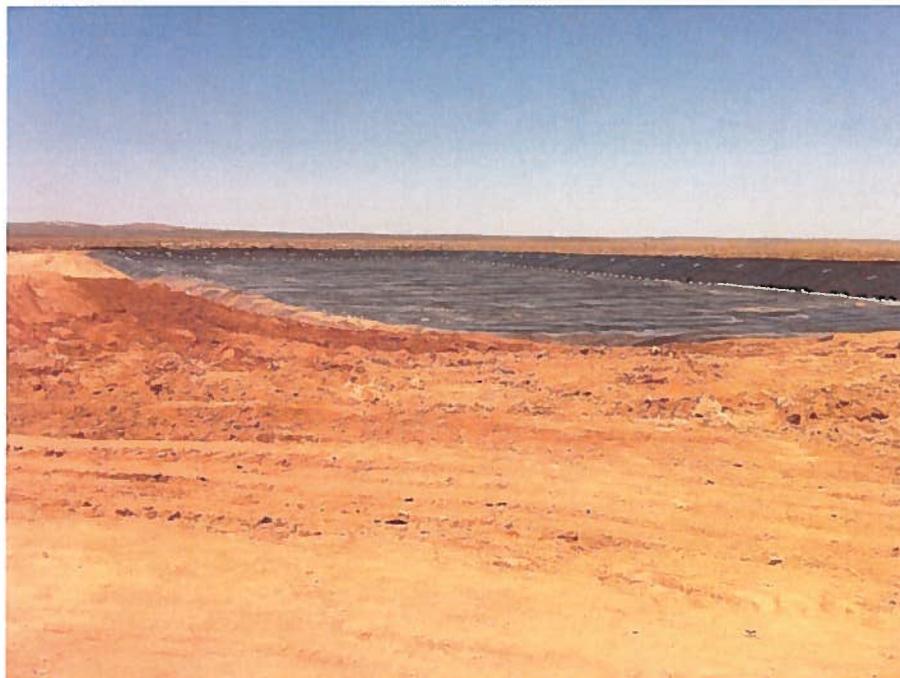
**Pond A Completed (looking west)**

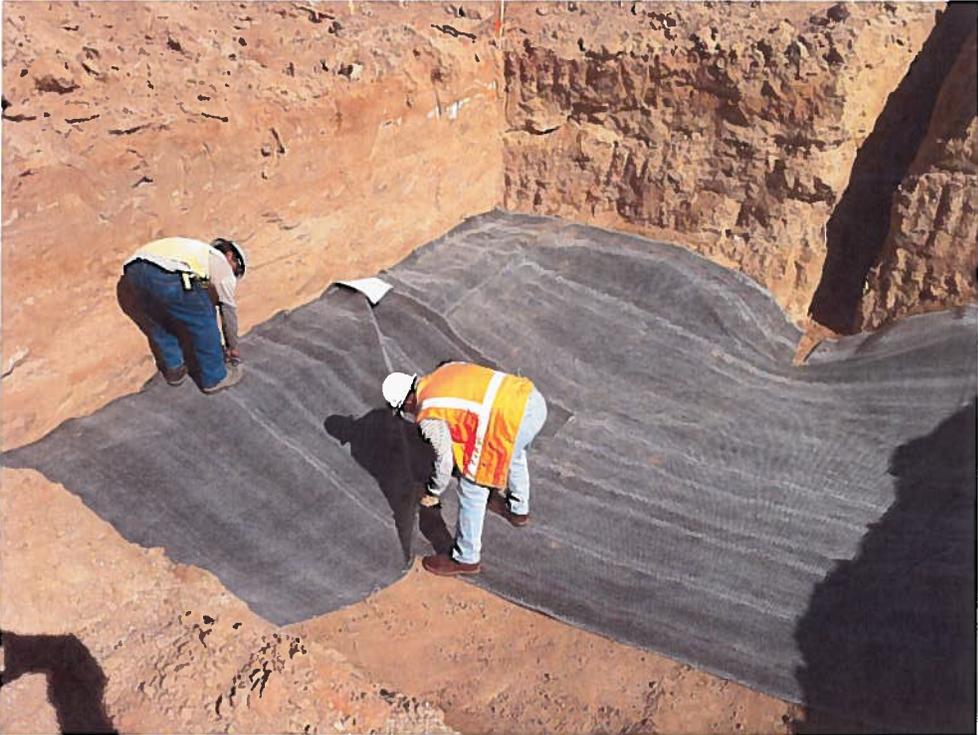
**Figure 3 - Lysimeter GCL Installation**

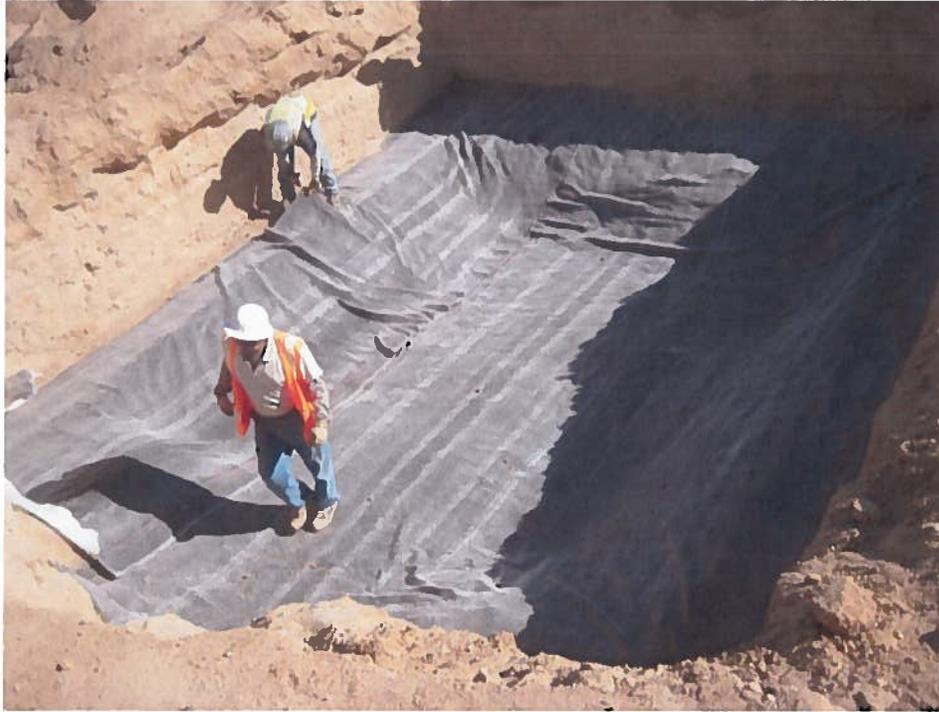
**Figure 4 - Completed Lysimeter GCL Installation**

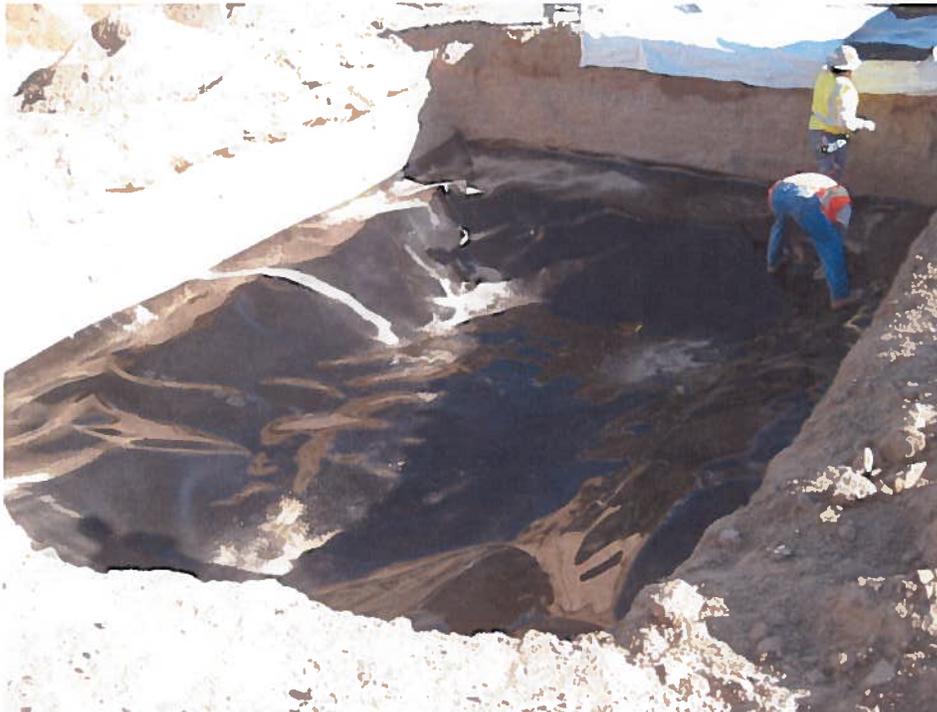
**Figure 5 - Lysimeter HDPE Liner Installation**

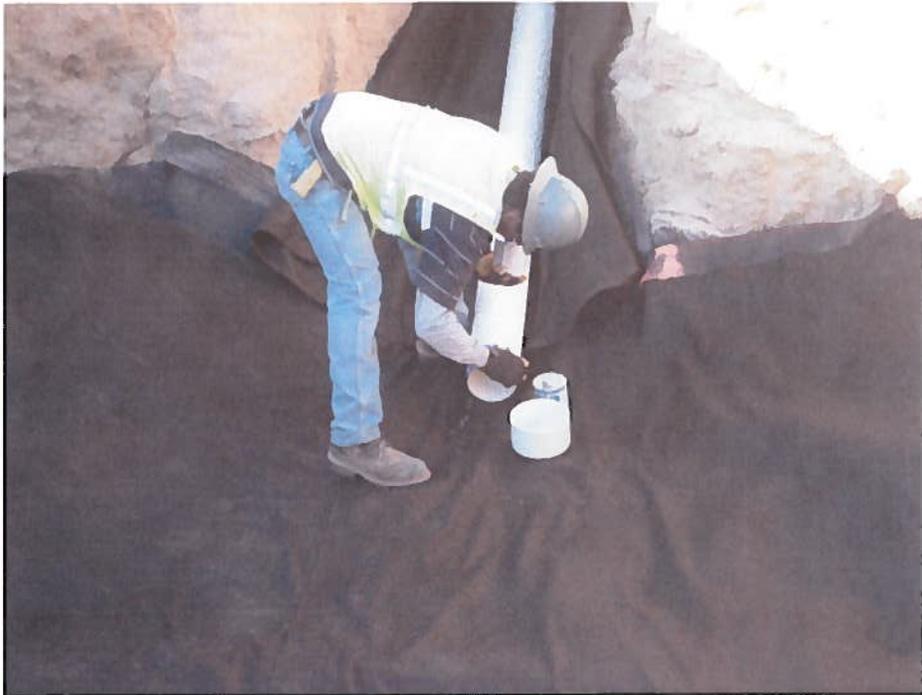
**Figure 6- Lysimeter Geotextile Cushion Fabric and PVC Monitoring Pipe Placement**

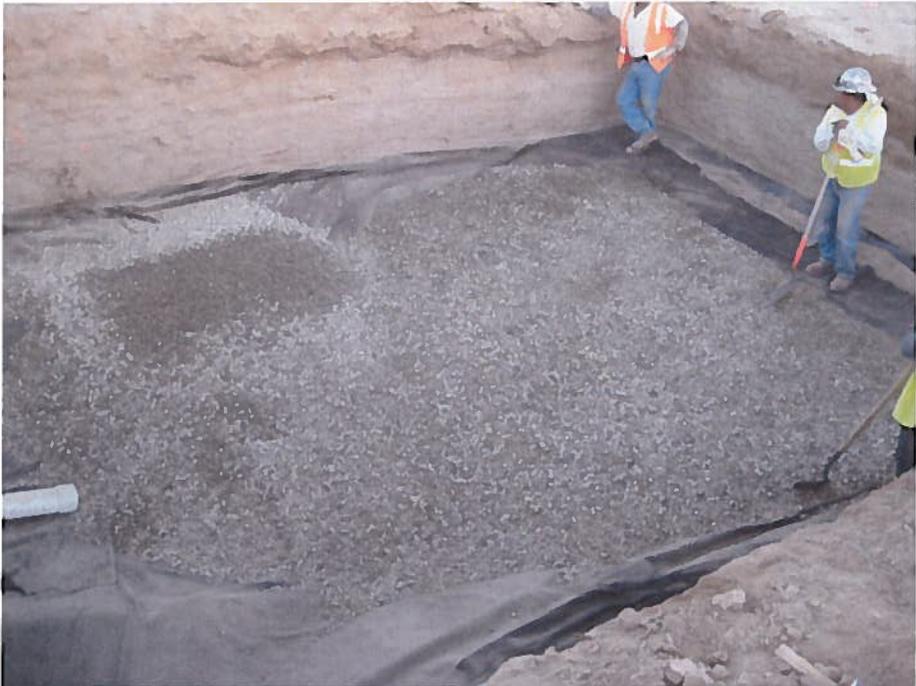
**Figure 7 - Lysimeter Washed Gravel Placement**

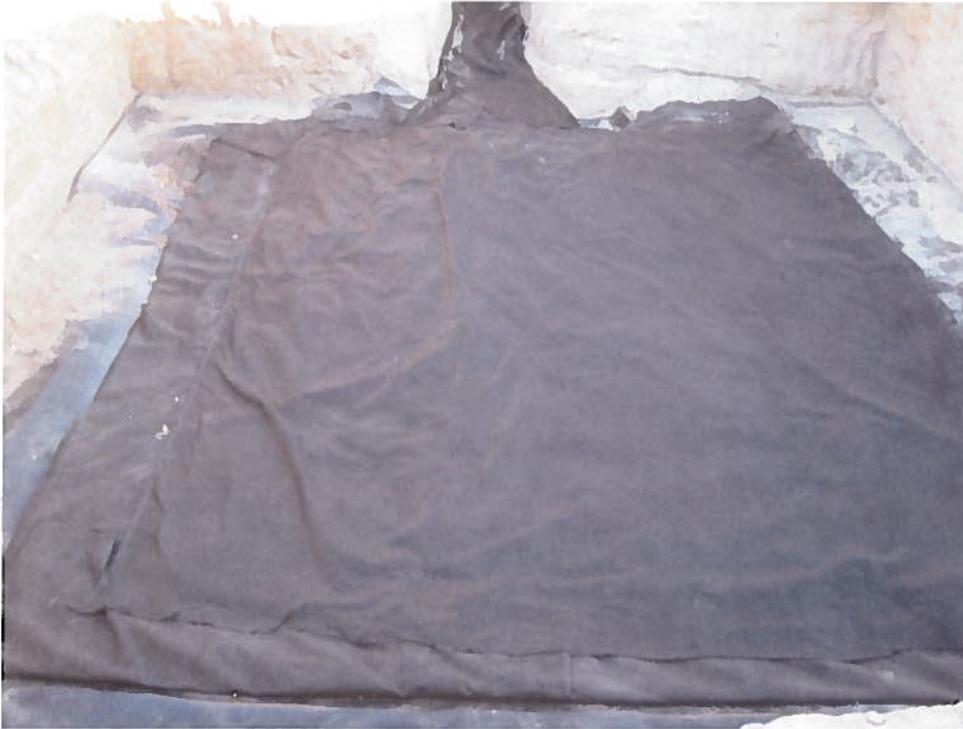
**Figure 8 - Lysimeter Gravel Wrap with Geotextile Fabric**

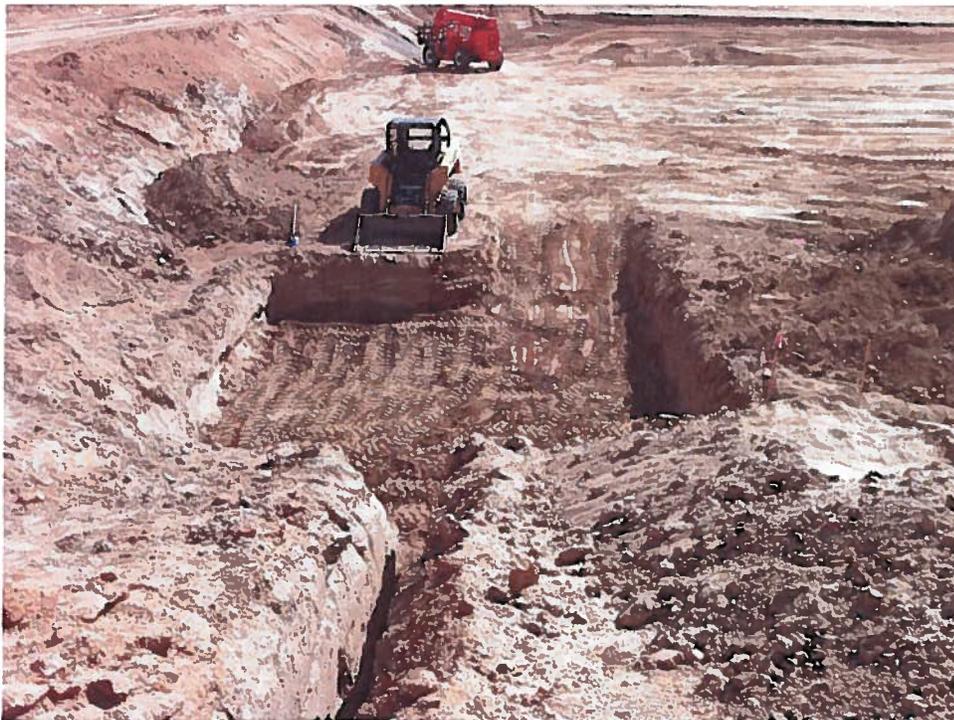
**Figure 9 - Lysimeter Select Soil Backfill**

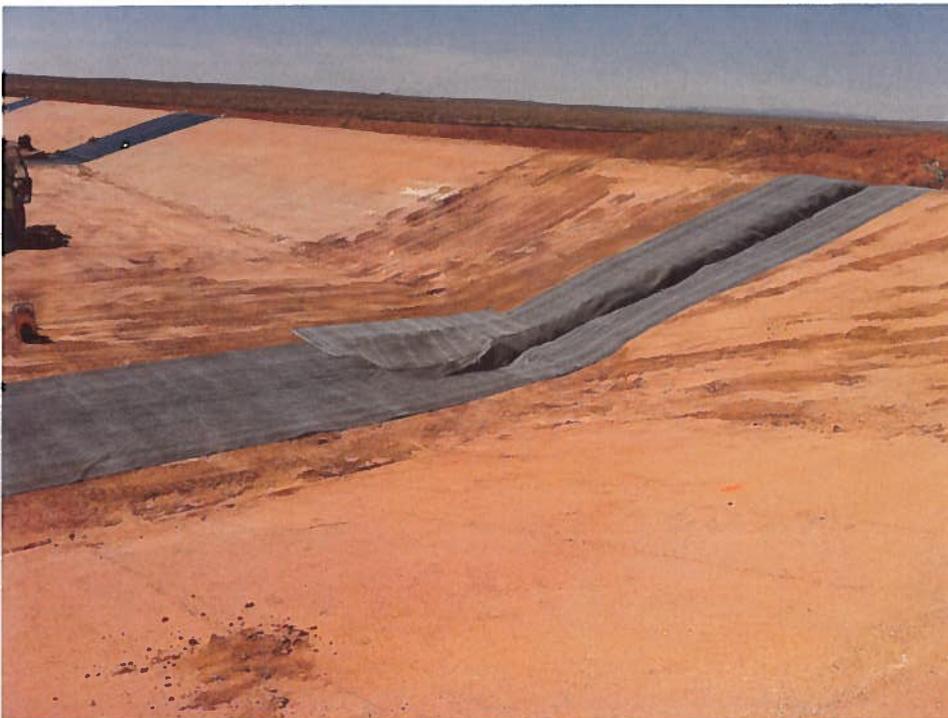
**Figure 12 - LDMS GCL Installation**

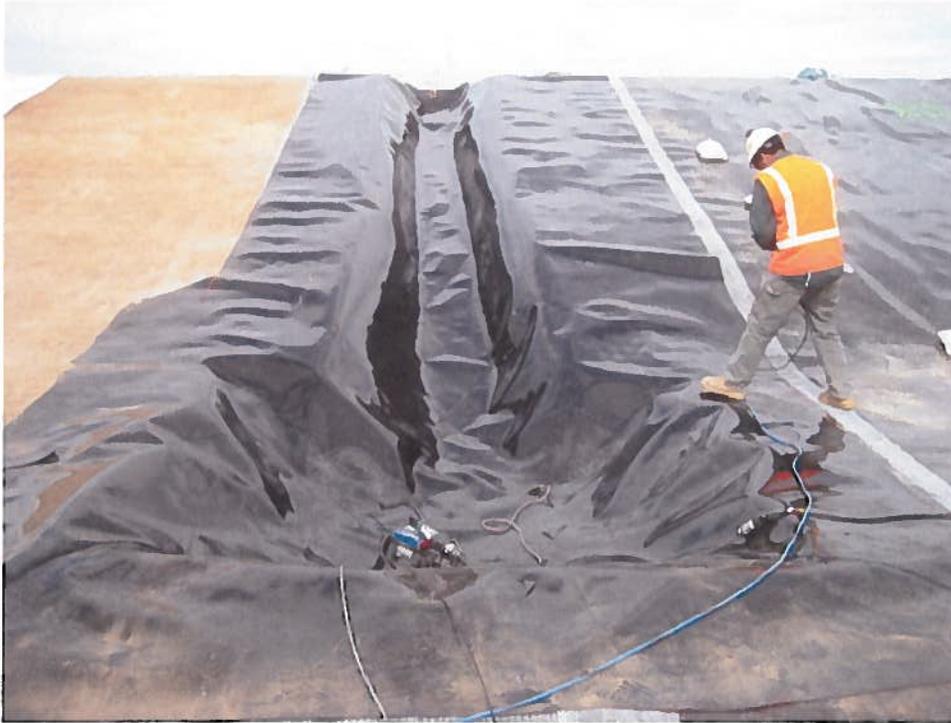
**Figure 13 - LDMS HDPE Liner Installation**

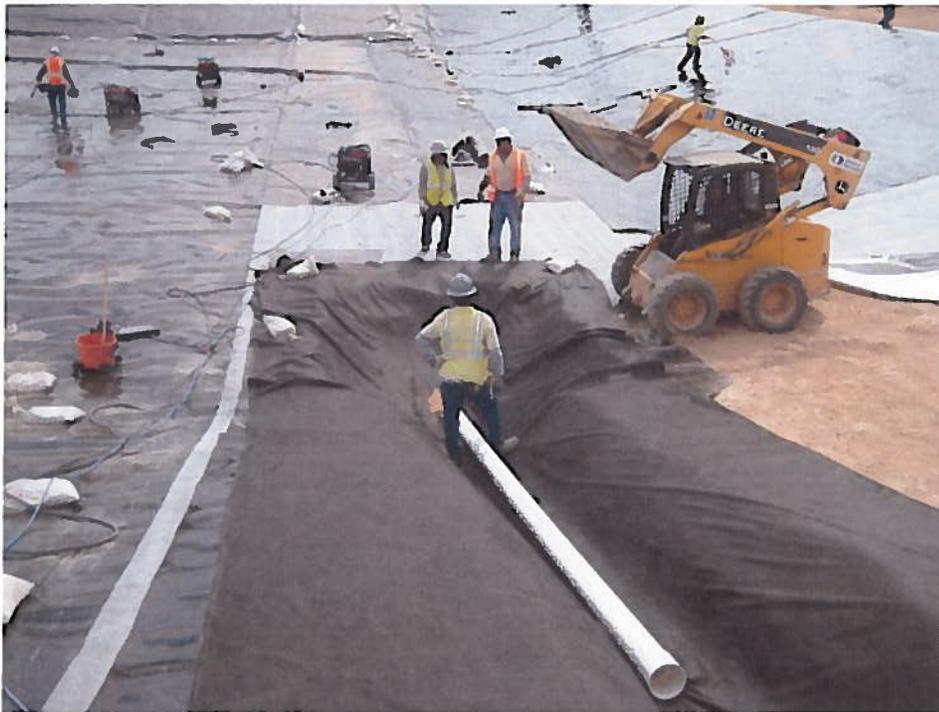
**Figure 14 - LDMS Monitoring Pipe**

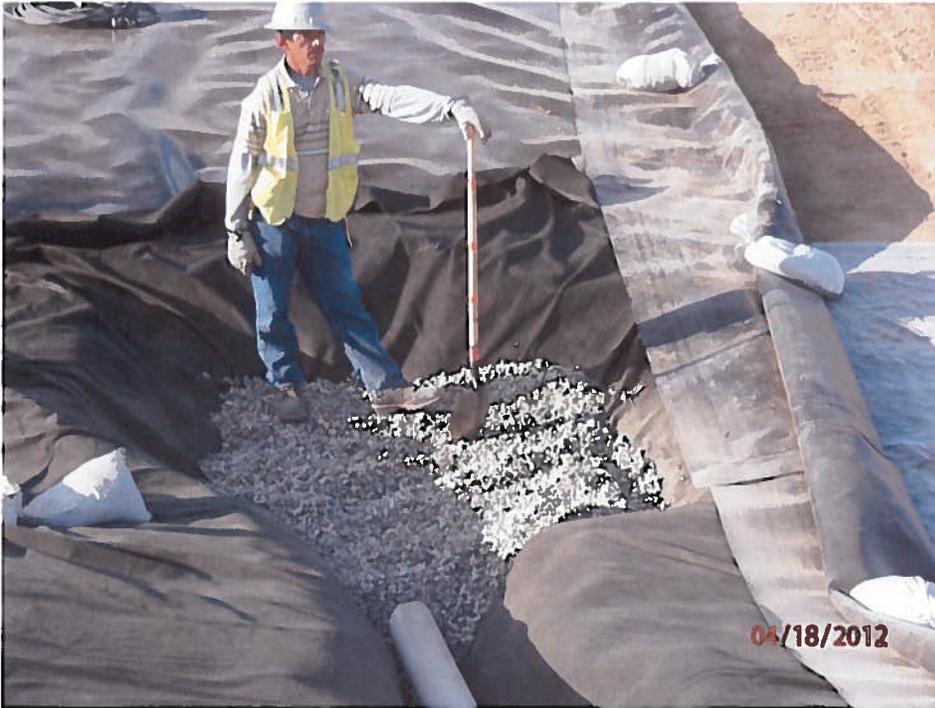
**Figure 15 - LDMS 2-feet of Washed Gravel Placement**

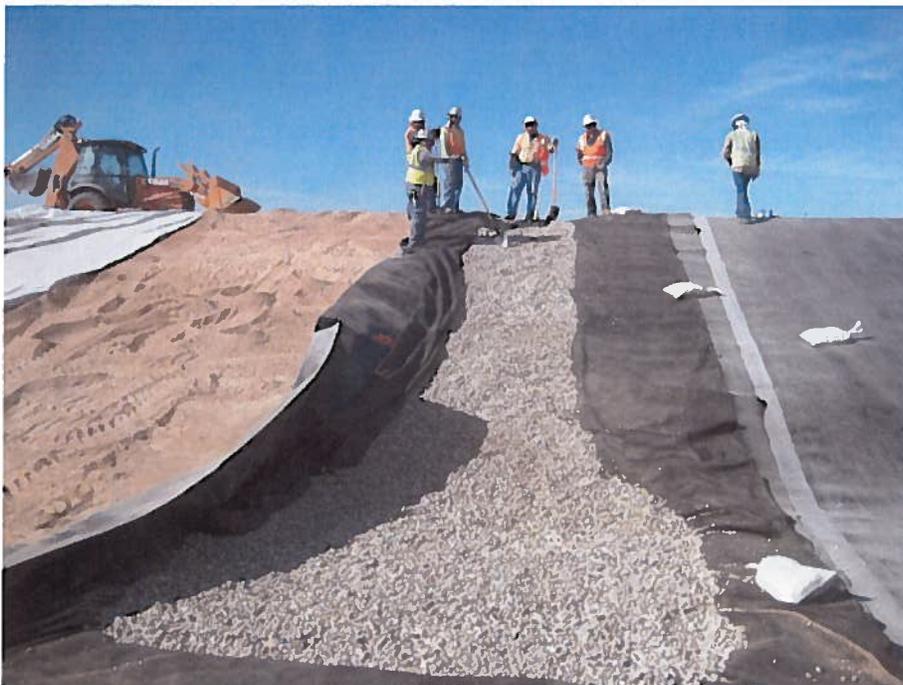
**Figure 16 - LDMS Gravel Placement above Detection Piping**

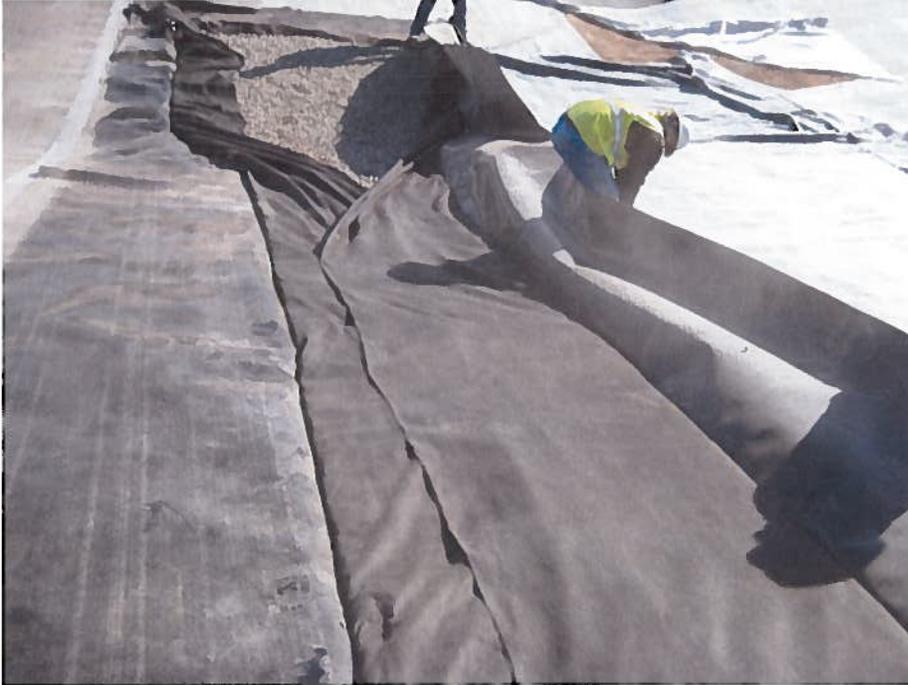
**Figure 17 - LDMS Gravel Wrapped In Nonwoven Geotextile Filter Fabric**

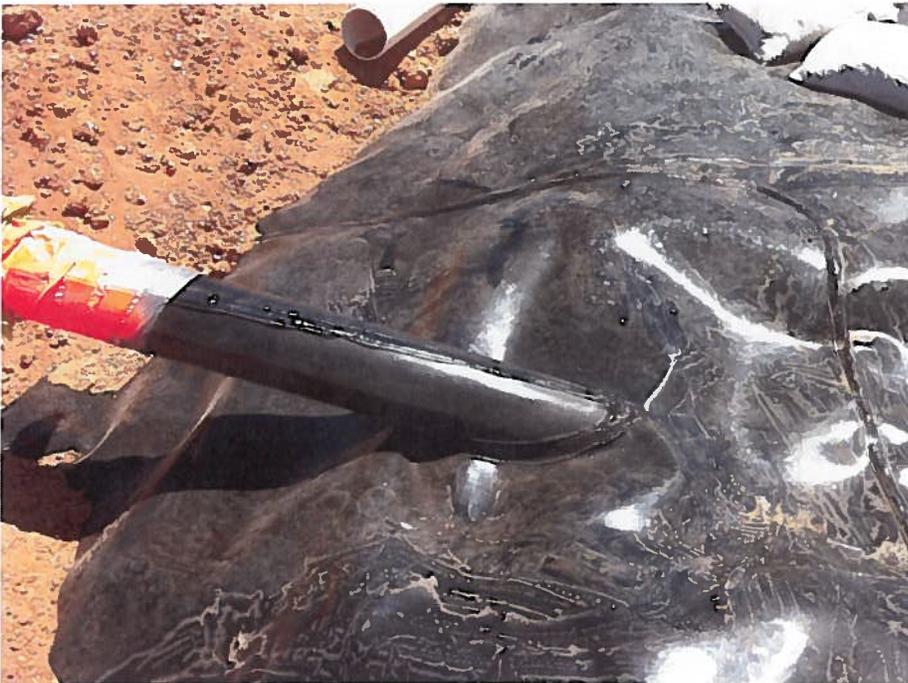
**Figure 18 - Final LDMS HDPE Liner Boot Penetration**

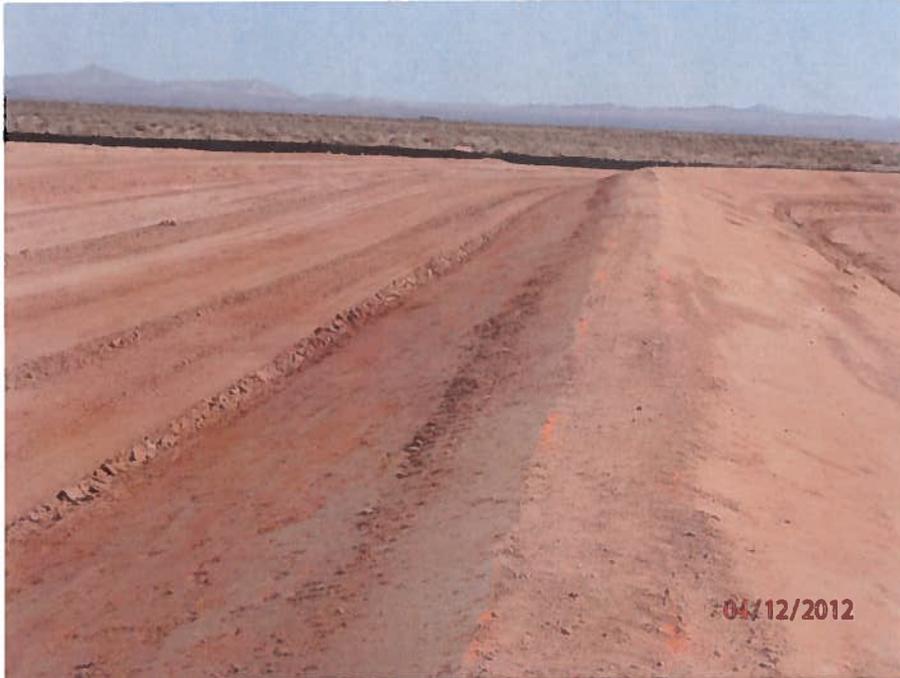
***Section 4.2.4.2 Liner Deployment (paragraph 2) of the ZEI report is detailing the floor ballast and perimeter anchor trench construction and does not relate to the bottom Lysimeter. However, the surface impoundment perimeter anchor trench system was constructed in accordance with the approved drawings Section C and E, sheet 6 of 9, respectfully. The perimeter anchor system is secured in-place with a minimum of 4-feet of compacted select fill above the liner.***

**Figure 19 - Surface Impoundment Perimeter Anchorage Sloped to 3:1**

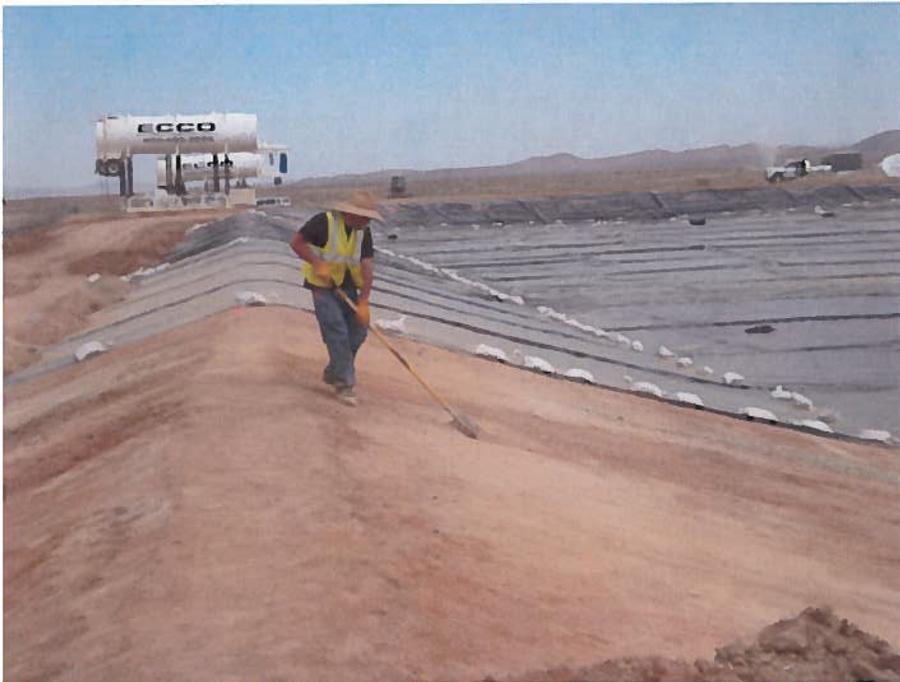
**Figure 20 - Perimeter Anchorage System**

***The surface impoundment liner system is ballasted around the perimeter of the impoundments by a 2-foot minimum horizontal run and an additional 9-foot length of liner buried at a downward sloping inclination of 2:1 (horizontal: vertical) such that the leading edge is below the basin floor. The anchorage system was constructed per Detail C, sheet 6 of 9.***

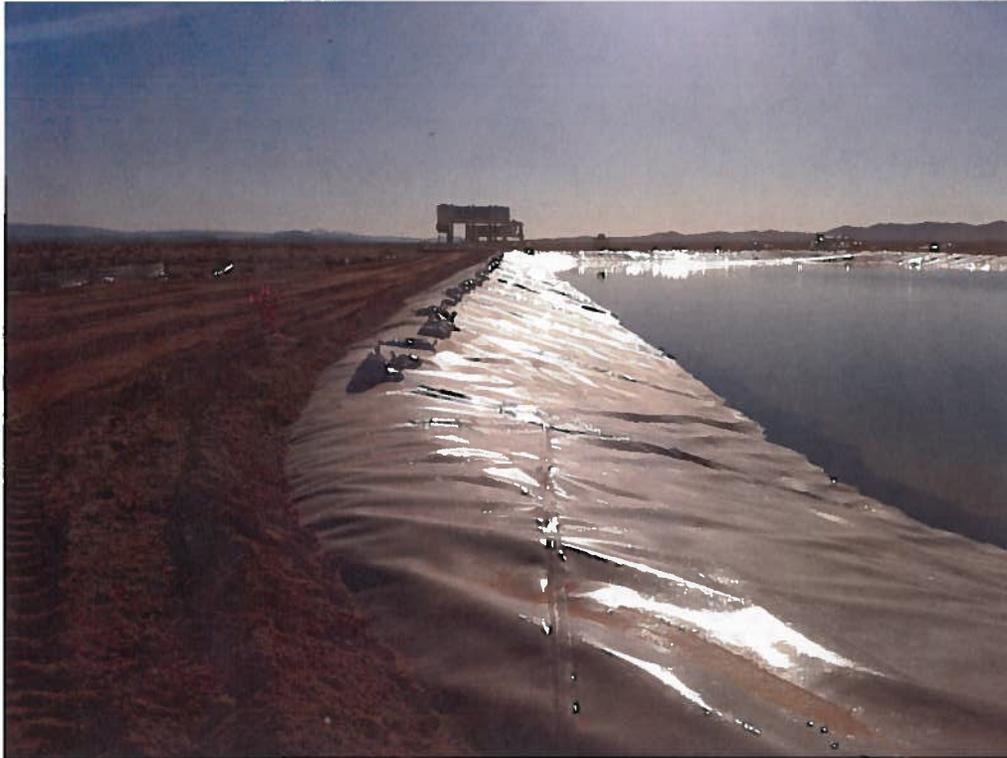
**Figure 21 - Final Backfill Perimeter Anchor Trench**

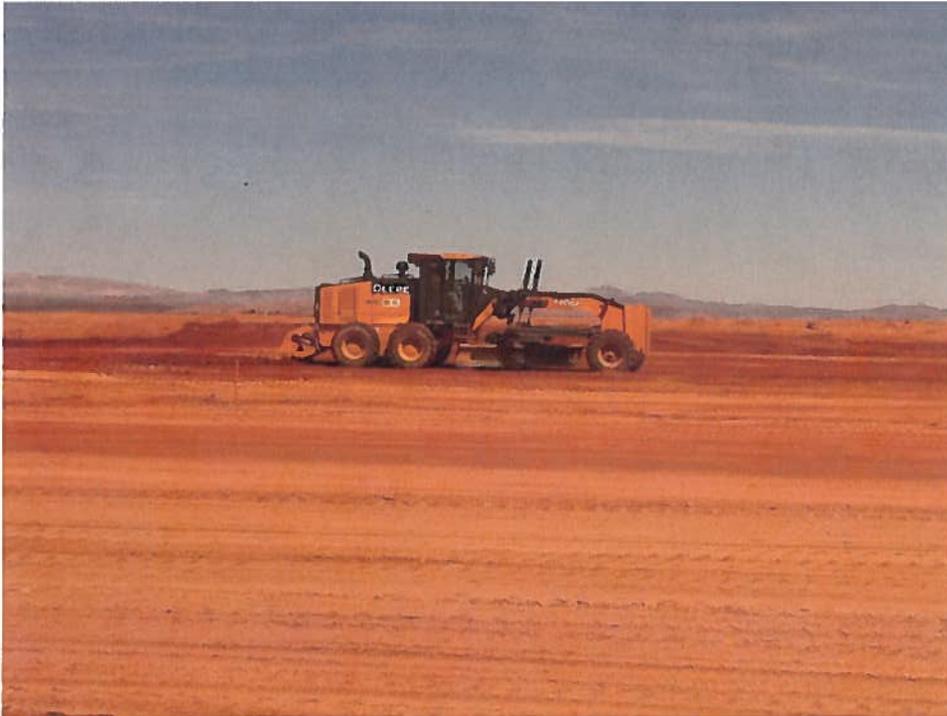
***The waste pile soil liner consists of a minimum 12-inch of engineered select fill which consist of native subgrade material scarified and moisture conditioned and compacted to 90 percent relative compaction as defined by ASTM D1557. The waste pile was first cleared of all native organics and bladed uniform followed by scarifying the in-place soils to a depth of 12 to 14-inches. Water was added as needed to control the moisture content of the processed soil. Compaction of the soil was achieved using a vibratory roller and heavy equipment until the fill was firm and unyielding. Moisture/Density testing was performed on the processed pad and fill at a frequency of one (1) test per 1,000 cubic yards of material processed, placed and compacted. Sladden Engineering provided the field sketch showing quality control test locations and supporting compaction results.***

**Figure 22 - Waste Pile Grading Operation Subgrade Preparation**

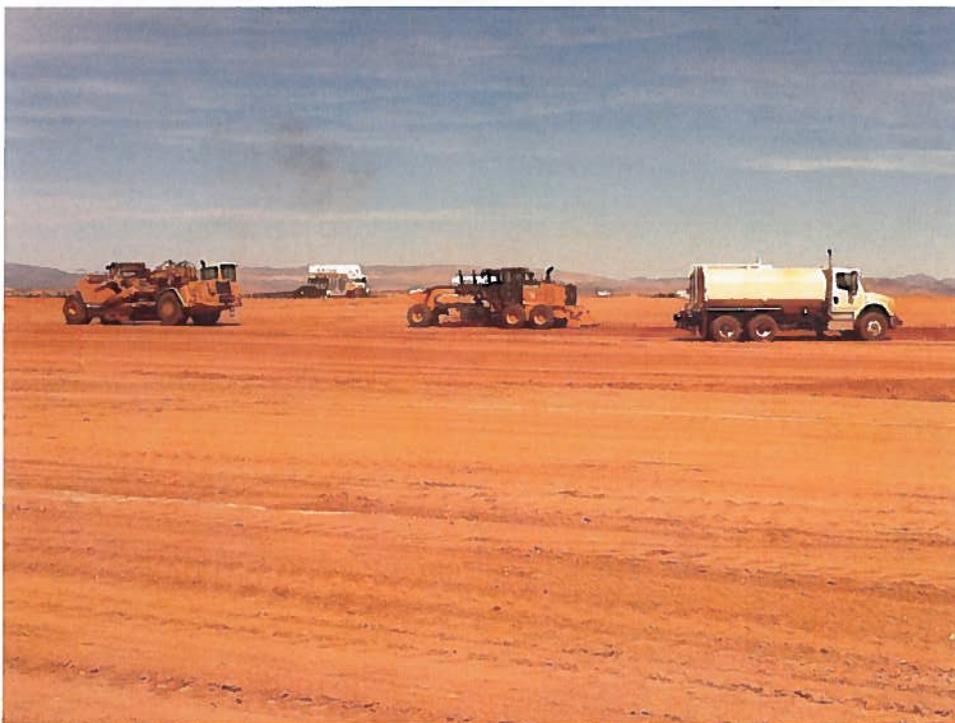
**Figure 23 - Waste Pile Subgrade Scarify, Watering and Compacting**

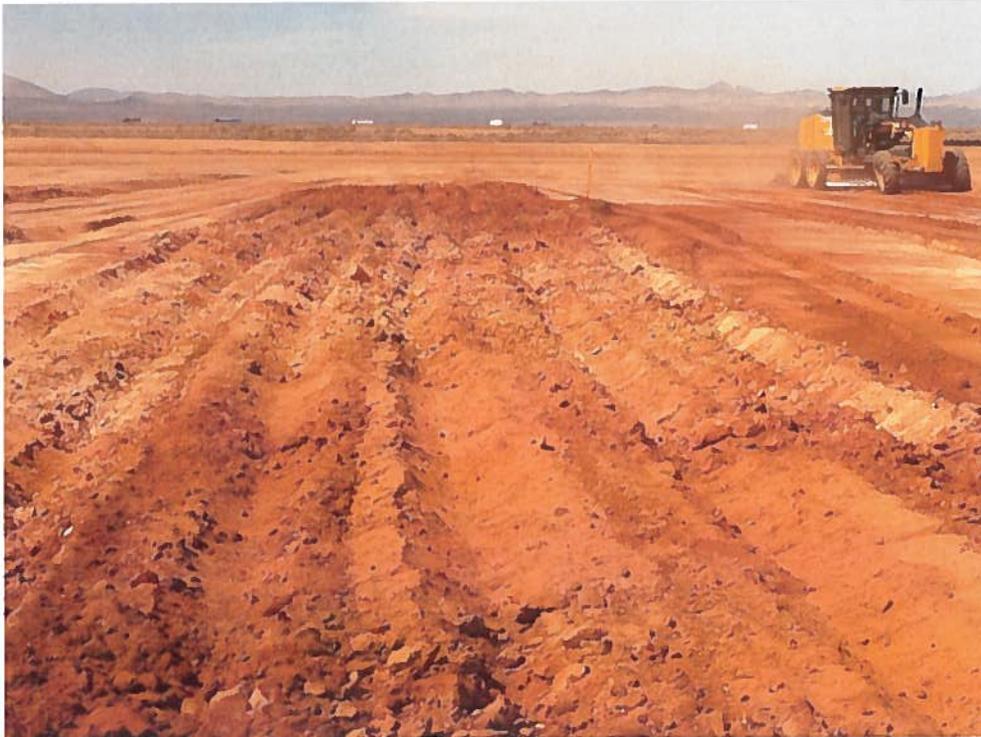
**Figure 24 - Waste Pile Soil Processing**

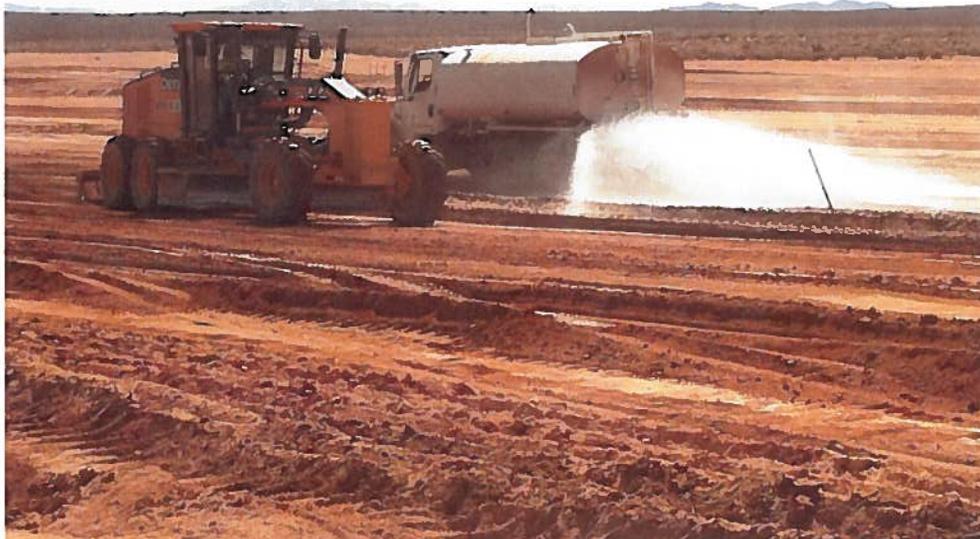
**Figure 25 - Waste Pile Grading and Moisture Conditioning**

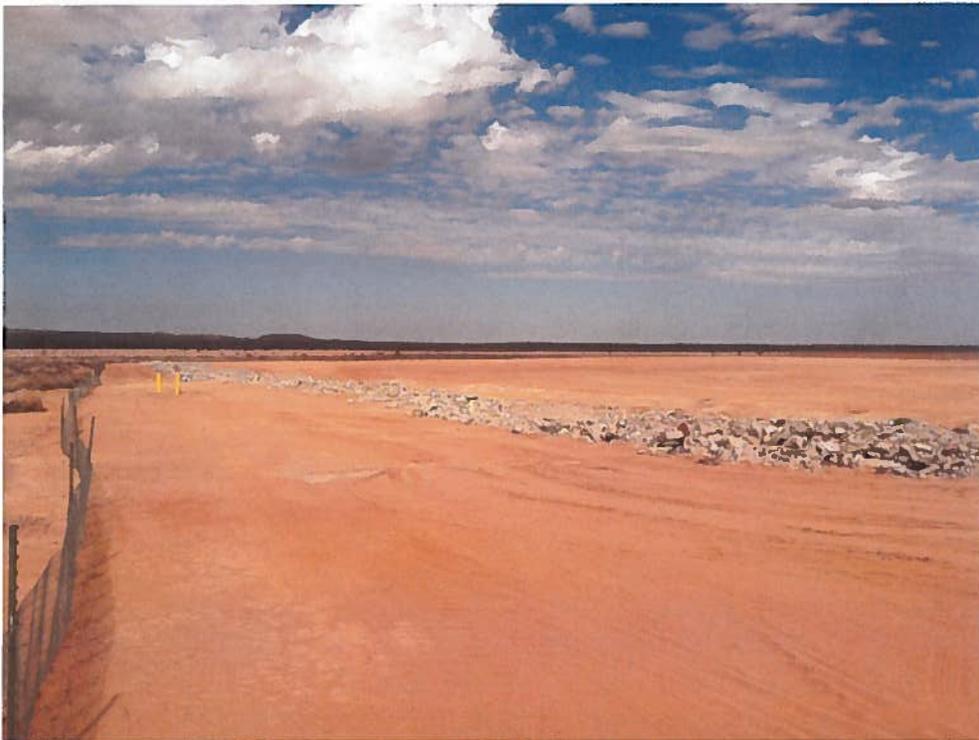
**Figure 28 - Perimeter Drainage Channel with 1/4 ton Rip-Rap armor - Looking West**
