**Exhibit No. 1**

# NOTICE

DATE: 12/2/14  
PROJECT: VALENCIA  
PROJECT #: GR-1692  
ADDRESS: SAN AITO PL

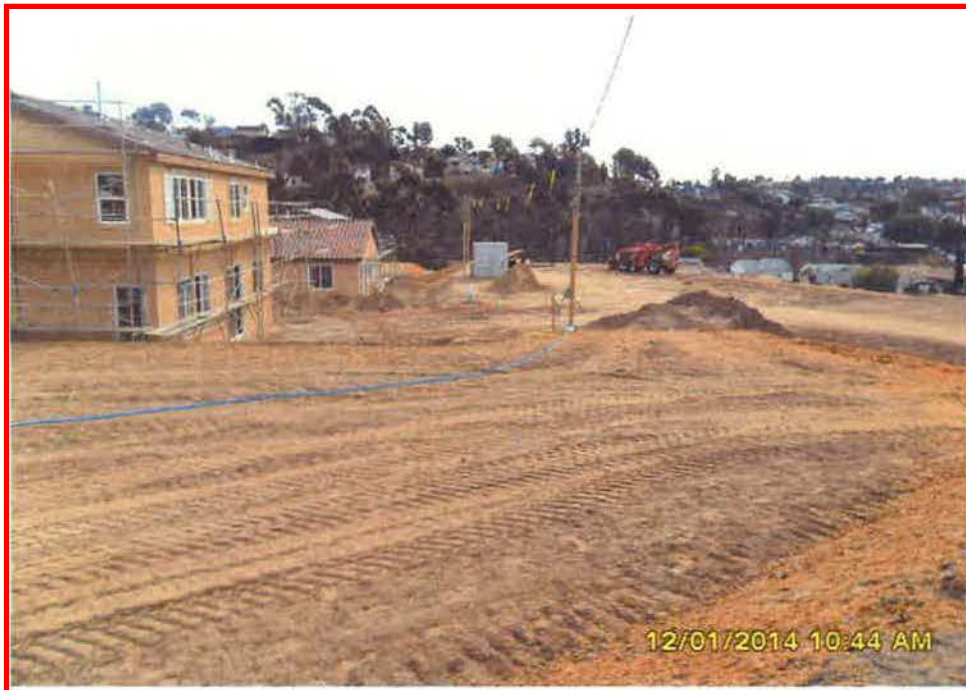
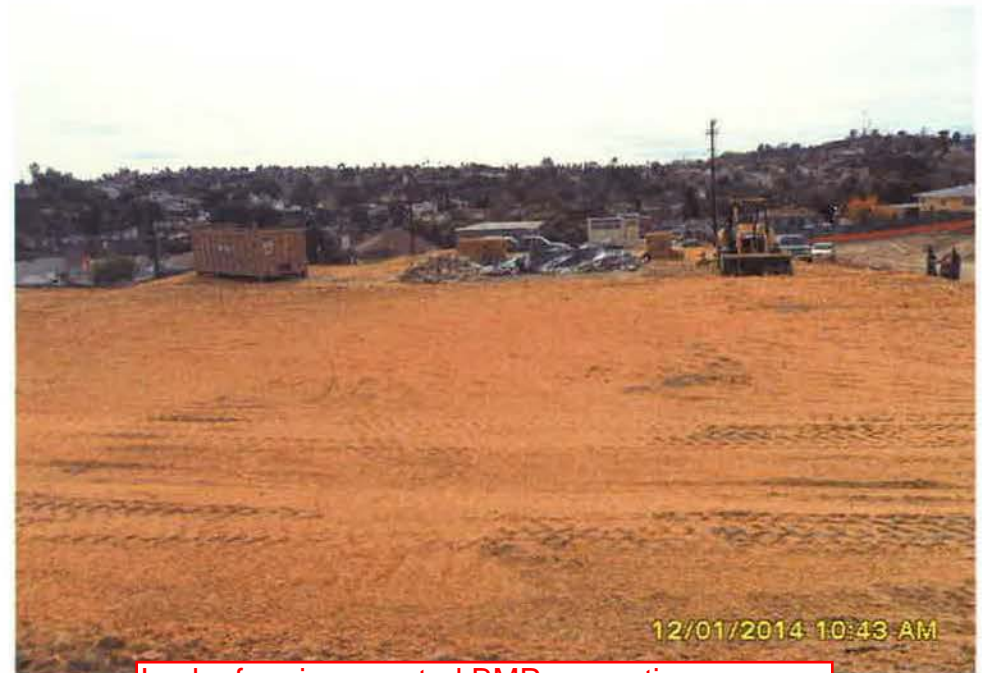
Lack of eroison control BMPs on inactive areas.

See STOP WORK NOTICE - Discharge is  
IMMINENT if NOAA forecast correct: 100% Heavy  
 Rain this afternoon.  
 I call to Tim Anderson this morning at 9am.  
 Left V-mail that situation needed attention ASAP - NO  
 Return call

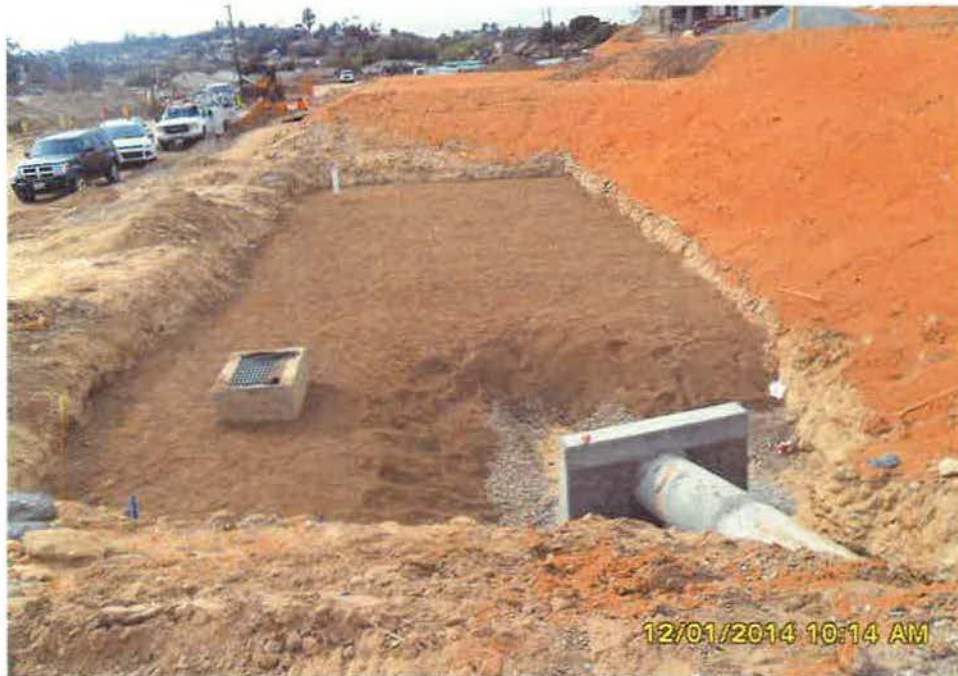
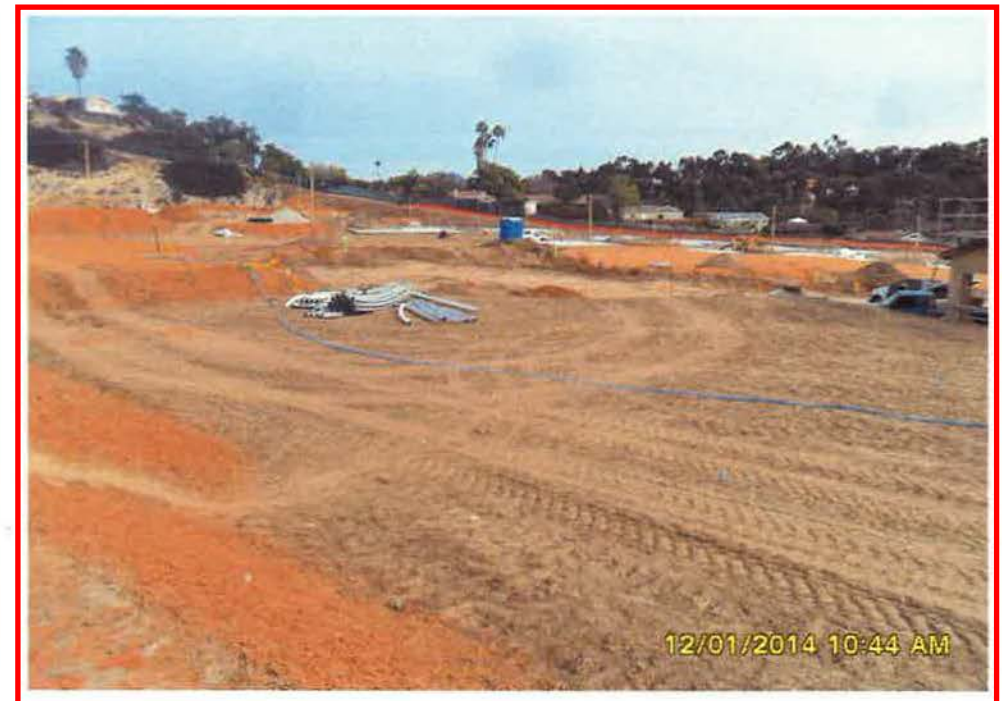
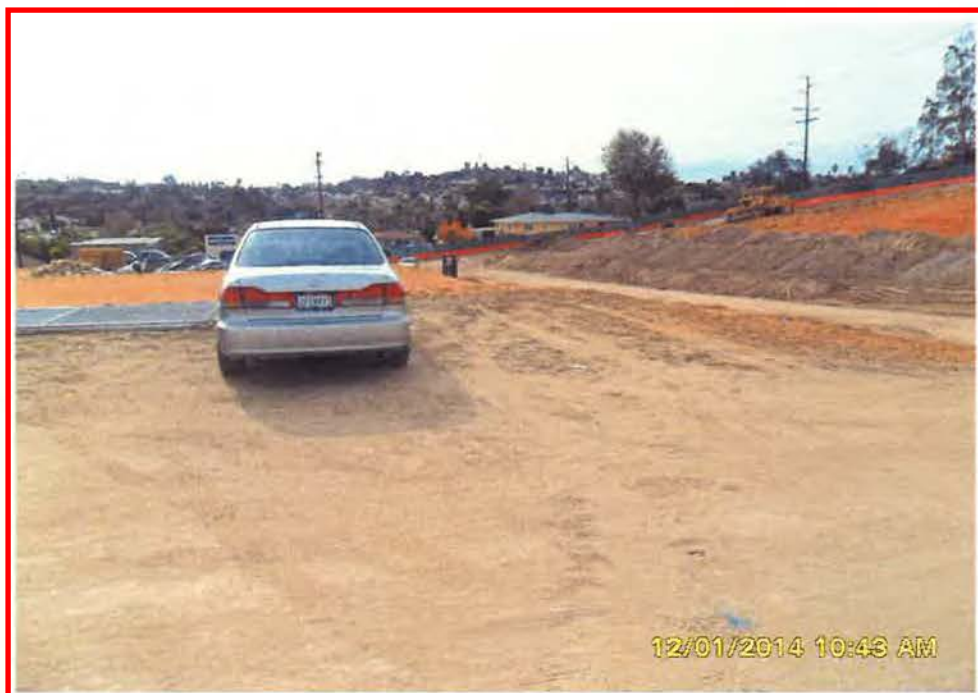
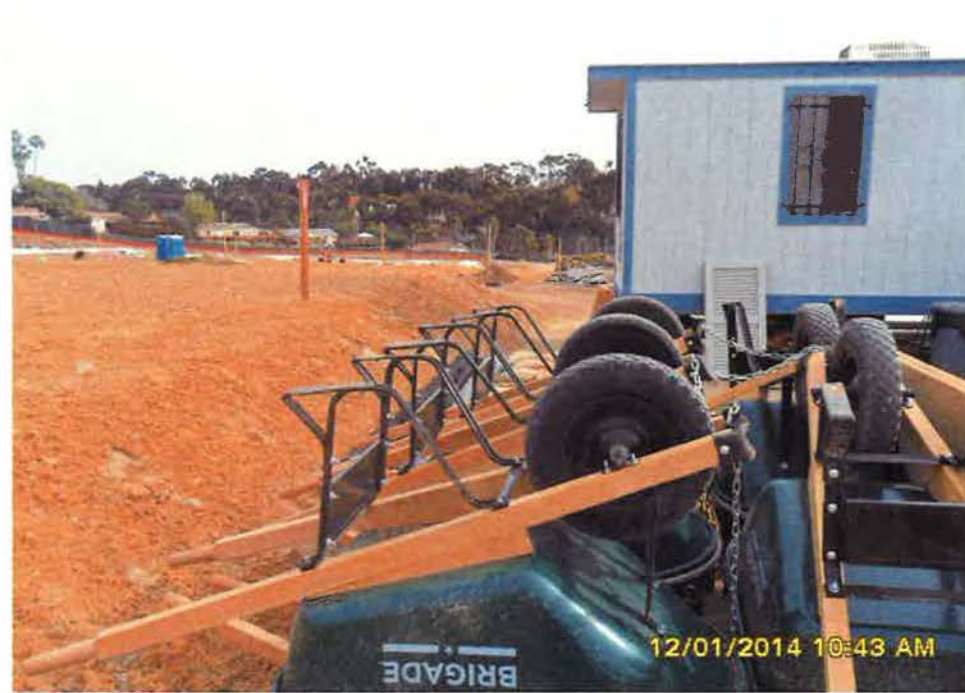
Lack of eroison control BMPs on active areas.

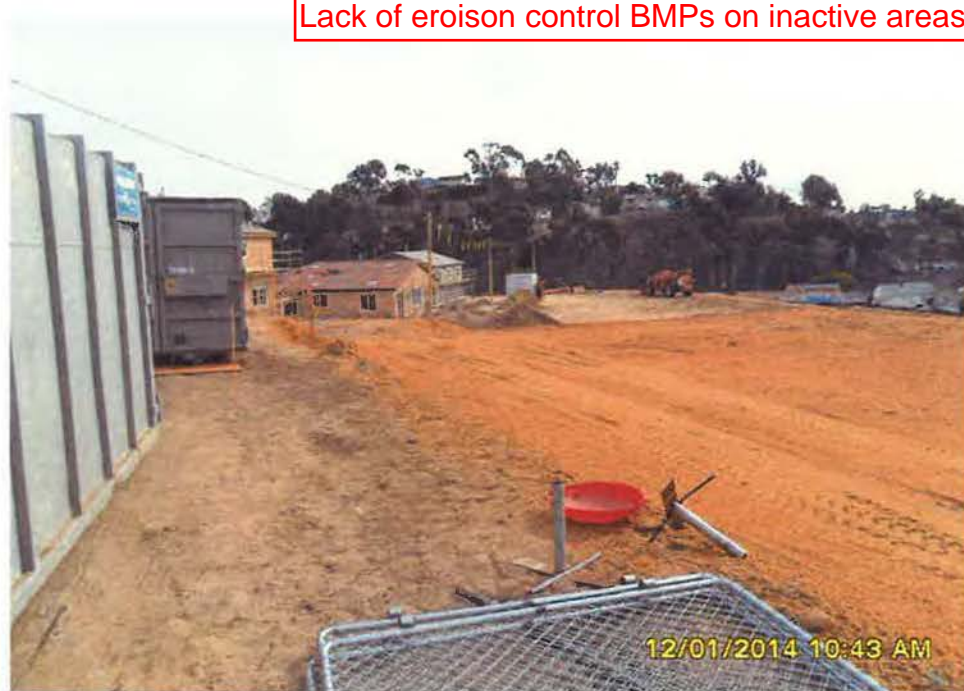
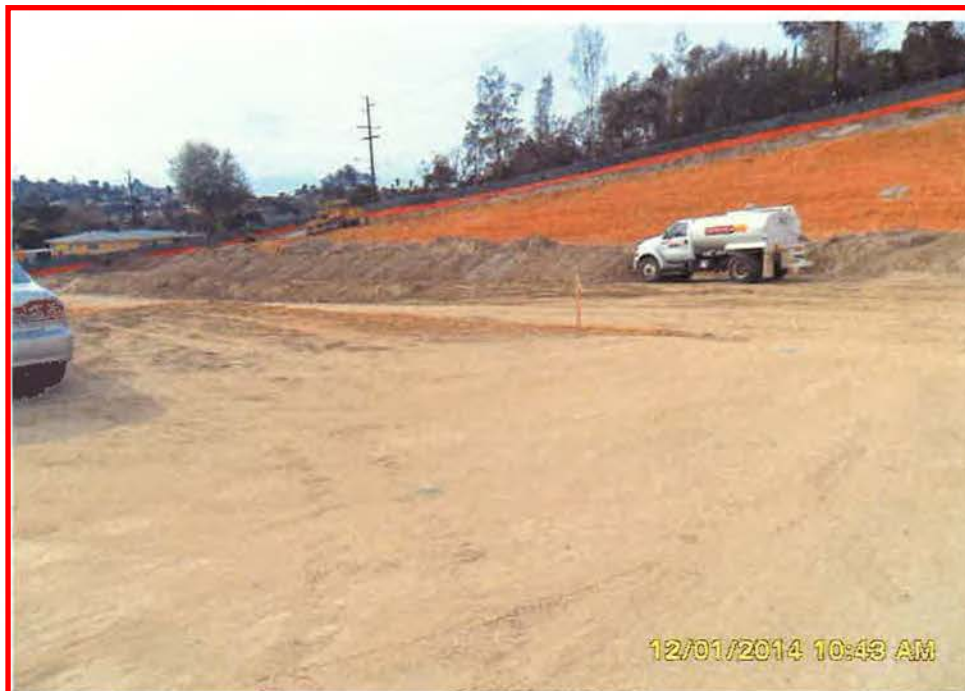
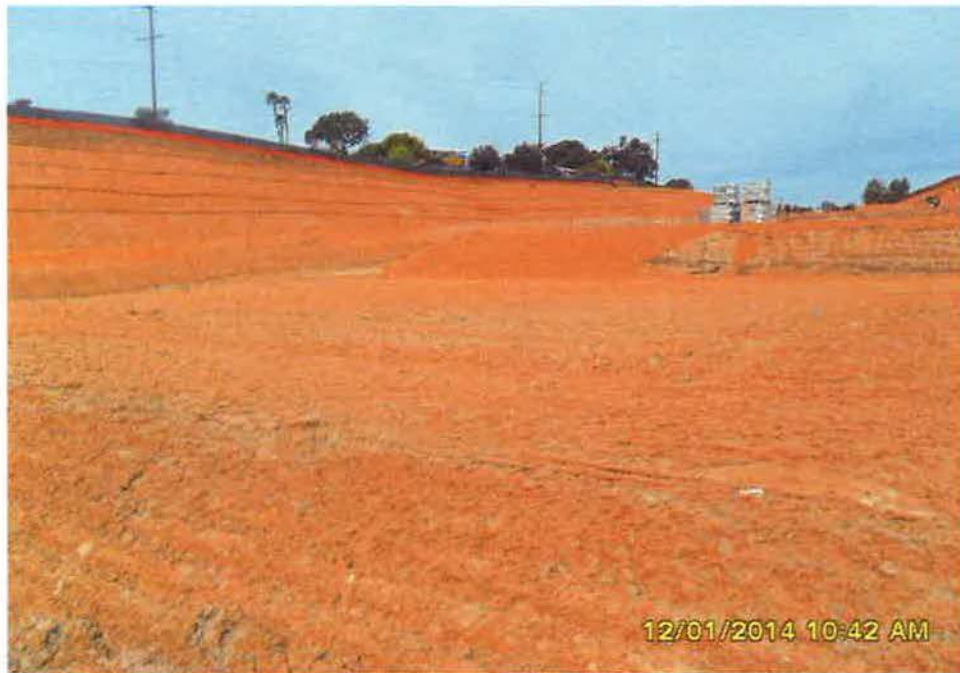
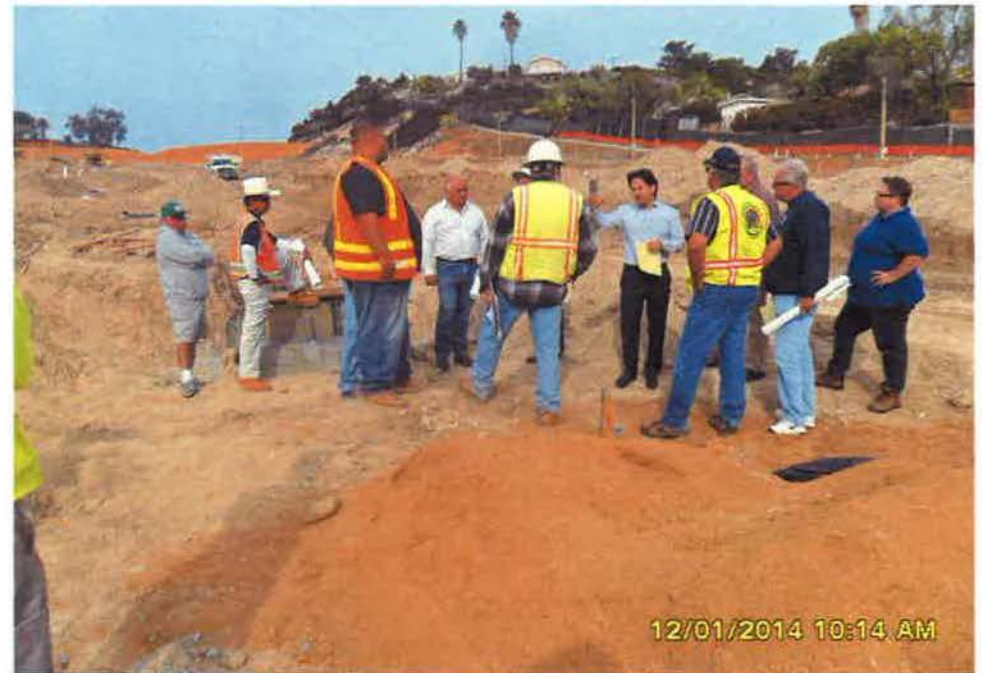
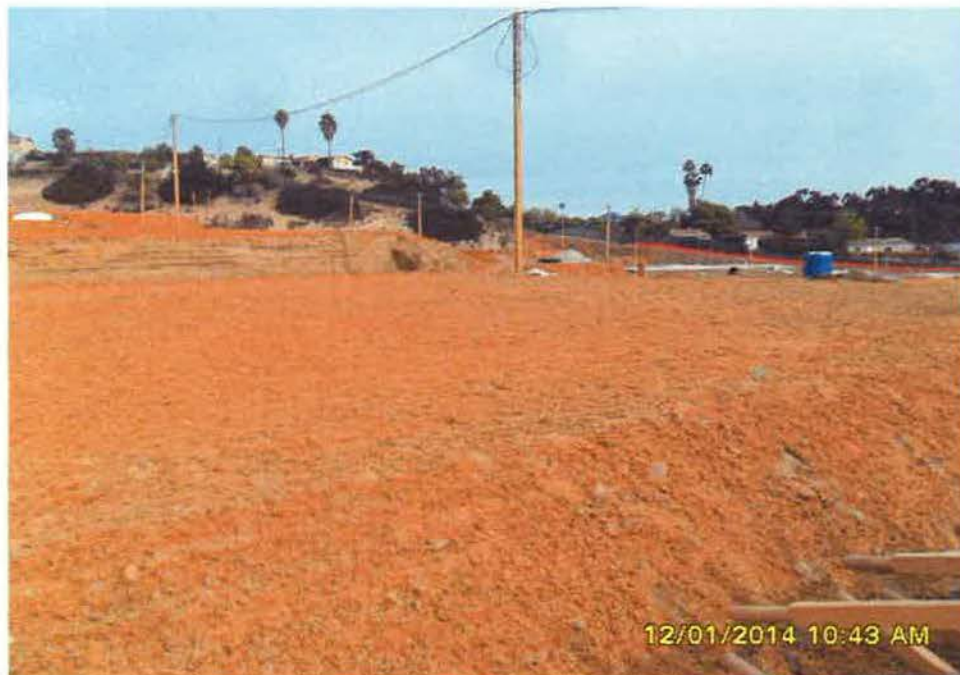
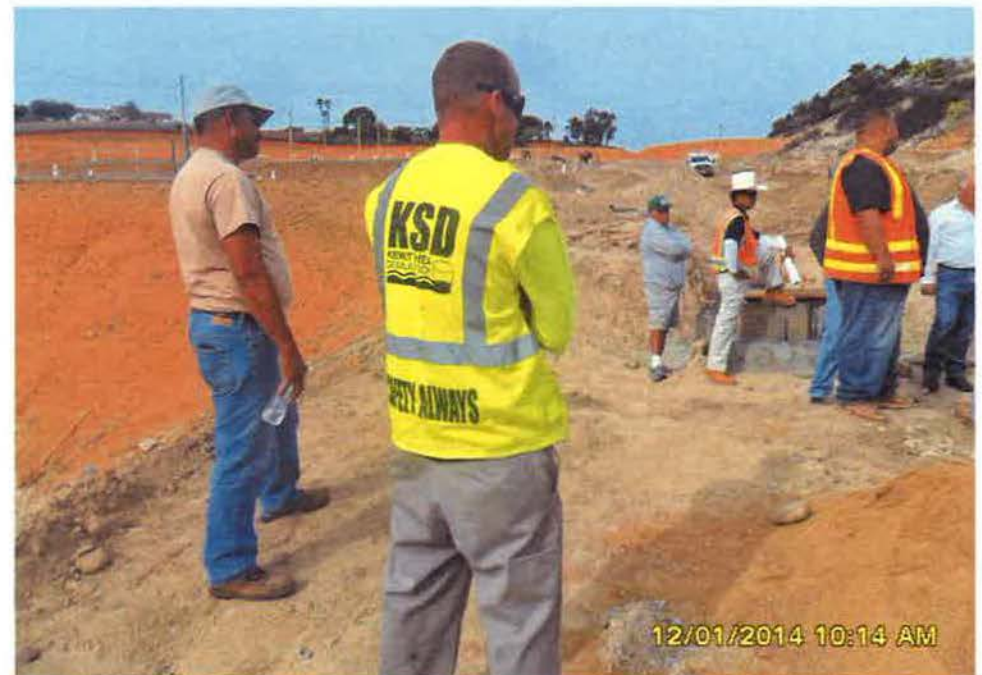
Lack of eroison control BMPs on inactive areas.

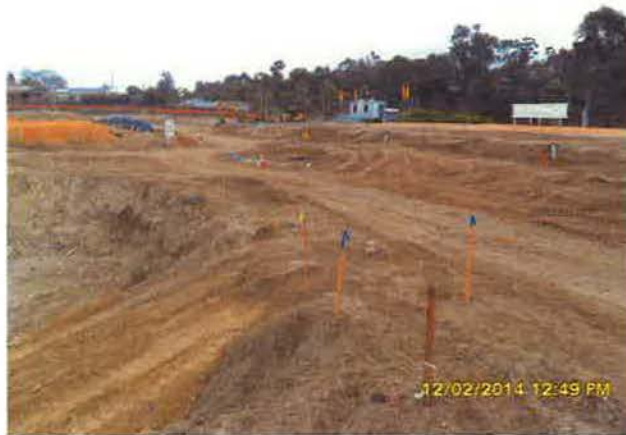
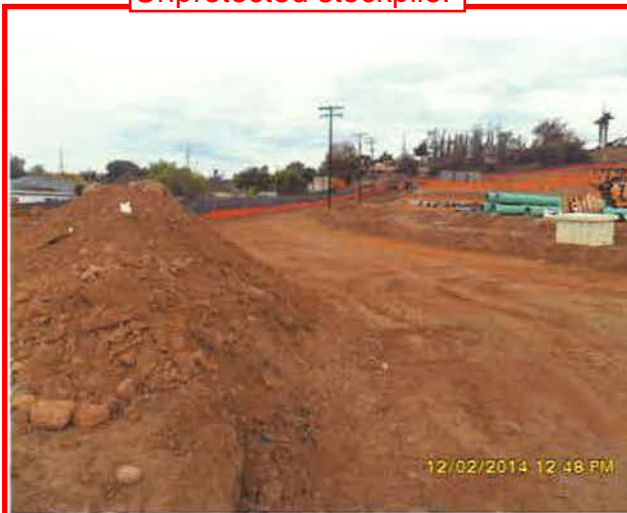
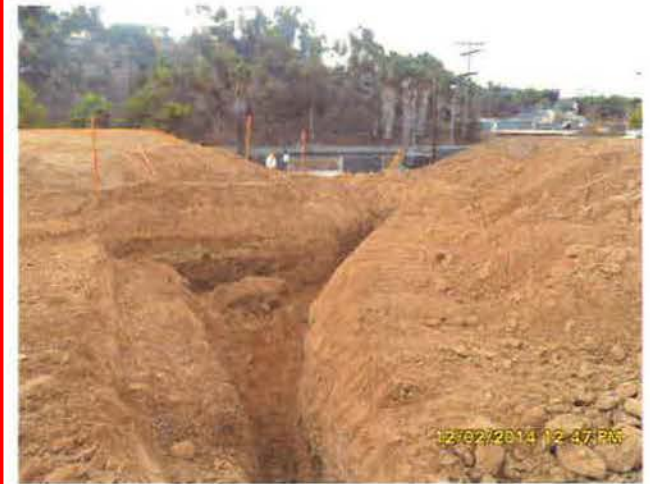
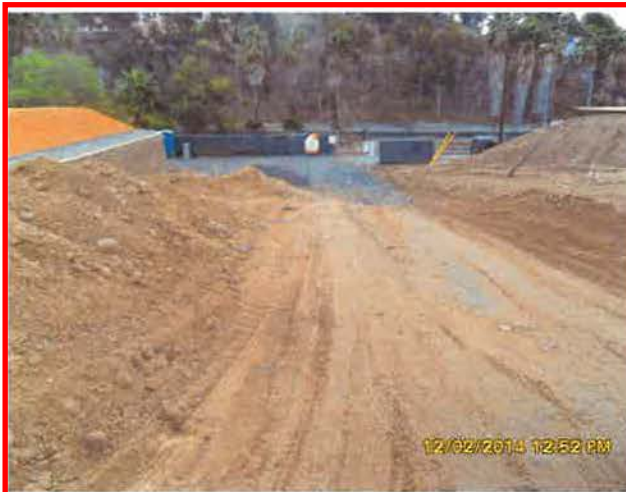
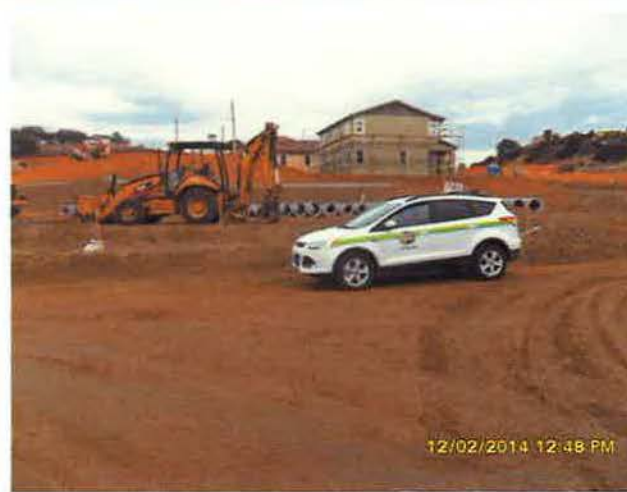
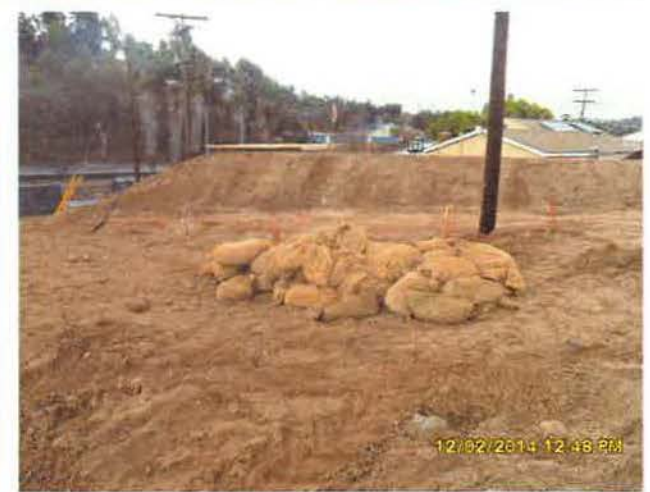
Unprotected stockpile.

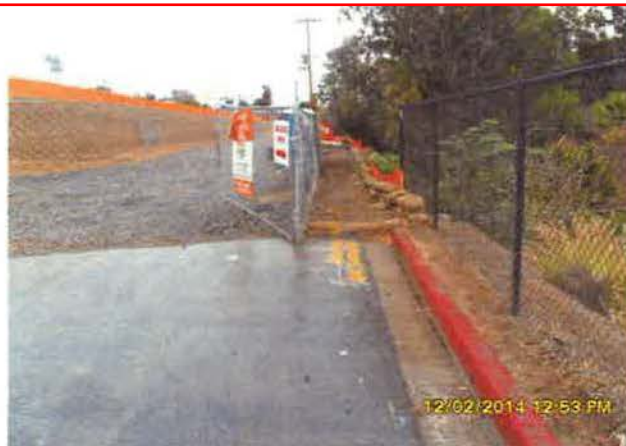
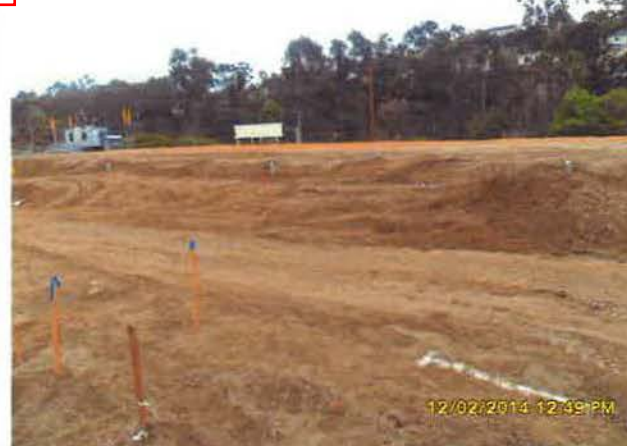
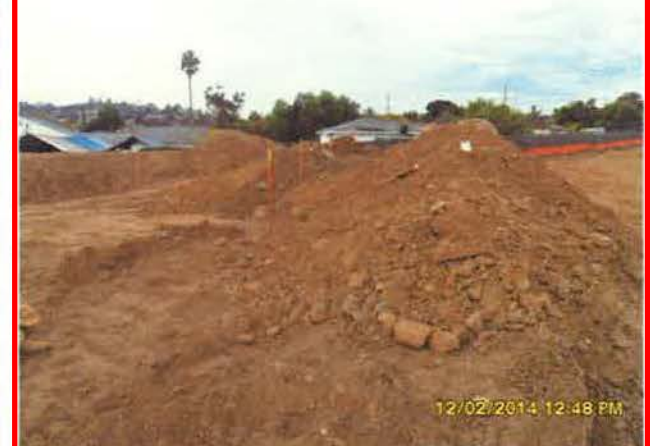
Lack of eroison control BMPs on inactive areas.

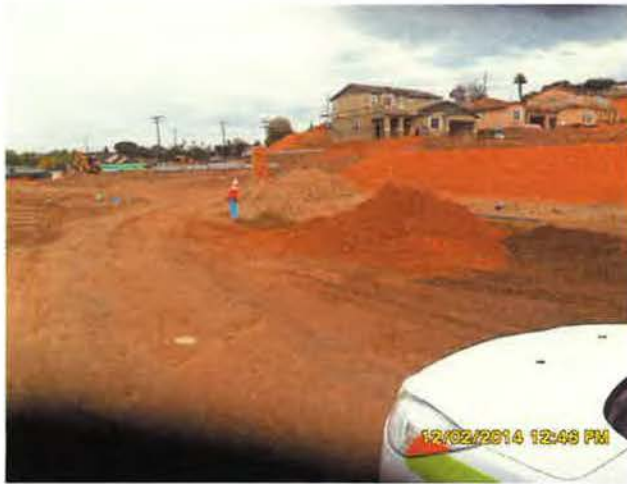
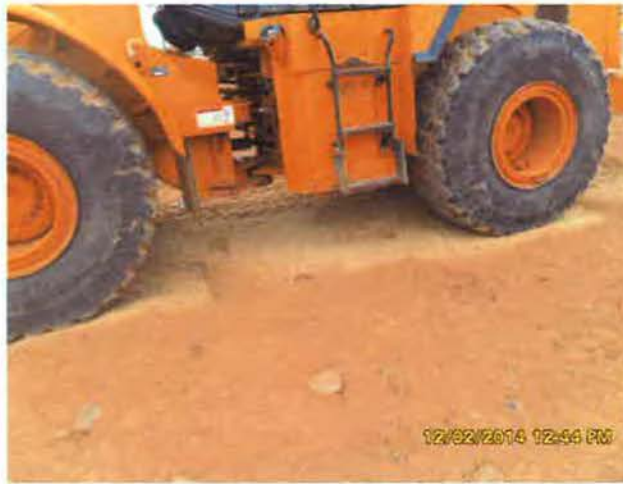
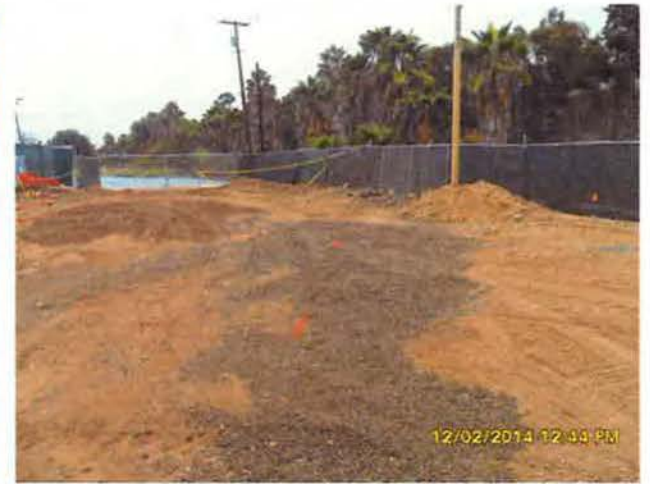
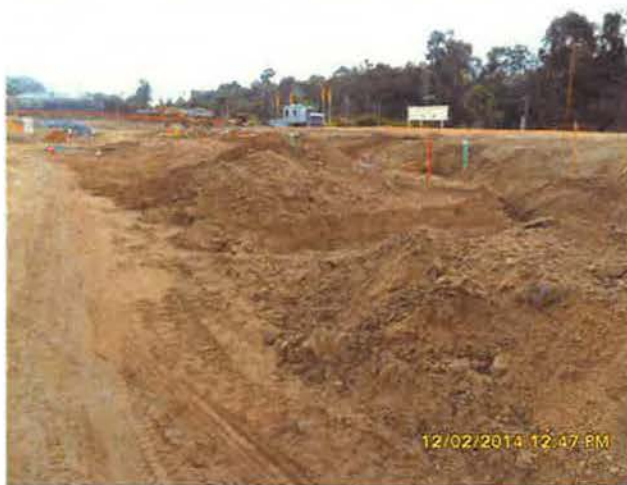
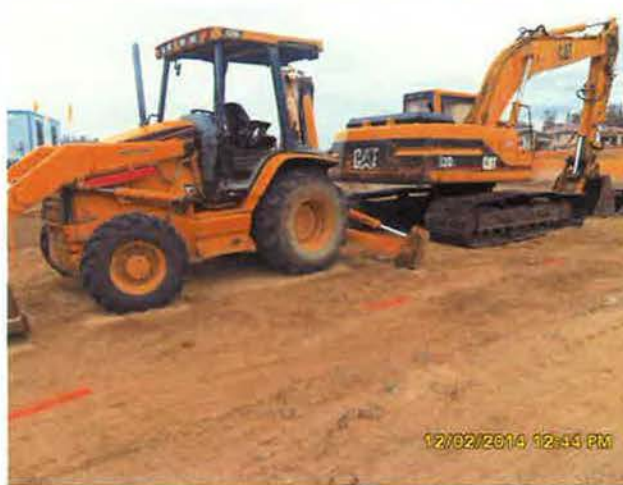
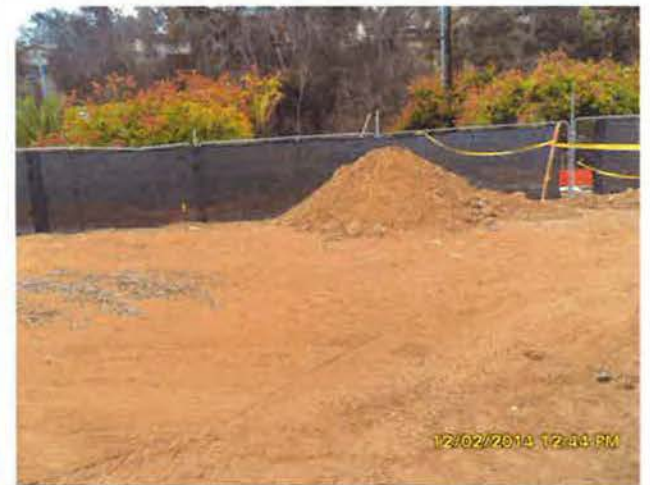
Stockpiles lack coverage and perimeter containment.

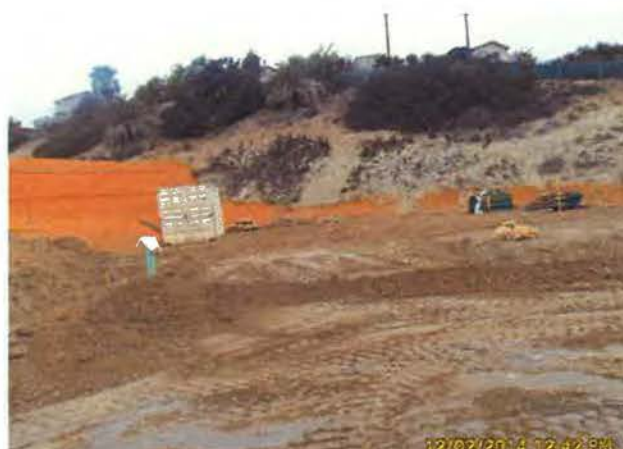
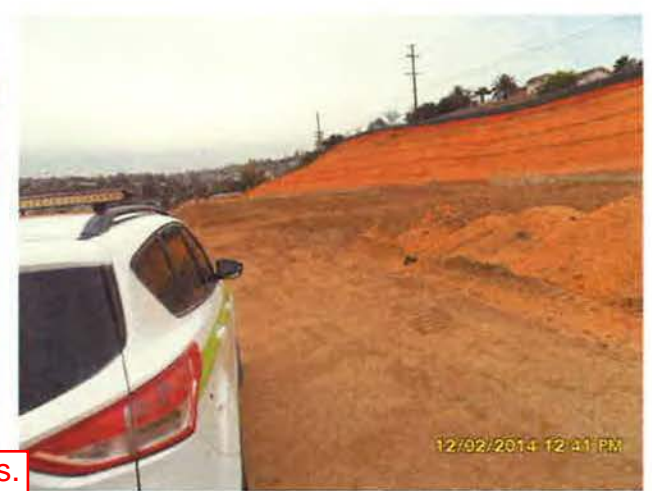
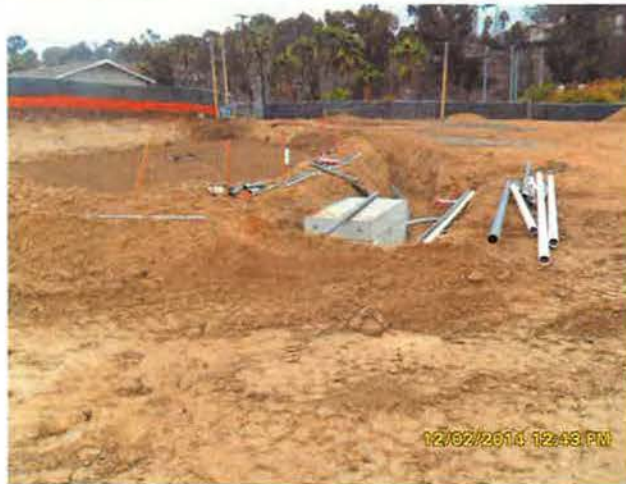
Lack of eroison control BMPs on active areas.

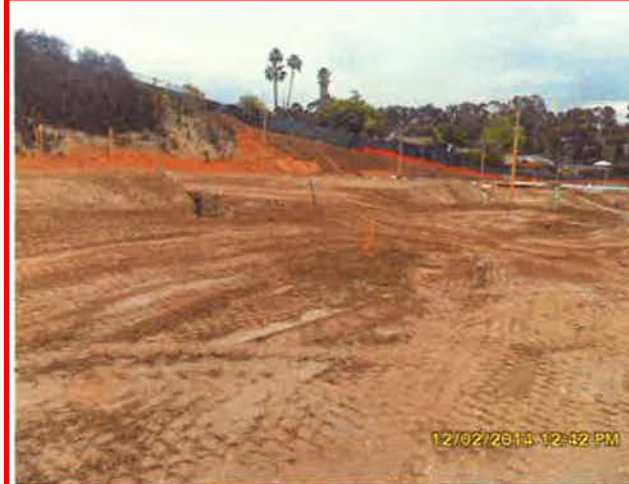
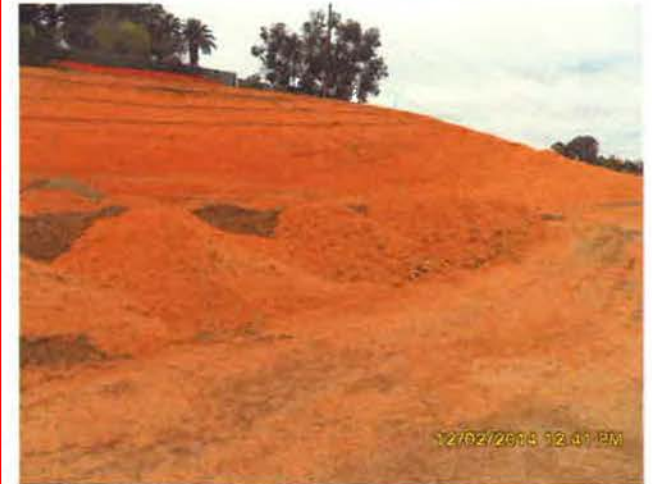
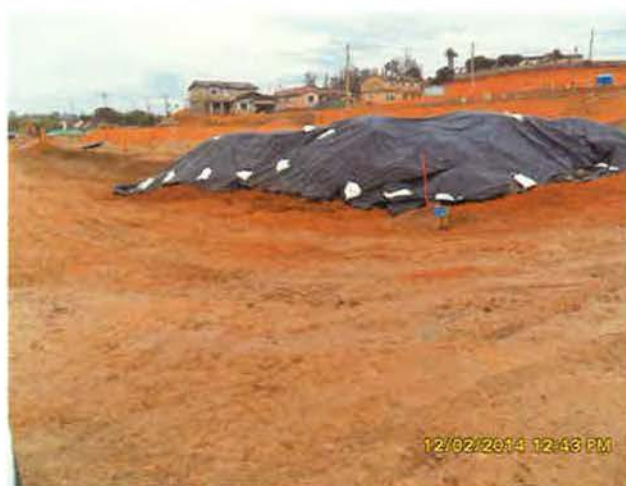
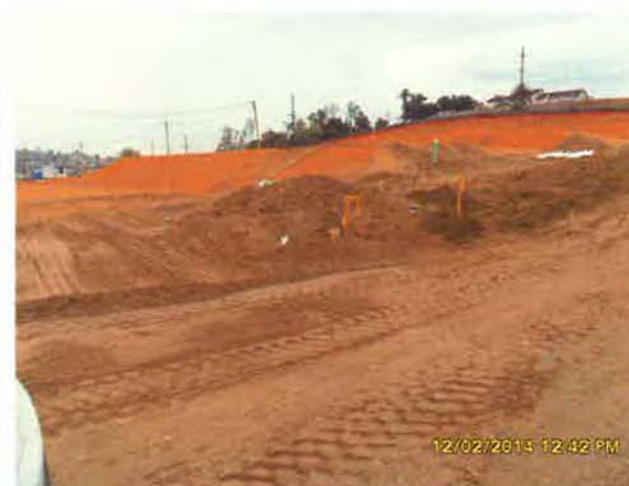
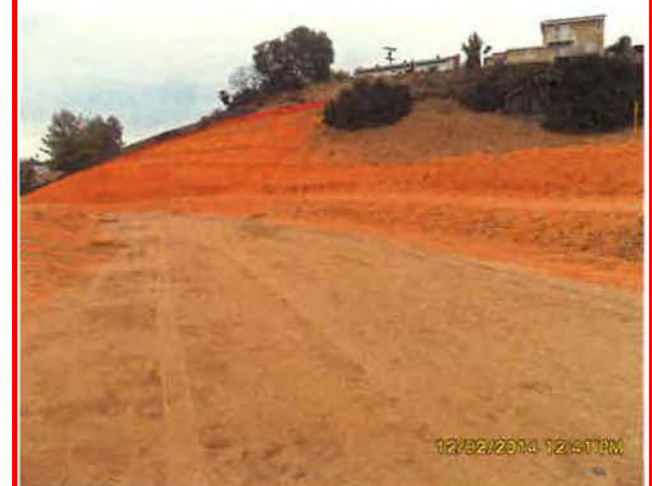
Lack of eroison control BMPs on inactive areas.

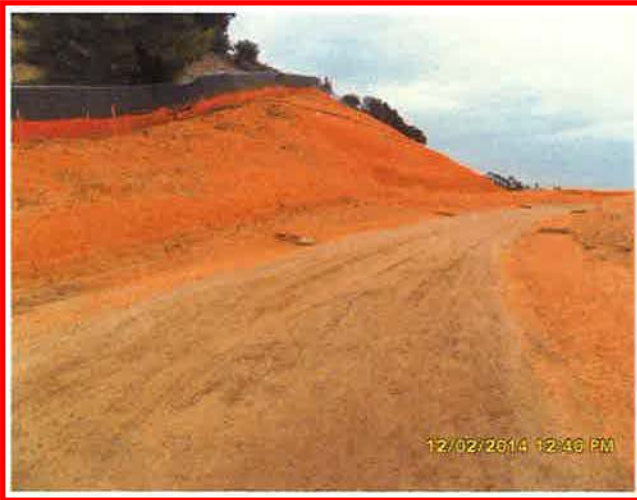
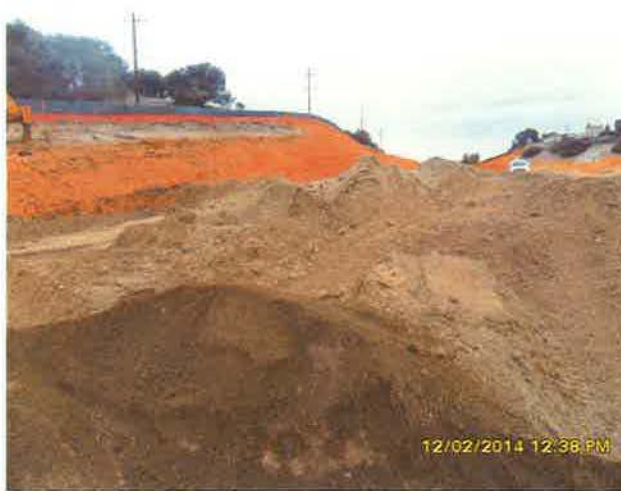
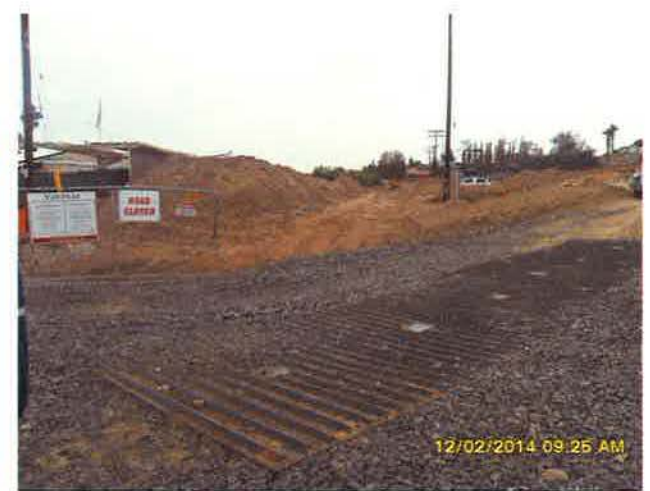
Lack of eroison control BMPs on inactive areas.

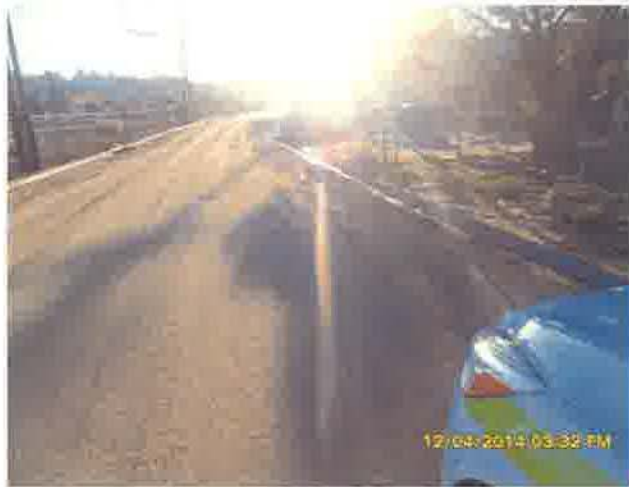
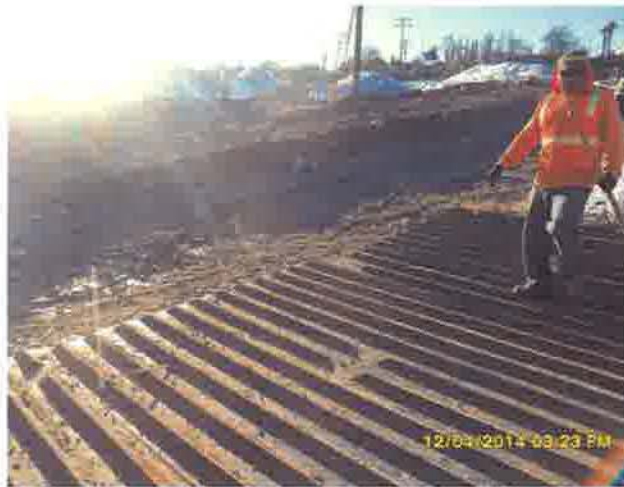
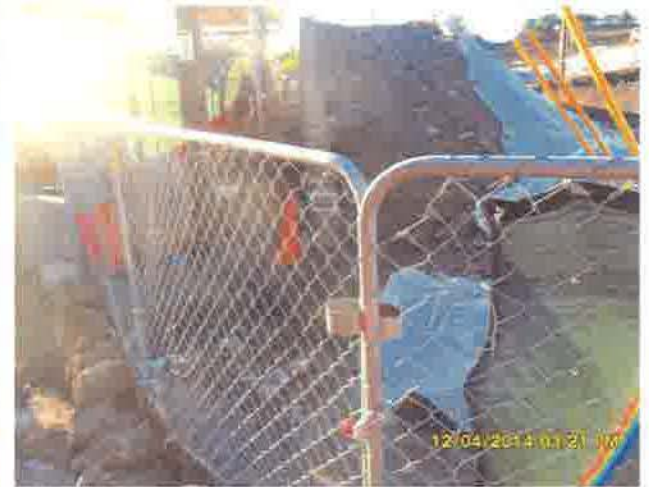
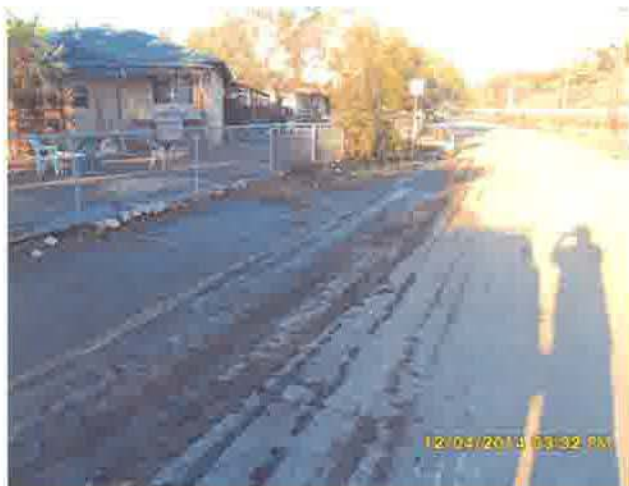
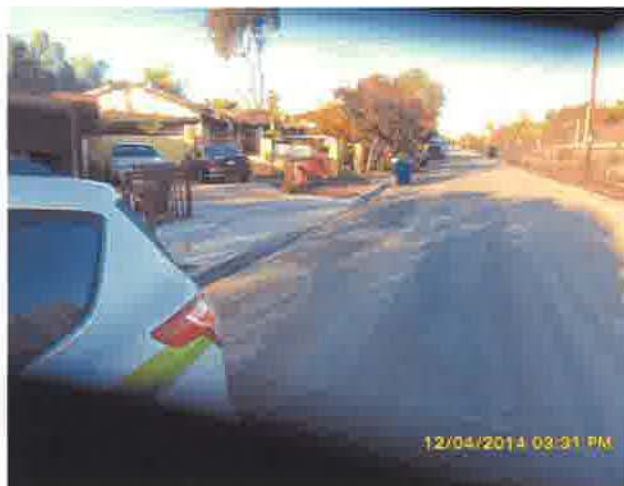
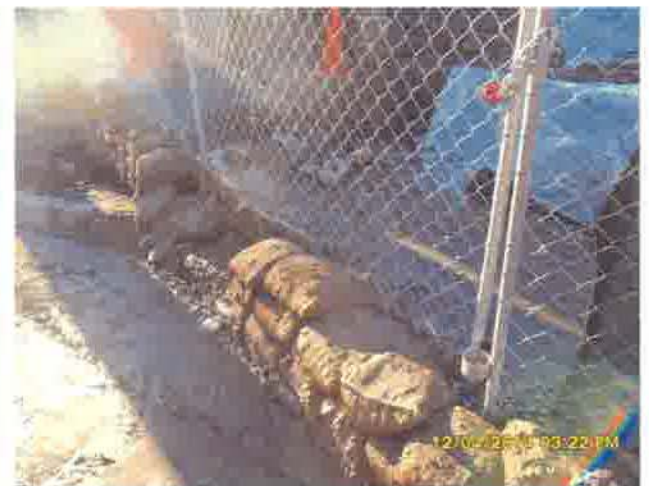
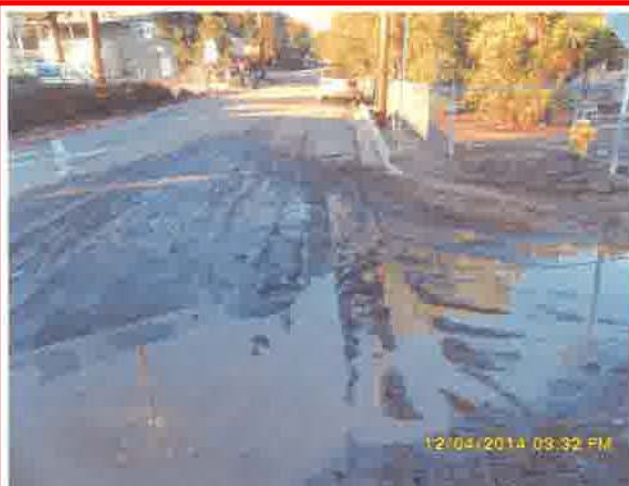
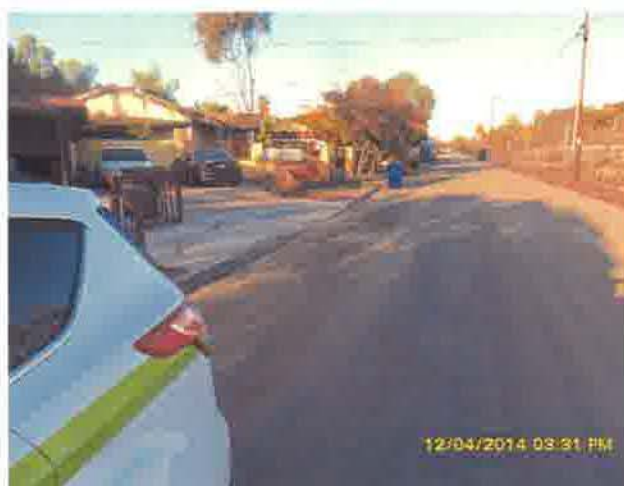
Sediment in street.

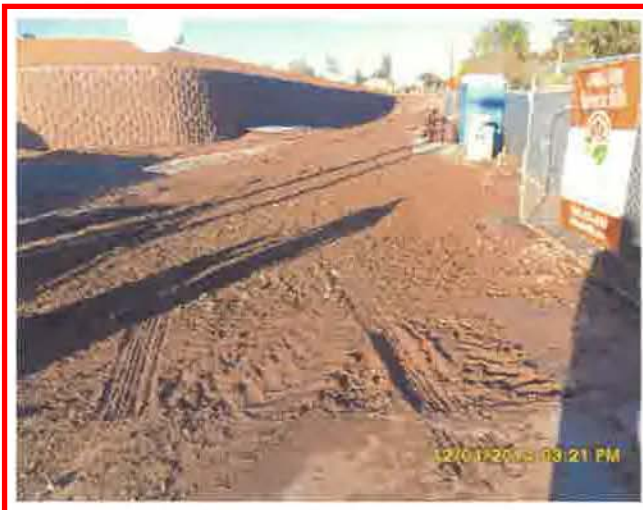
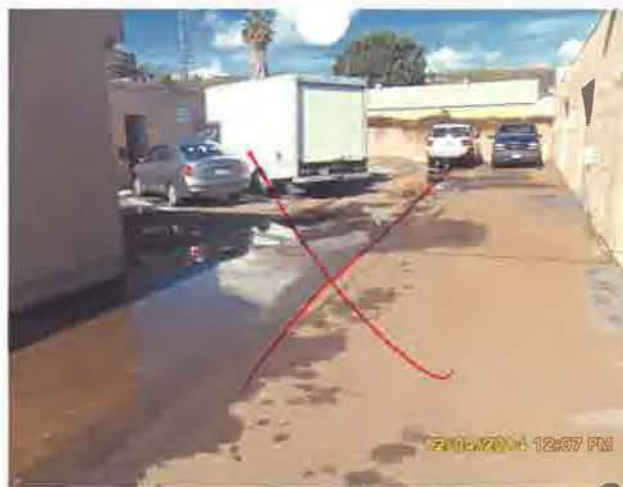
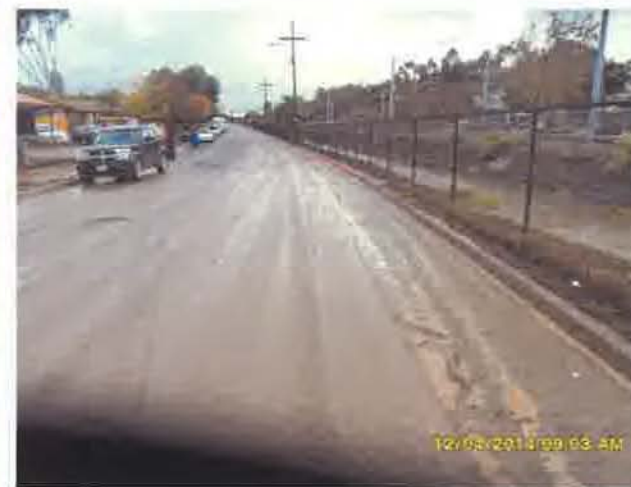
Lack of erosion control in inactive areas.

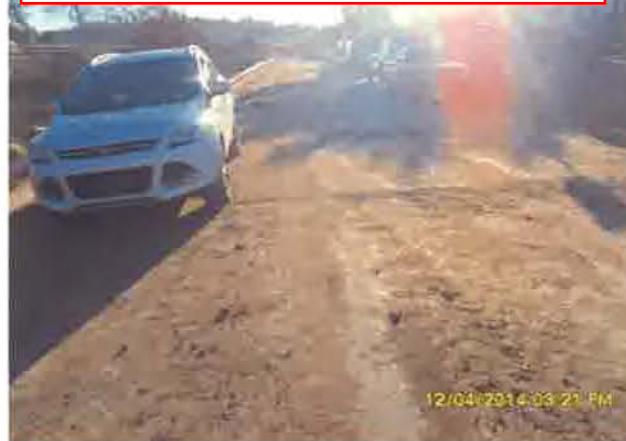
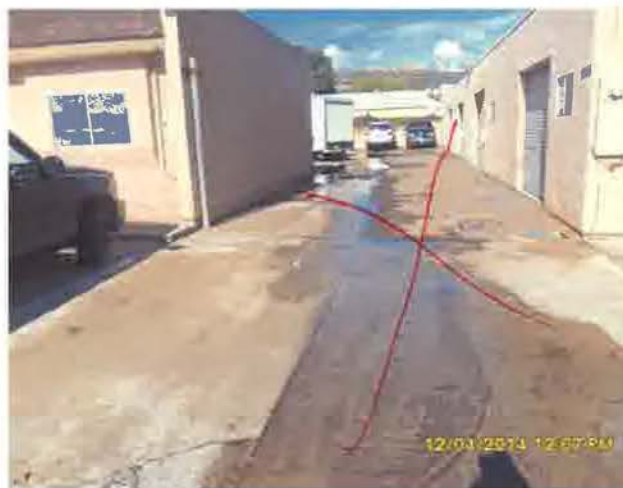
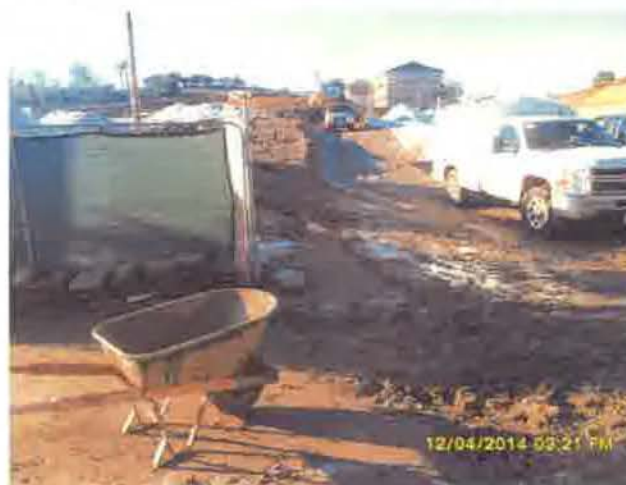
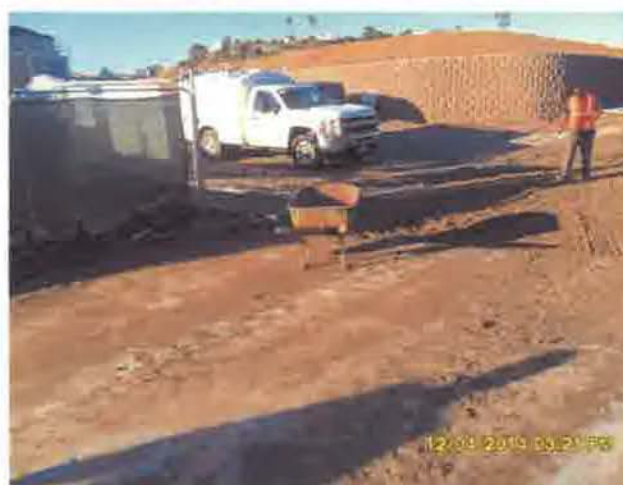
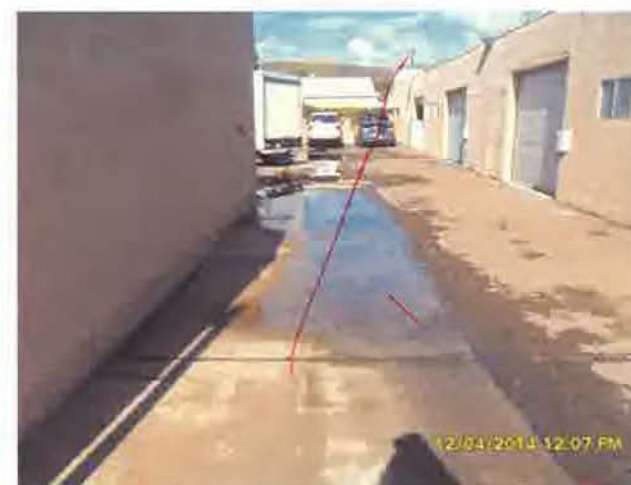
Lack of erosion control BMPs on active areas.

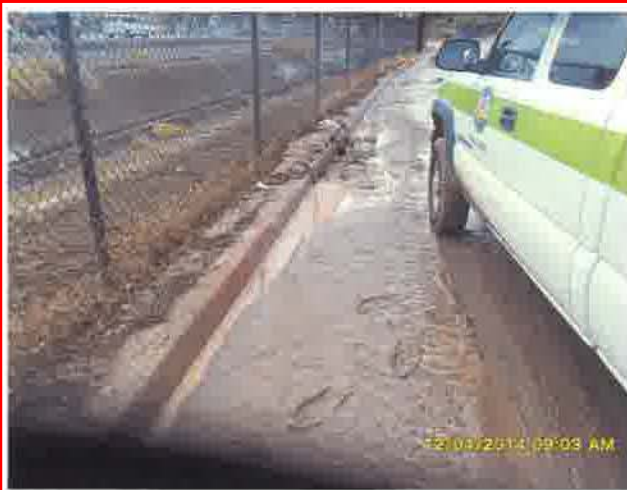
Sediment in street.

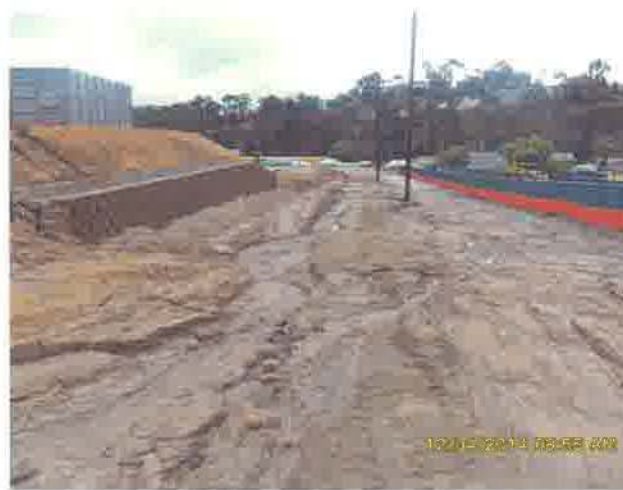
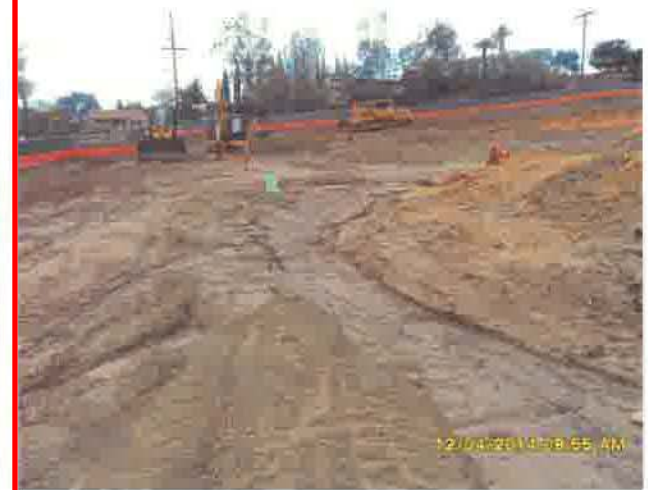
Although stockpile is partially covered it lacks perimeter containment.

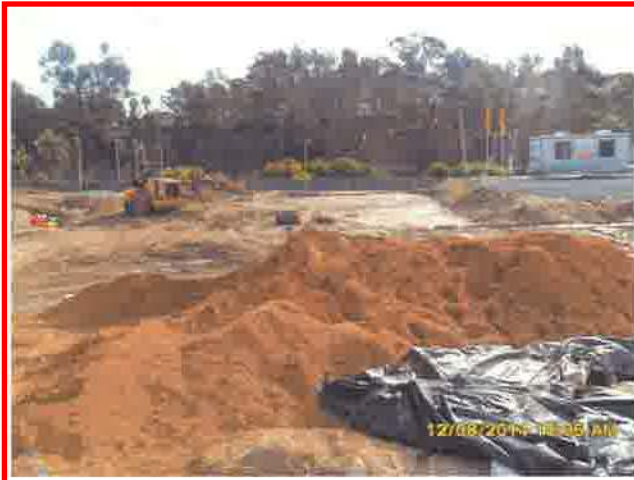
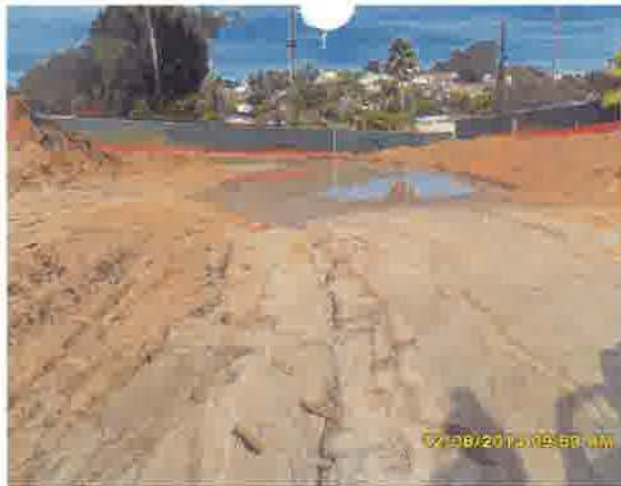
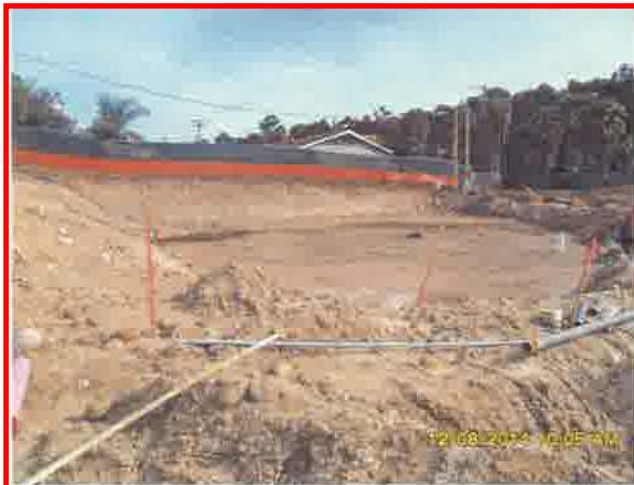
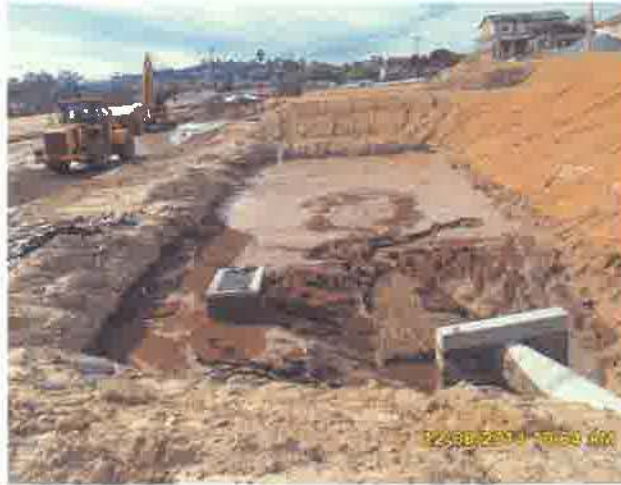
Uncovered stockpile.
