**Exhibit No. 1**

# NOTICE

DATE: 12/2/14  
PROJECT: VALENCIA  
PROJECT #: GR-1692  
ADDRESS: SAN AITO PL

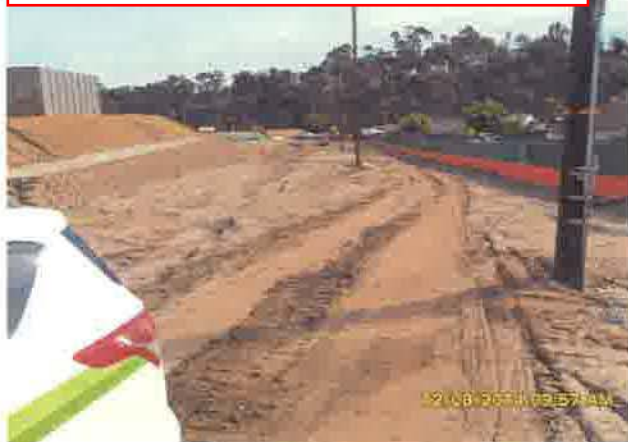
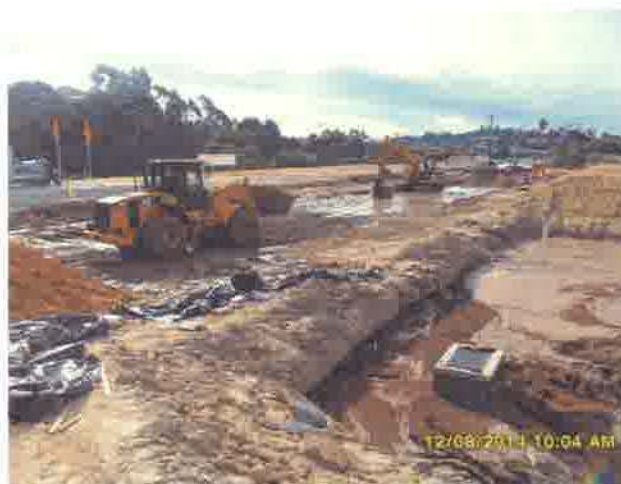
Lack of erosion controls in active areas.

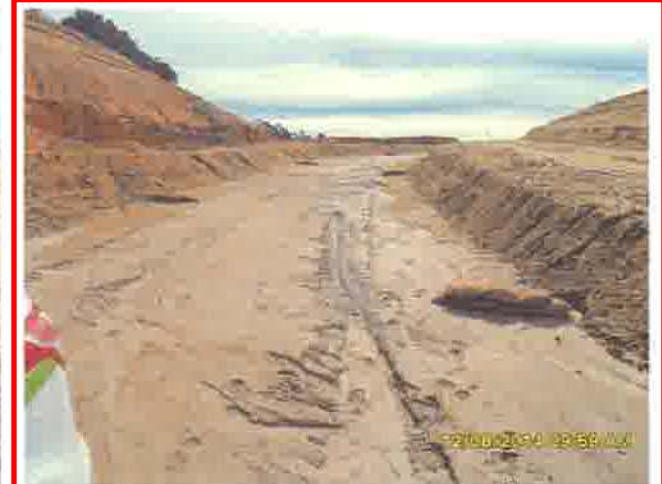
Lack of erosion controls in inactive areas.

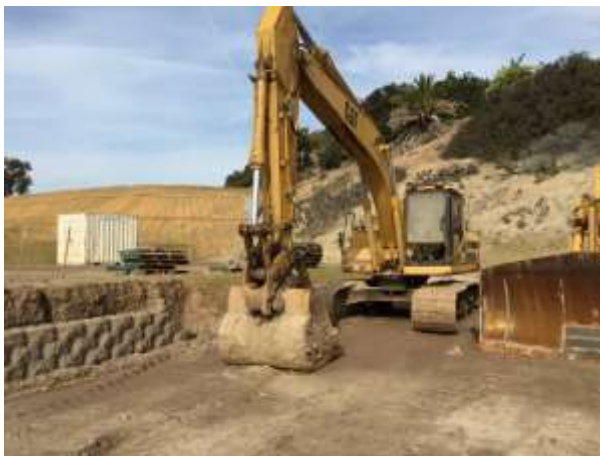
**Photo 2**

**Photos 2 and 3** show **construction equipment and vehicles without** appropriate BMPs (e.g. **drip pans**) to prevent oil, grease, or fuel to leak in to the ground, storm drains, or surface waters. Most vehicles observed during inspection lacked appropriate BMPs.

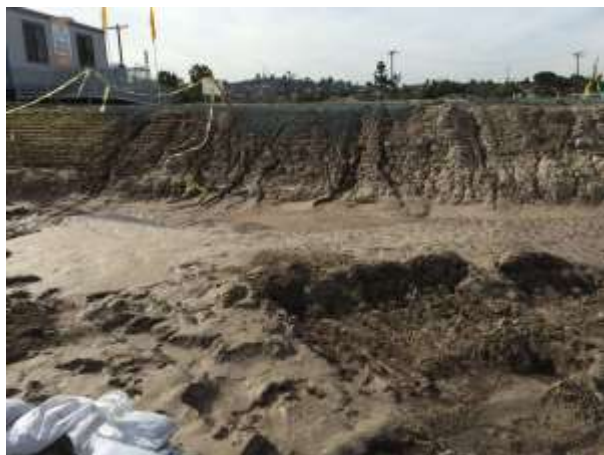
Photo 4

3. Several areas were **observed to be inactive**, or could be scheduled to be inactive, **without effective soil cover** to control potential erosion. Several completed building pads and several inactive slopes (See Photos 4 through 7) lacked any effective soil cover for erosion control. The lack of erosion controls in these areas contributed to **unauthorized sediment discharges from the site** (See Photos 9 through 11). All construction sites are required to provide effective soil cover for inactive areas (i.e. areas that have been disturbed and not scheduled to be re-disturbed for at least 14 days) and all finished slopes, open space, utility backfill, and completed lots.

**Photos 4 through 7** show completed building pads and adjacent slopes without any erosion controls and evidence of significant erosion and sediment transport. **Photo 8** shows evidence of erosion and sediment transport in unpaved road sloping to locations shown in Photos 9 through 11. Sediment from completed lots and slopes in Photos 4 through 7 transported to road in Photo 8 lacking any erosion control measures during storm events, and inadequate runoff controls to reduce and prevent transport of sediment through site.

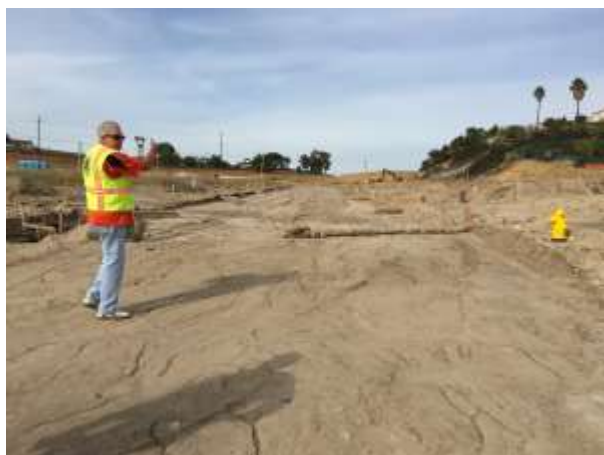
Photo 8

4. **Active areas** were observed to **lack appropriate erosion control BMPs** (runoff control and soil stabilization) to prevent erosion during storm events (See Photo 8). The project manager and QSP could not describe any erosion control measures that were in place or were ready to be deployed before the December 3 and 4, 2014 and December 11, 2014 storm events. Risk Level 2 construction sites are required to implement appropriate erosion control BMPs (runoff control and soil stabilization) in conjunction with sediment control BMPs for areas under active construction.

- a. Pursuant to Provision X and Section E.3 of Attachment D of State Water Board Order No. 2009-0009-DWQ:** Risk Level 2 dischargers shall implement appropriate erosion control BMPs (runoff control and soil stabilization) in conjunction with sediment control BMPs for areas under active construction.
- b. Observation:** During the December 15, 2014 inspection, the San Diego Water Board inspector observed several active areas of the site that did not have appropriate erosion control BMPs in place or ready to be deployed. See attached December 15, 2014 Facility Inspection Report Finding 4 and Photo 8.

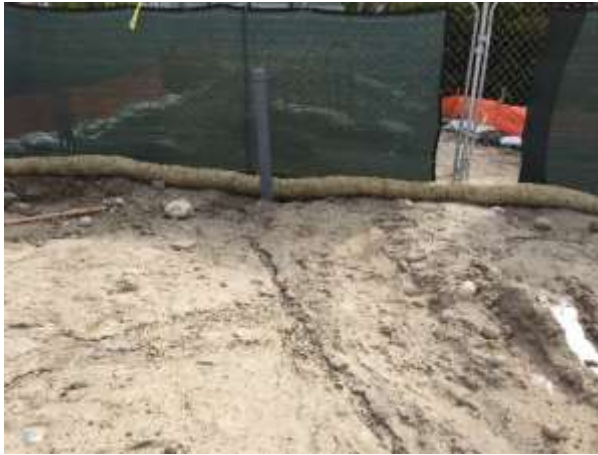
6. Lack of effective perimeter sediment controls observed which resulted in unauthorized sediment discharges from the site (See Photos 9 through 14). All construction sites are required to establish and maintain effective perimeter controls and stabilize all construction entrances and exits to sufficiently control erosion and sediment discharges from the site.
7. **Lack of effective run-on and runoff controls** observed within and around the site which contributed to sediment discharges from the site (See Photos 4 and 14). All construction sites are required to effectively manage run-on, all runoff within the site and all runoff that discharges off the site.

**Photos 9 through 12** show inadequate implementation of perimeter sediment controls and run-on/runoff controls to prevent discharges of sediment from the site. Photo 9 shows evidence of erosion and sediment transport from road shown in Photo 8 to perimeter with inadequately installed perimeter sediment and runoff controls (i.e. fiber roll not properly trenched and staked). Photos 10 shows evidence of sediment transport from the site beneath the inadequately installed perimeter sediment and runoff controls. Photo 11 shows evidence of sediment transport from the site to MS4 channel protected by silt fence and gravel bags. Photo 12 shows **sediment that has been discharged into the MS4 channel** due to inadequate implementation of erosion, sediment, and runoff controls by the site.

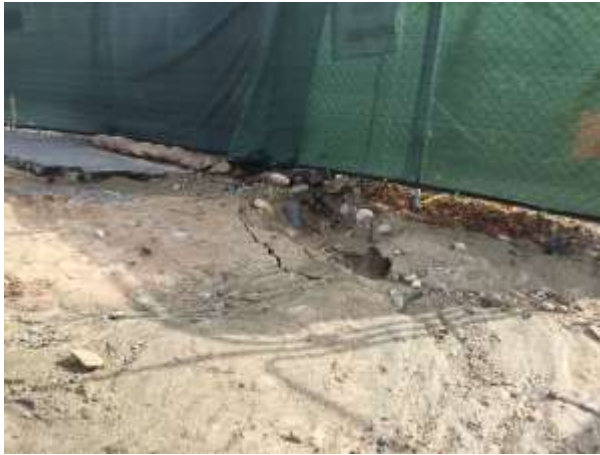
**Photo 13**

**Photos 13 and 14** show lack of effective perimeter sediment controls and run-on/runoff controls. Photo 13 shows evidence of erosion and sediment transport due to lack of perimeter run-on controls. Photo 14 shows evidence of sediment discharged from the site to the MS4 drainage system due to **erosion caused by run-on** that then ran off the site due to inadequate perimeter sediment controls and runoff controls.

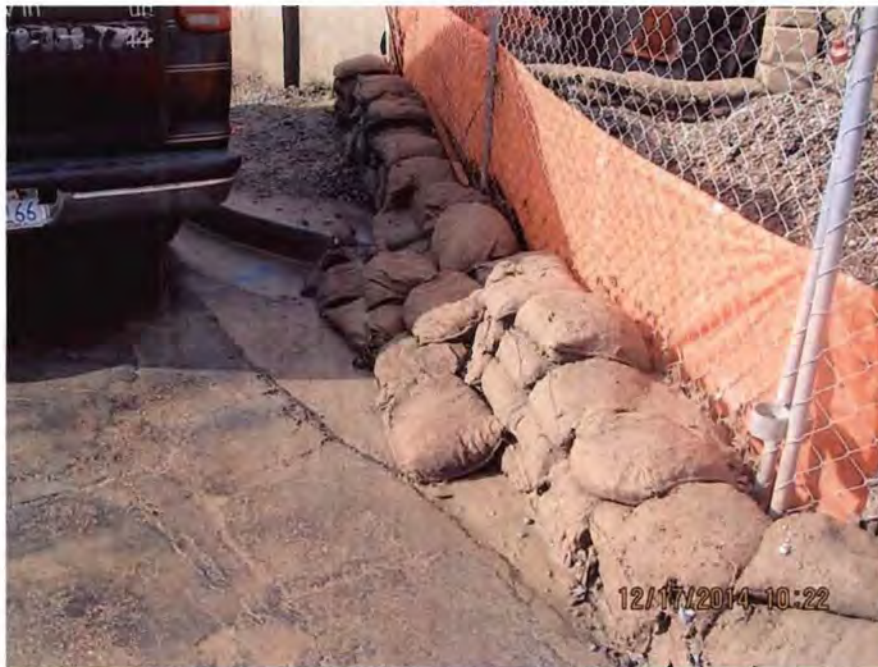
**Evidence of sediment discharge** was observed at the Akins entrance/exit location (Photos 1 and 2) and along the curb farther downstream (Photo 3). A crew from Downstream Services was power washing the curb along Akins to remove accumulated sediment (Photos 4, 5, and 6). This indicates that there likely had been a noticeable sediment discharge earlier in the day. Based on talking with the crew, our understanding is that they were working on behalf of the Valencia project, and they also planned to use a vactor truck to remove accumulated sediment from the downstream storm drain on Akins. The crew was taking measures to prevent discharge of water from power washing, including using a vactor truck to reclaim the water, but a small amount of water was observed discharging to the inlet along Akins. The water was seeping through gravel bags around the inlet and discharge to the storm drain. A sample of the power washing discharge water was collected, and turbidity was measured at 52 NTU.

Photo 1. Evidence of sediment discharge at Akins entrance/exit

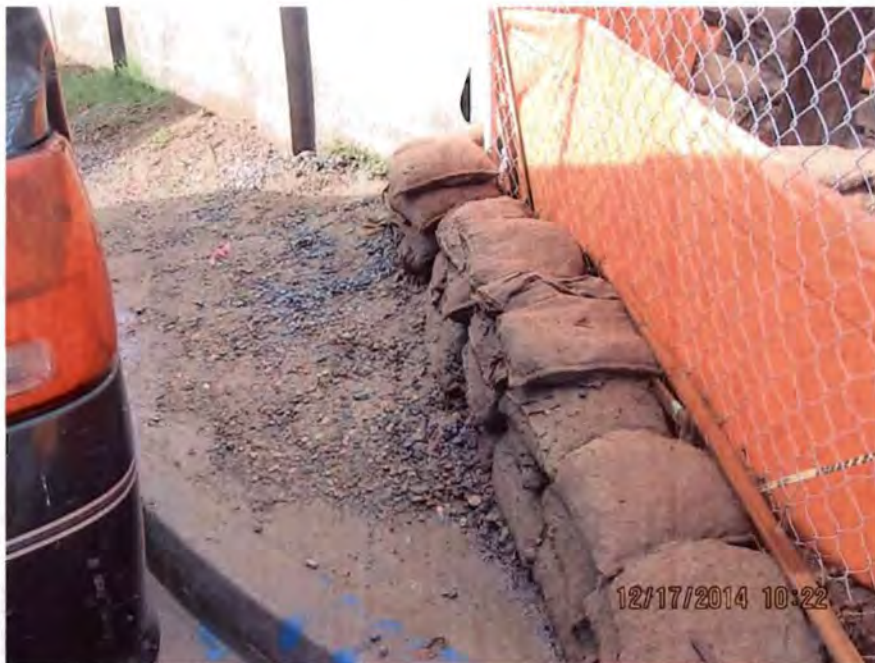
Photo 2. Evidence of sediment discharge at Akins entrance/exit

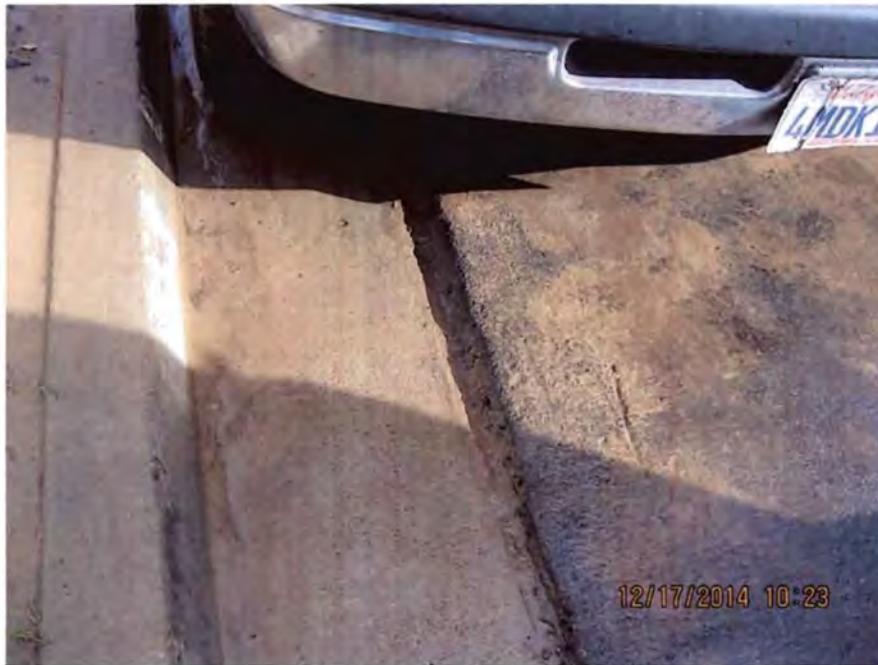
Photo 3. Sediment accumulation along Akins curb gutter, downstream of Akins entrance/exit

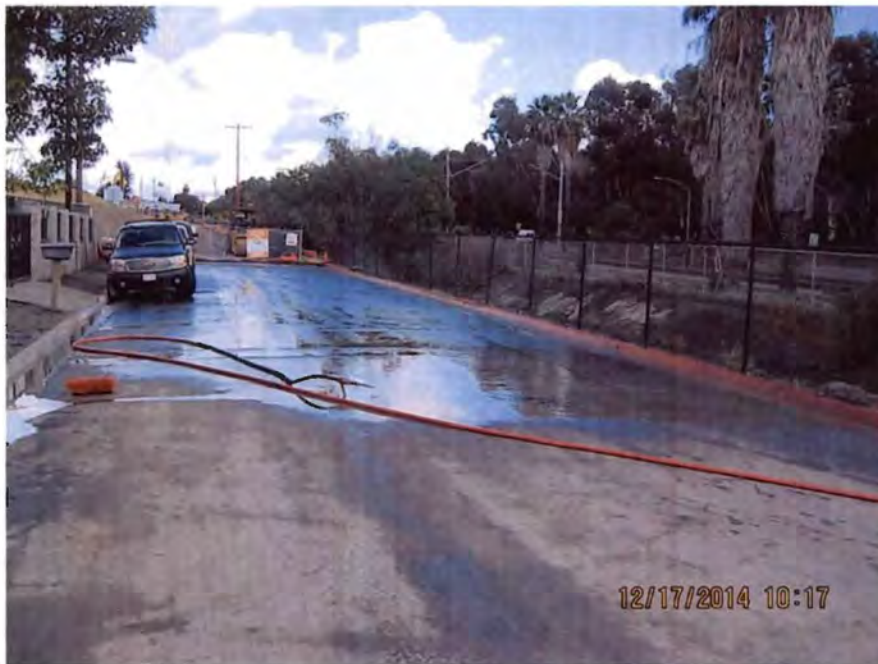
Photo 4. Power washing activity performed by Downstream Services

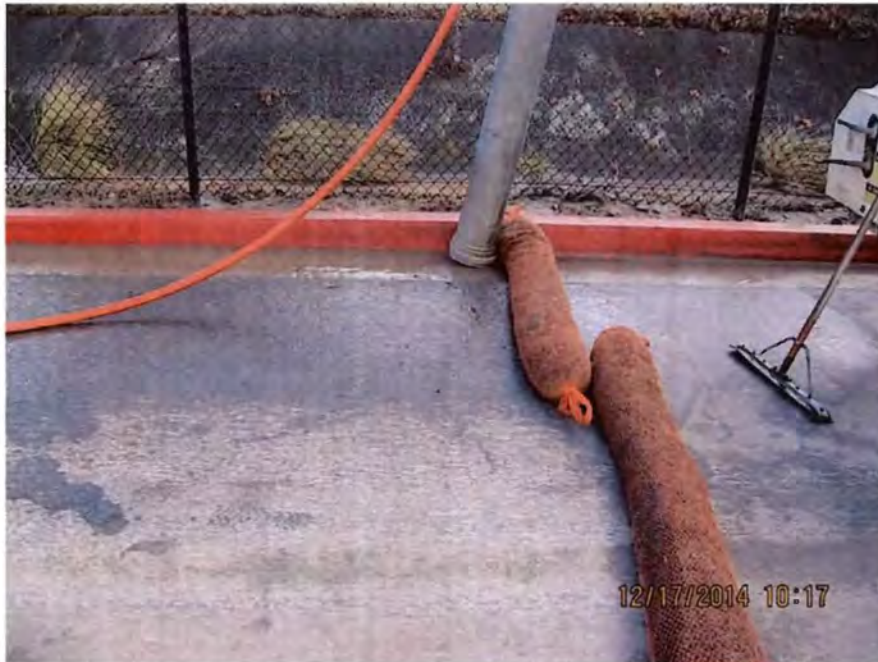
Photo 5. Power washing activity performed by Downstream Services

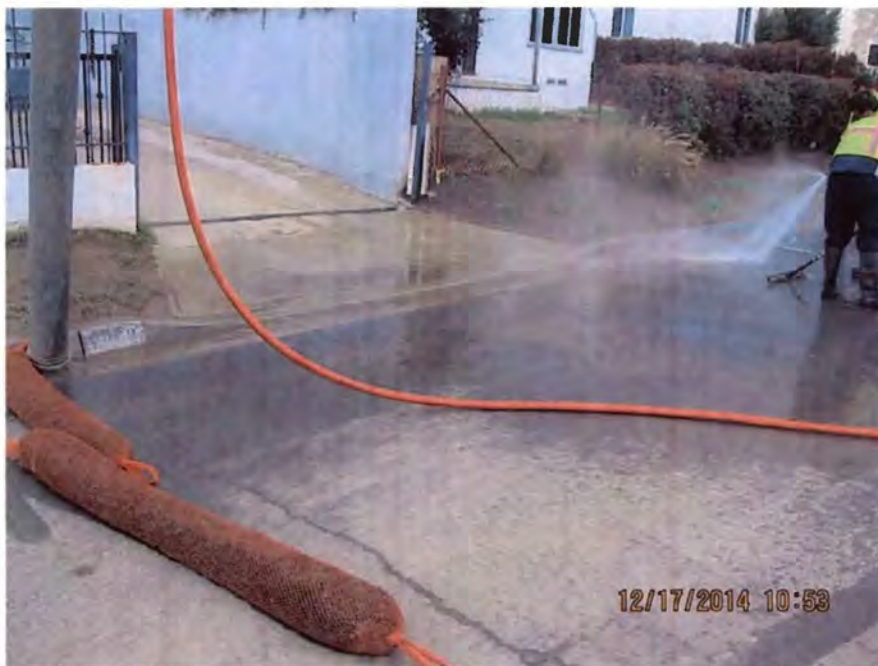
Photo 6. Power washing activity performed by Downstream Services

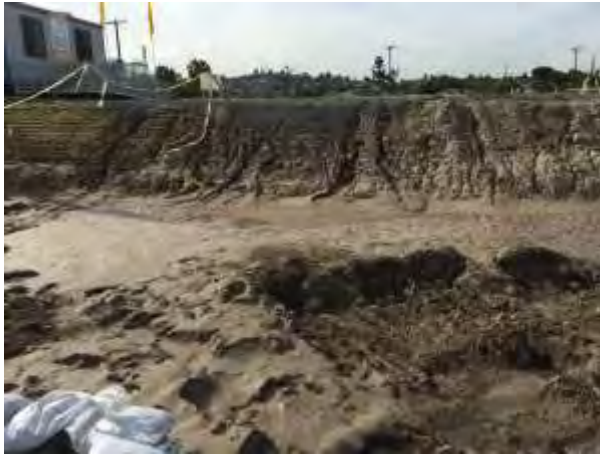
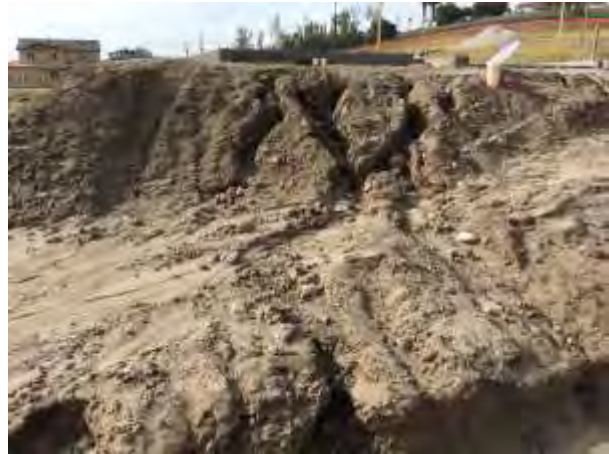
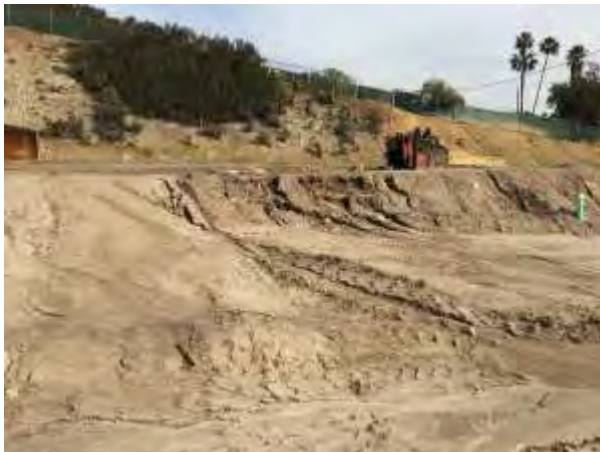
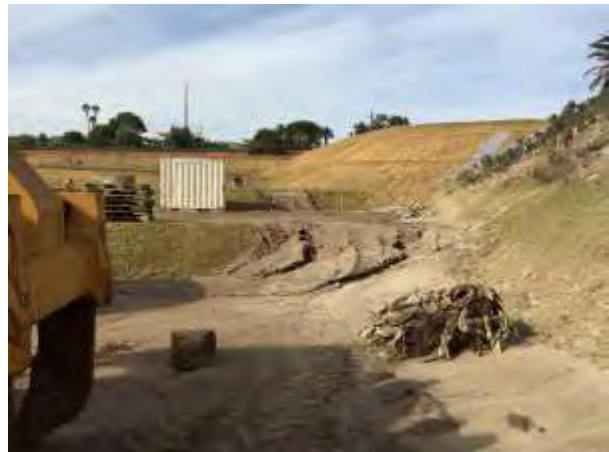
3. Several areas were observed to be inactive, or could be scheduled to be inactive, without effective soil cover to control potential erosion. Several completed building pads and several inactive slopes (See Photos 4 through 7) lacked any effective soil cover for erosion control. The lack of erosion controls in these areas contributed to unauthorized sediment discharges from the site (See Photos 9 through 11). All construction sites are required to provide effective soil cover for inactive areas (i.e. areas that have been disturbed and not scheduled to be re-disturbed for at least 14 days) and all finished slopes, open space, utility backfill, and completed lots.

**Photos 4 through 7** show completed building pads and adjacent slopes without any erosion controls and evidence of significant erosion and sediment transport. **Photo 8** shows evidence of erosion and sediment transport in unpaved road sloping to locations shown in Photos 9 through 11. Sediment from completed lots and slopes in Photos 4 through 7 transported to road in Photo 8 lacking any erosion control measures during storm events, and inadequate runoff controls to reduce and prevent transport of sediment through site.

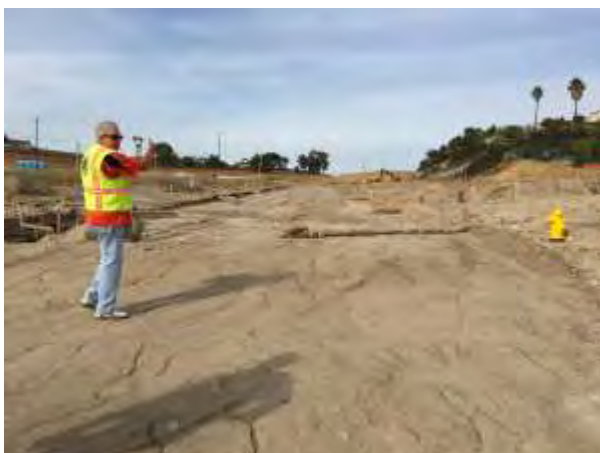
Photo 8

4. Active areas were observed to lack appropriate erosion control BMPs (runoff control and soil stabilization) to prevent erosion during storm events (See Photo 8). The project manager and QSP could not describe any erosion control measures that were in place or were ready to be deployed before the December 3 and 4, 2014 and December 11, 2014 storm events. Risk Level 2 construction sites are required to implement appropriate erosion control BMPs (runoff control and soil stabilization) in conjunction with sediment control BMPs for areas under active construction.

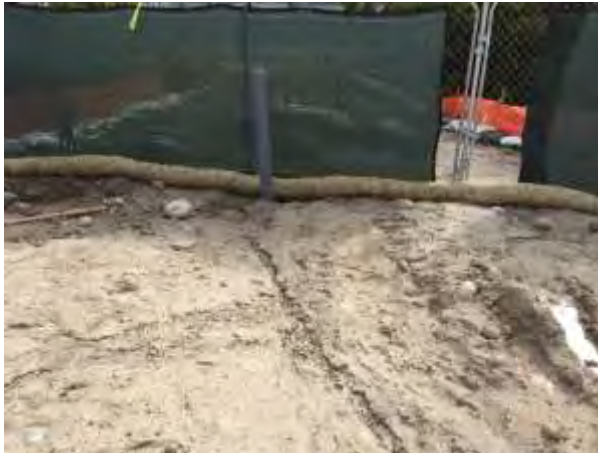
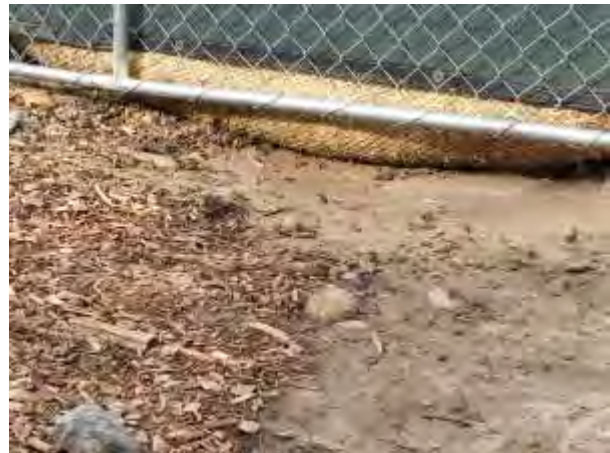
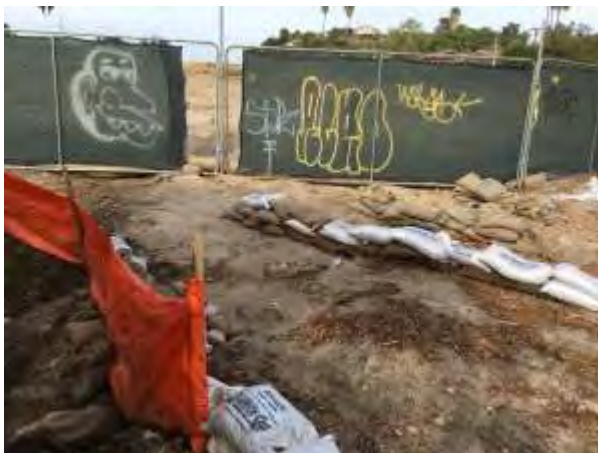
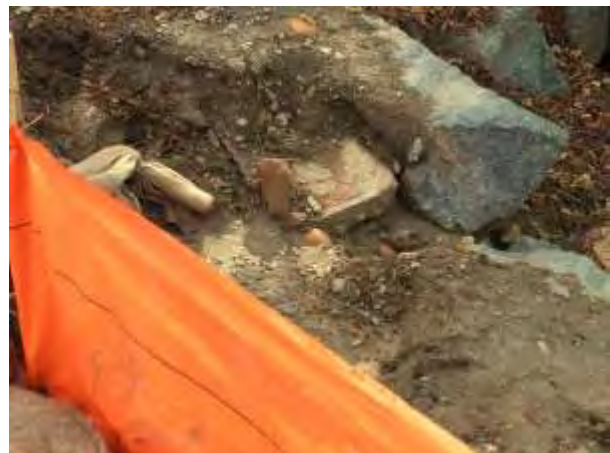
6. Lack of effective perimeter sediment controls observed which resulted in unauthorized sediment discharges from the site (See Photos 9 through 14). All construction sites are required to establish and maintain effective perimeter controls and stabilize all construction entrances and exits to sufficiently control erosion and sediment discharges from the site.
7. Lack of effective run-on and runoff controls observed within and around the site which contributed to sediment discharges from the site (See Photos 4 and 14). All construction sites are required to effectively manage run-on, all runoff within the site and all runoff that discharges off the site.

**Photos 9 through 12** show inadequate implementation of perimeter sediment controls and run-on/runoff controls to prevent discharges of sediment from the site. Photo 9 shows evidence of erosion and sediment transport from road shown in Photo 8 to perimeter with inadequately installed perimeter sediment and runoff controls (i.e. fiber roll not properly trenched and staked). Photos 10 shows evidence of sediment transport from the site beneath the inadequately installed perimeter sediment and runoff controls. Photo 11 shows evidence of sediment transport from the site to MS4 channel protected by silt fence and gravel bags. Photo 12 shows sediment that has been discharged into the MS4 channel due to inadequate implementation of erosion, sediment, and runoff controls by the site.

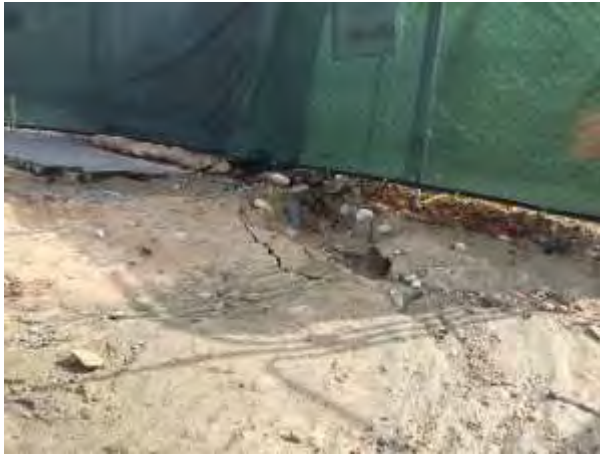
**Photo 13**

**Photos 13 and 14** show lack of effective perimeter sediment controls and run-on/runoff controls. Photo 13 shows evidence of erosion and sediment transport due to lack of perimeter run-on controls. Photo 14 shows evidence of sediment discharged from the site to the MS4 drainage system due to erosion caused by run-on that then ran off the site due to inadequate perimeter sediment controls and runoff controls.

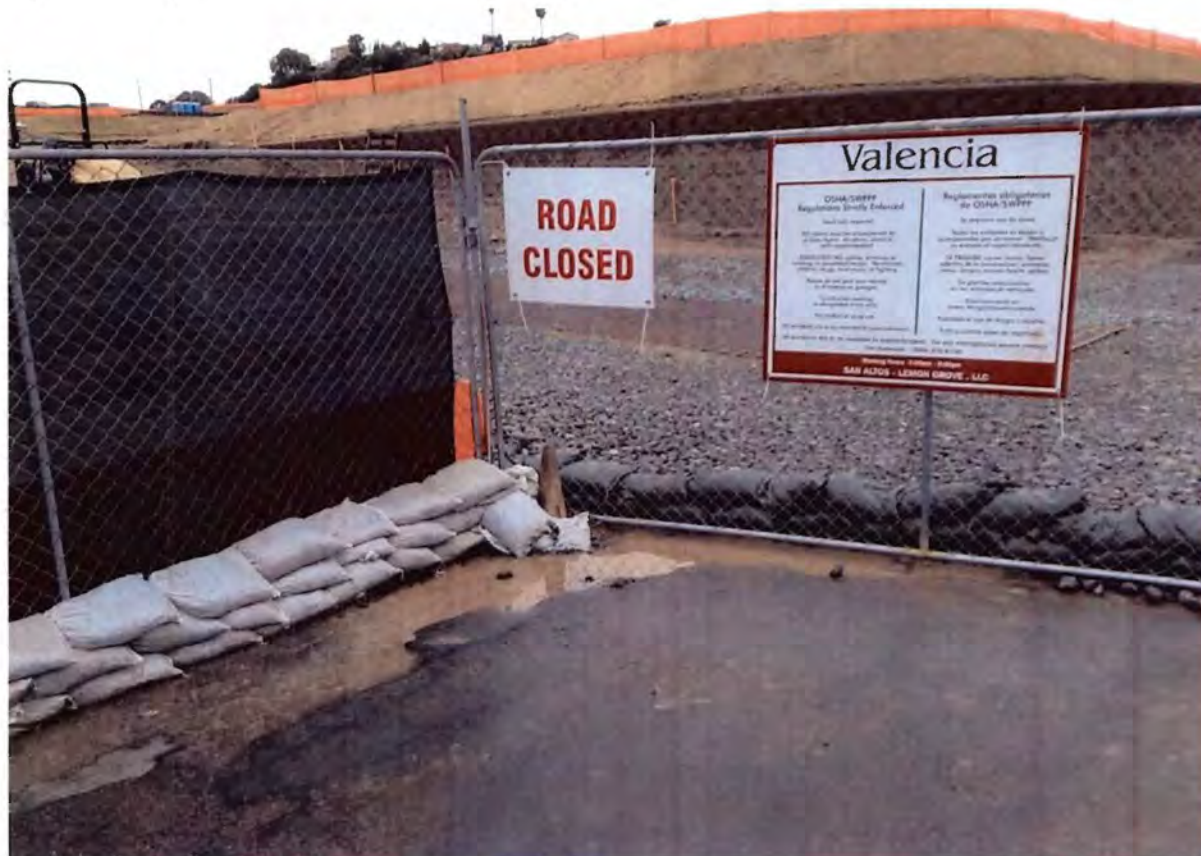
Some sediment had settled out at the bottom of the pools of water in both of the locations at which samples were collected, and care was taken not to disturb the settled sediment when samples were taken. Note that because water had been pooled and sediment had settled out over time, the turbidity results as given above are likely lower than the turbidity of the discharge that had occurred earlier when it was raining. To approximate that effect, the settled sediment at the Akins entrance/exit location was disturbed, and a sample was taken a few minutes later. The turbidity of that sample was 998 NTU.

Photo 1. Ponded Water at Akins Avenue Entrance/Exit

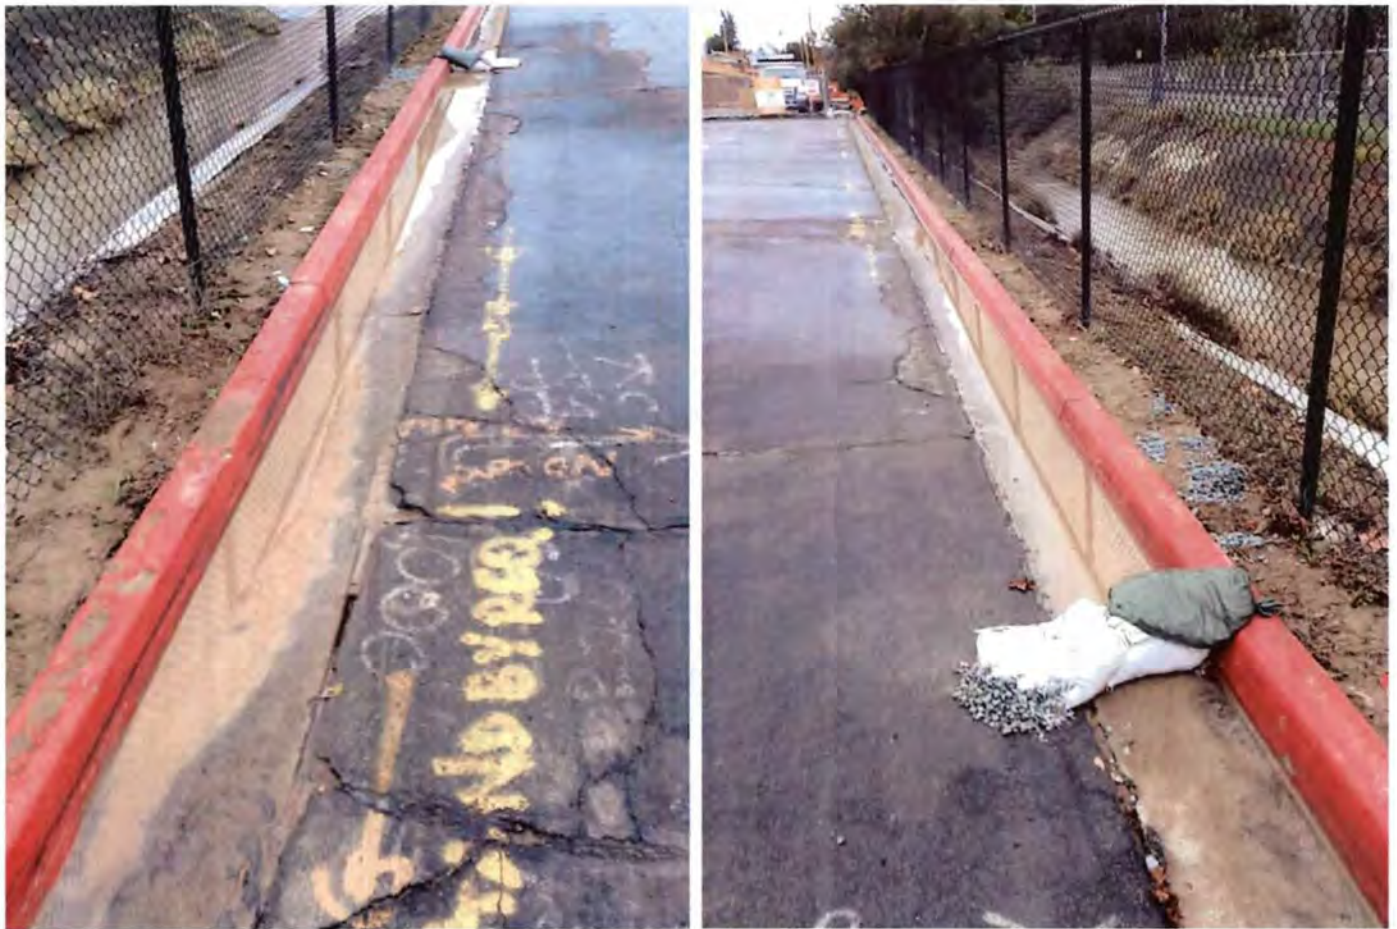
Photos 2 & 3. Ponded Water at First Set of Gravel Bags Downstream of Akins Avenue Entrance/Exit (Looking downstream and upstream, respectively)

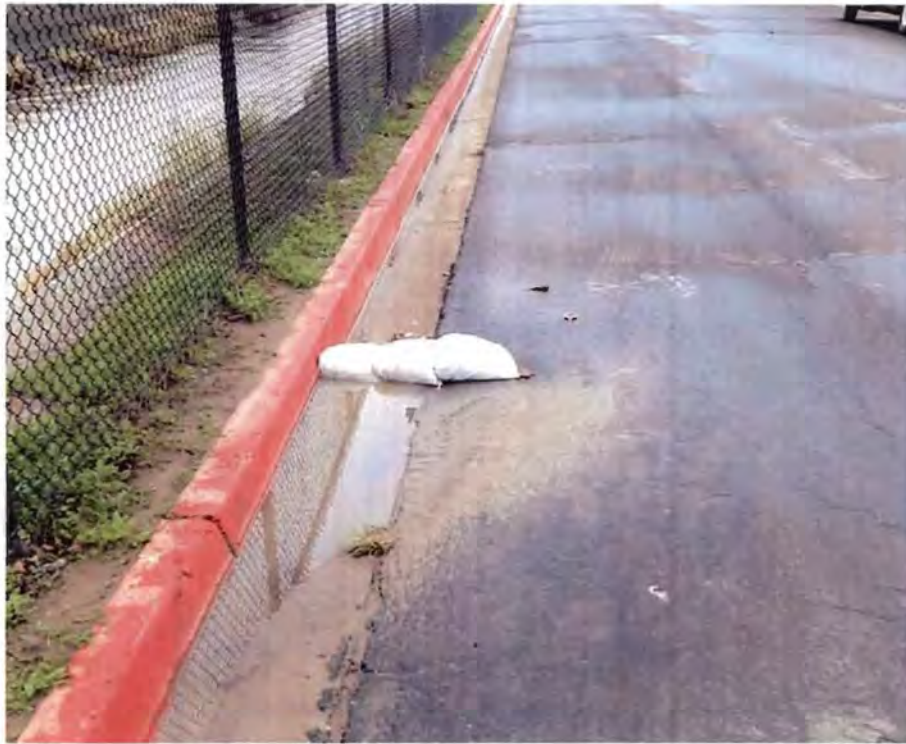
Observations farther downstream along the curb indicated that in some places sediment had been conveyed around gravel bag installations. Photo 4 gives an example of this. Sediment accumulation was also noted along Akins Avenue, close to the storm drain inlet.

Photo 4. **Evidence of Discharge Carrying Sediment** around Gravel Bags along Akins Avenue

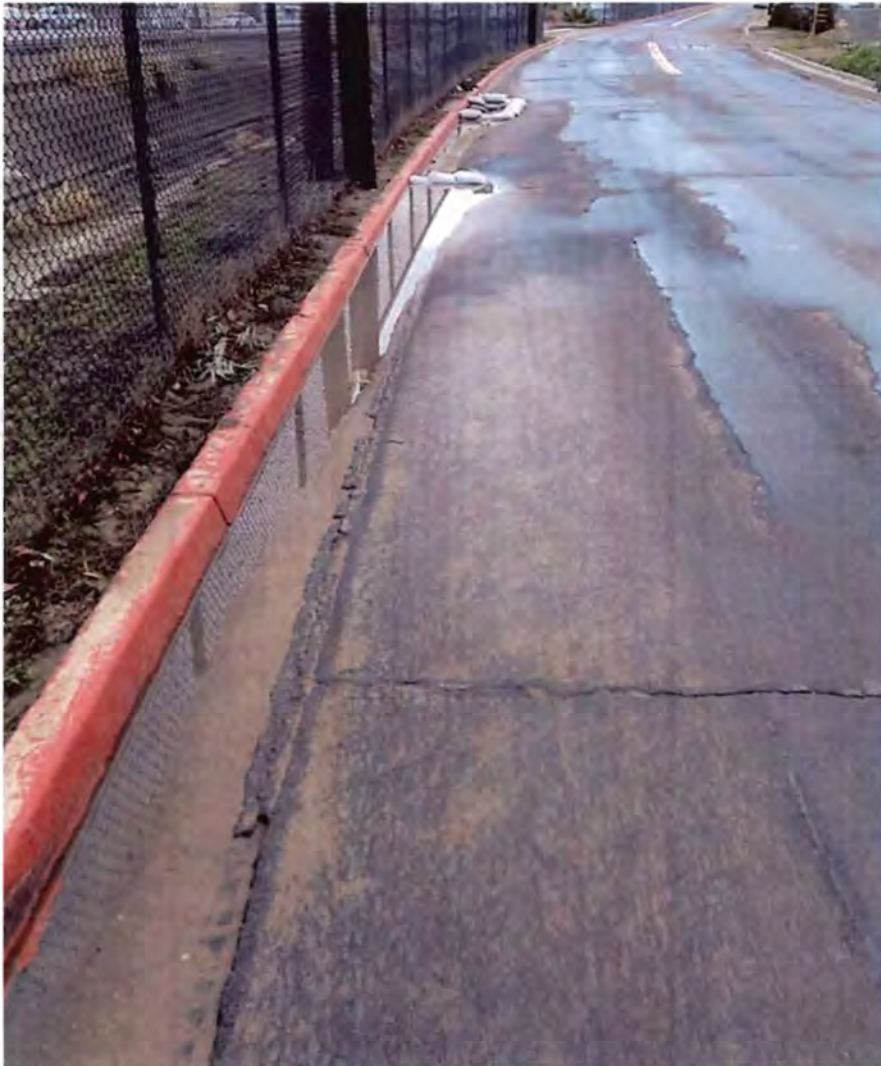
Photo 5. Sediment Accumulation along Akins Avenue, Close to Inlet

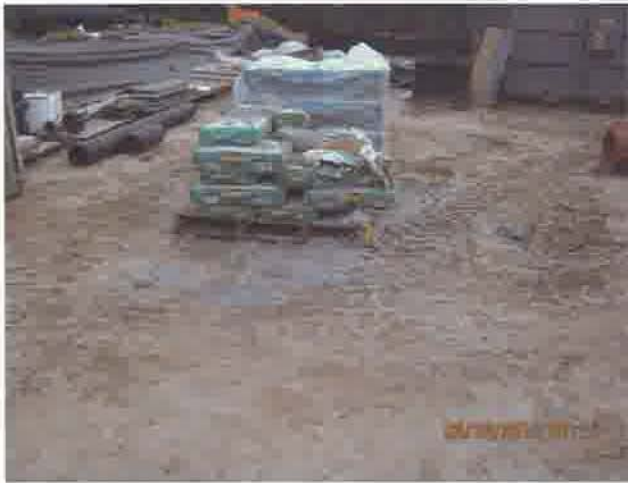
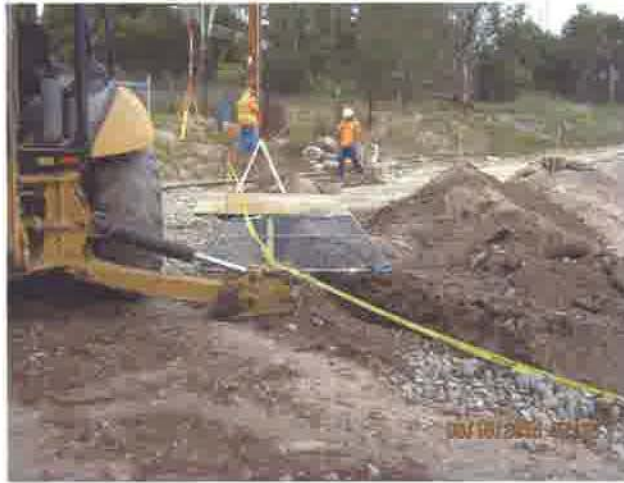
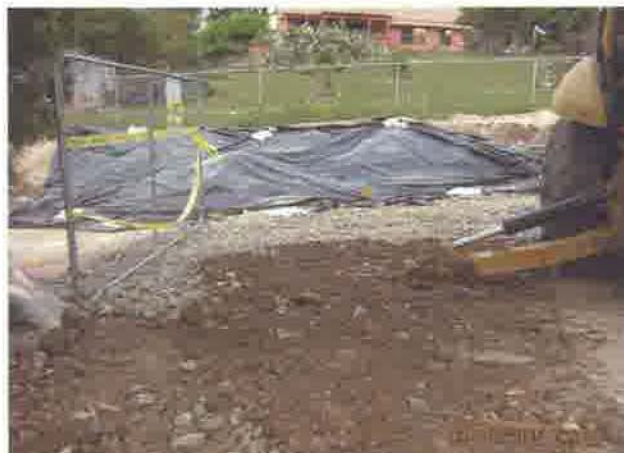
Failure to cover and provide secondary containment.

- ① IMPLEMENT ADEQUATE EROSION CONTROLS ON SLOPES & SIDEWALLS
- ② CLEAN UP CONCRETE WASTE OBSERVED AT MULTIPLE LOCATIONS  
AND ENSURE THAT ALL EMPLOYEES USE WASHOUTS PROPERLY
- ③ IMPLEMENT ADEQUATE TRACKING CONTROLS IN DRIVEWAY  
TRANSITIONS FROM PAVEMENT TO EXPOSED LOTS
- ④ PROTECT INLET AND SURROUNDING AREA OF EXPOSED SOIL
- ⑤ SWEEP/CLEAN SEDIMENT FROM ROADWAY
- ⑥ IMPLEMENT ADEQUATE EROSION CONTROLS ON EXPOSED INACTIVE AREAS
- ⑦ PROVIDE STABILIZATION AT INLETS TO BASINS
- ⑧ REPLACE/REFRESH STABILIZED CONSTRUCTION ENTRANCE
- ⑨ IMPLEMENT ADEQUATE PERIMETER CONTROL BMPs
- ⑩ ENSURE THAT DRIP PANS ARE PLACED UNDER VEHICLES  
WHEN NOT IN USE
- ⑪ PROVIDE SECONDARY CONTAINMENT FOR LIQUID STORAGE

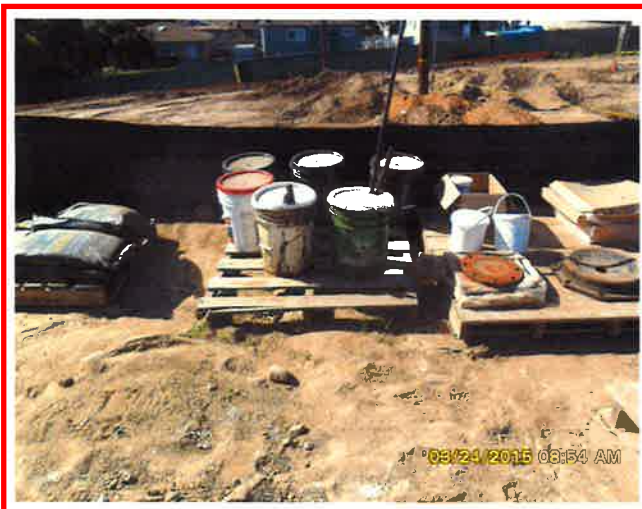
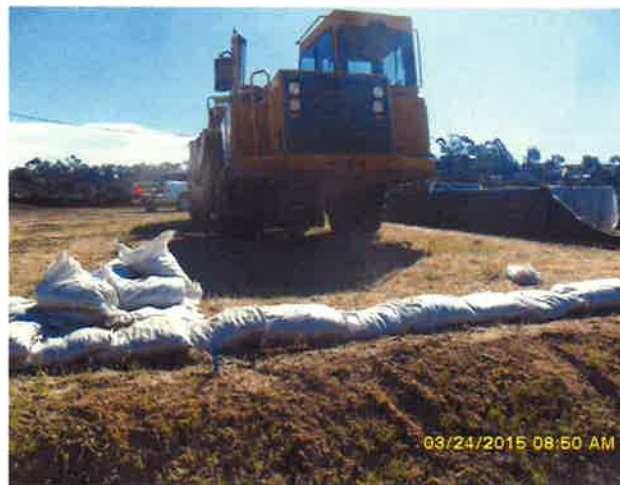
Failure to cover and provide secondary containment.

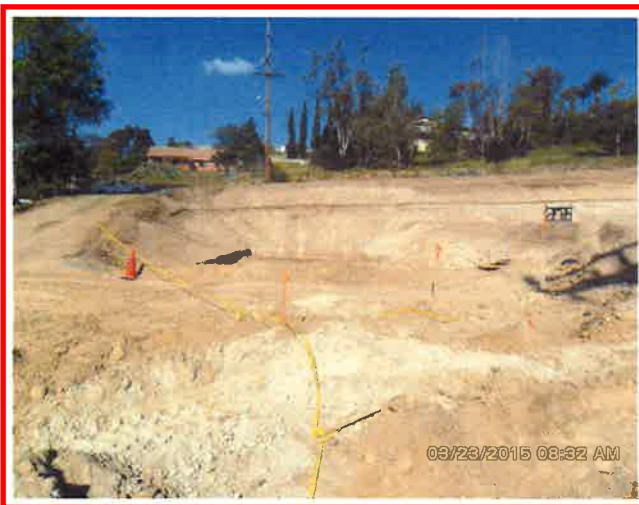
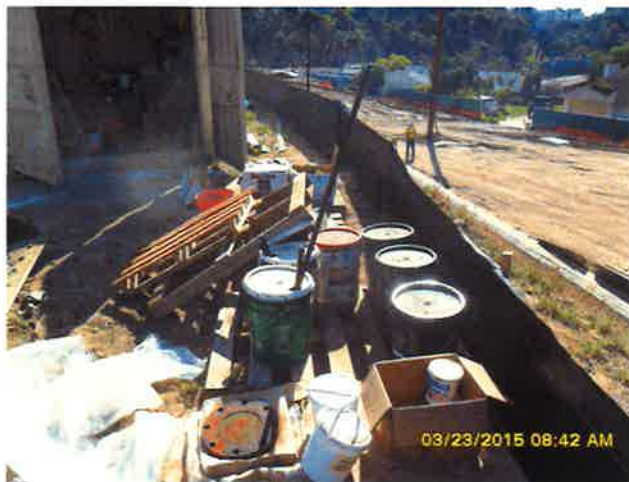
Lack of erosion controls in active areas.

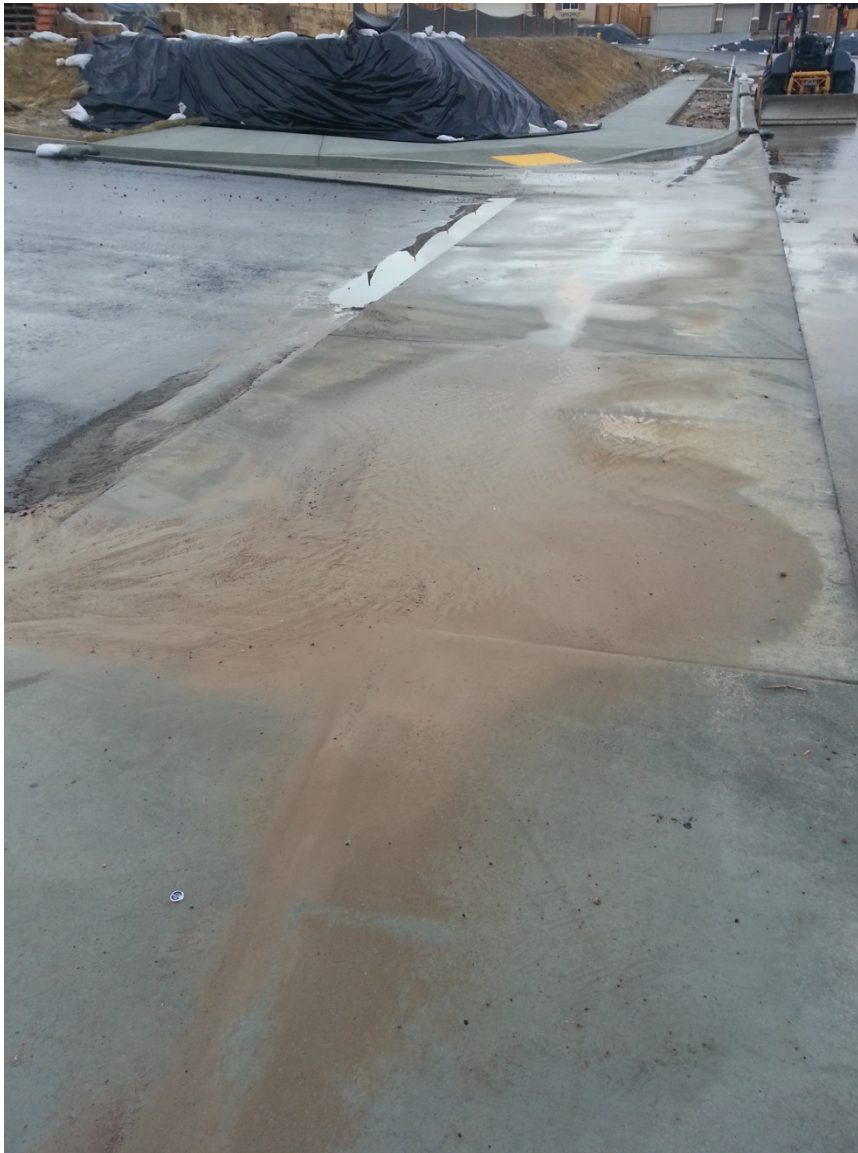
**Photograph No. 3:** 20150508\_191955.jpg, taken by Frank Melbourn, San Diego Water Board

**Photograph No. 3** looks northeast at the corner of Valencia Court and Orlando Drive from Orlando Drive. The photograph displays a **sediment discharge** from disturbed construction areas into the street. Except the area with plastic sheeting, displayed slopes in the photograph show signs of erosion, and were lacking erosion and sediment control BMPs at their base.

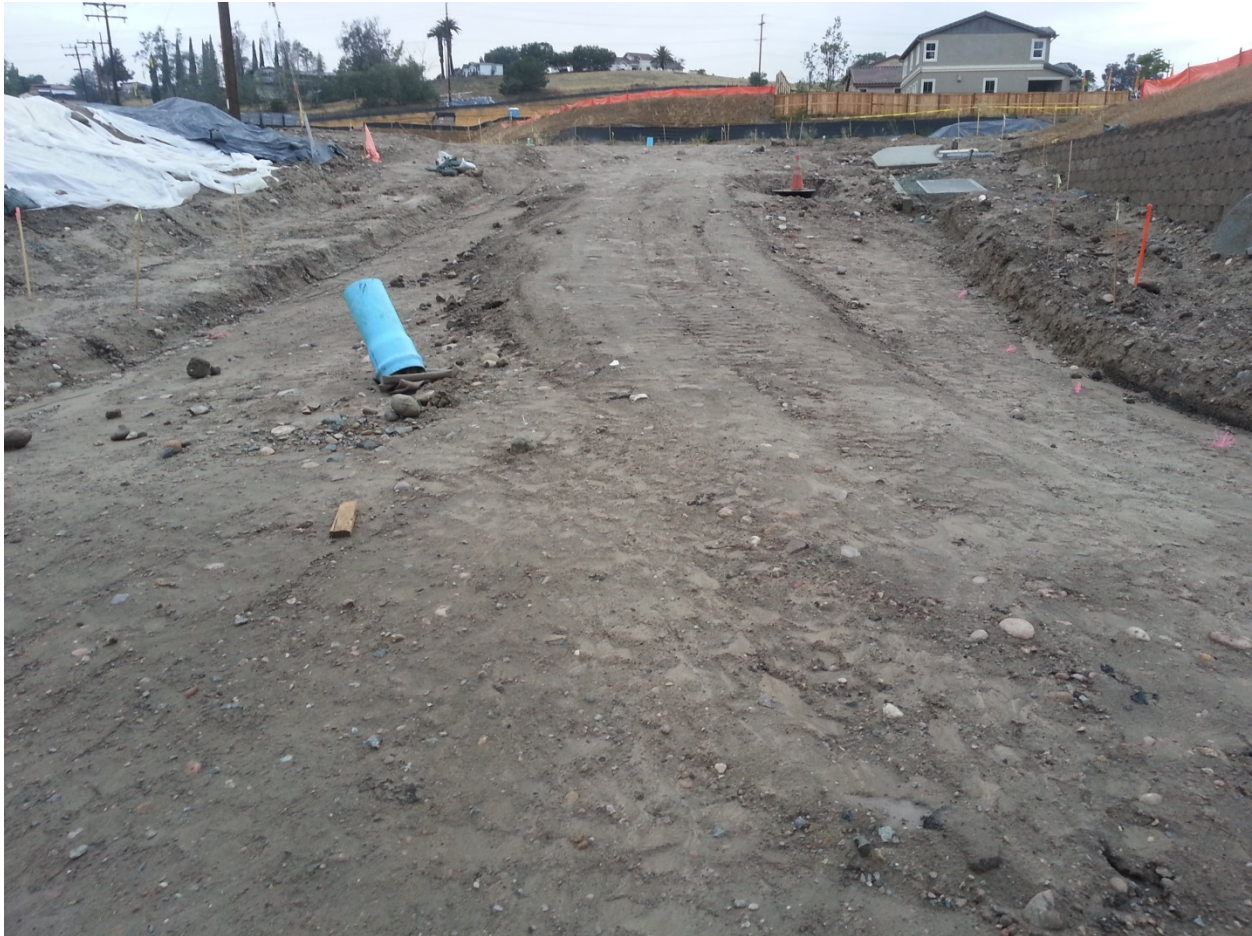
**Photograph No. 4:** 20150508\_192214.jpg, taken by Frank Melbourn, San Diego Water Board

**Photograph No. 4** looks northwest up Seville Way from Akins Avenue. The photograph displays disturbed soil without erosion control BMPs and sediment control BMPs.

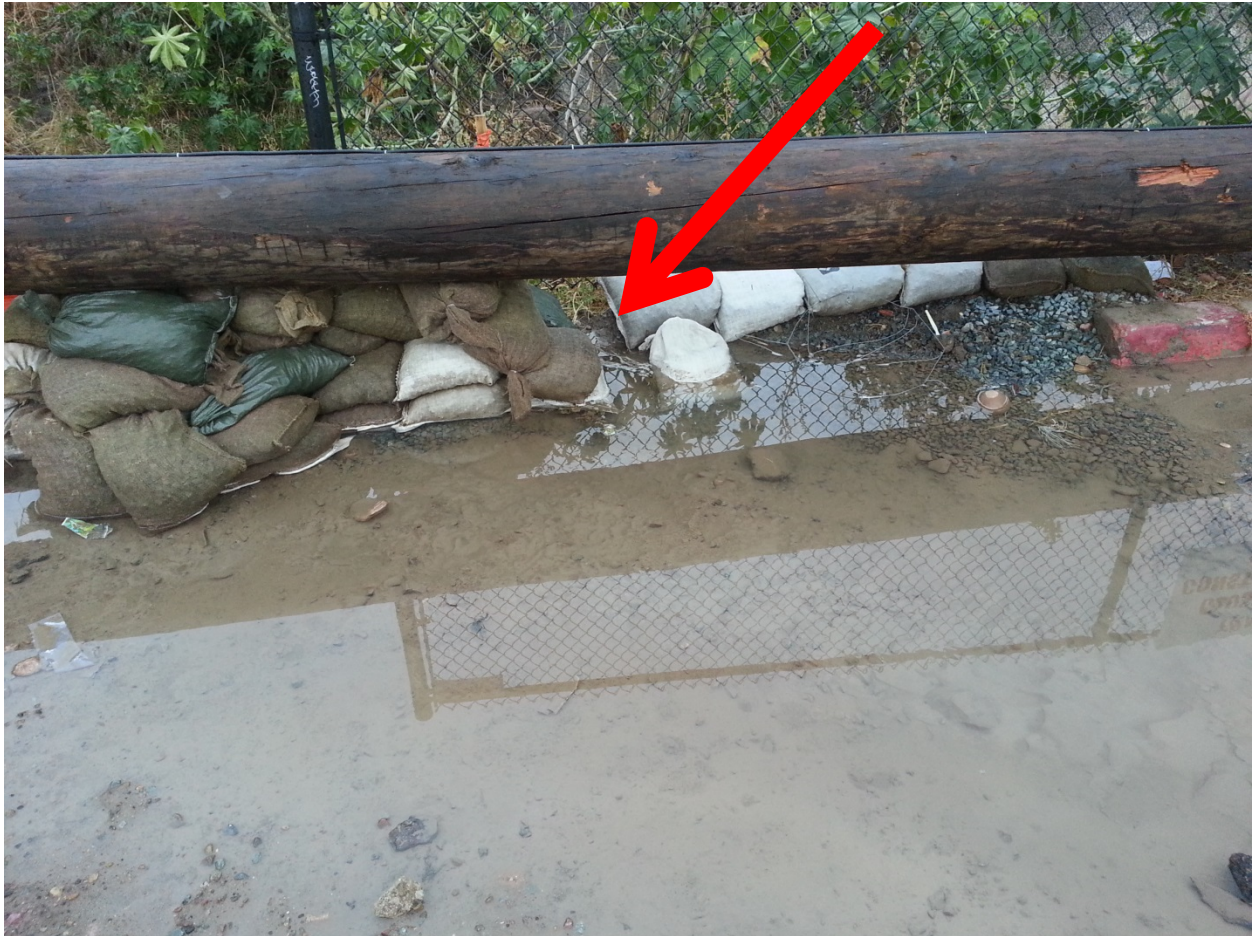
**Photograph No. 5:** 20150508\_192234.jpg, taken by Frank Melbourn, San Diego Water Board

**Photograph No. 5** looks southeast onto the unnamed tributary to Chollas Creek from the intersection of Seville Way and Akins Avenue. The photograph displays the **sediment discharge point** between the gap (identified by red arrow) in the site perimeter control BMPs into the unnamed tributary. A buildup of eroded sediment from the site can be seen at the base of the gravel bags.

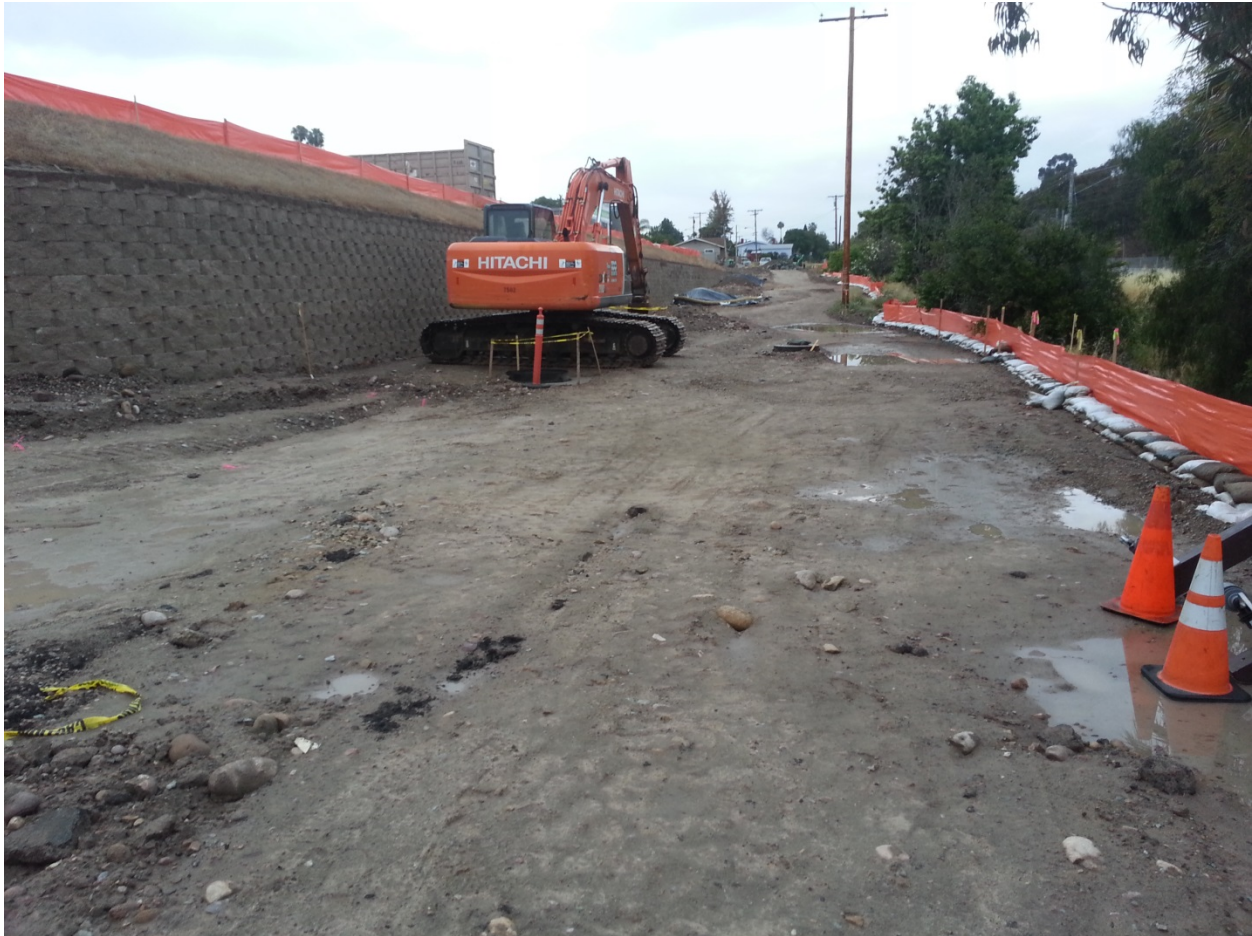
**Photograph No. 6:** 20150508\_192253.jpg, taken by Frank Melbourn, San Diego Water Board

**Photograph No. 6** looks northeast onto Akins Avenue from the intersection of Akins Avenue and Seville Way. The photograph displays disturbed soil without erosion control BMPs and sediment control BMPs. The photograph also displays perimeter control BMPs on the right hand side.
